THE REINFORCEMENT OF AN ASR AFFECTED INTAKE TOWER USING POST-TENSIONED TENDONS

Tetsuji Kubo^{1*}, Toshiharu Shibata¹, Chikao Sannoh¹, Kazuyuki Torii²

¹Hokuriku Electric Power Co. Ltd., <u>IAPAN</u>

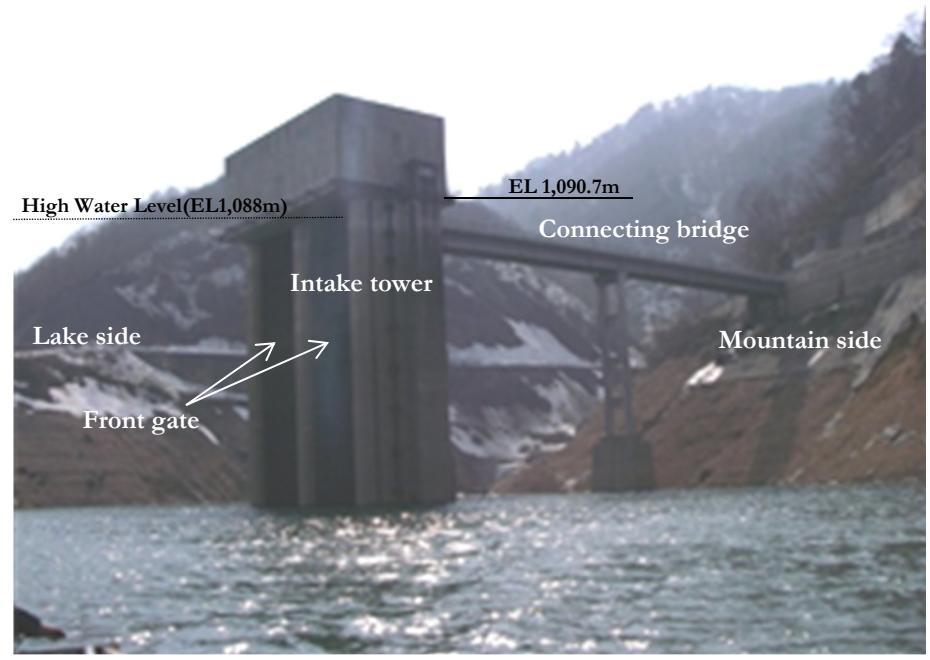
This intake tower is located at a dam in the upstream region of a river in Japan's Hokuriku District. Figure 1 shows the actual site. 74m³/s of water can pass through the intake tower and 400 thousand kW can be generated by using this water at 3 power stations located downstream of the tower. This electricity corresponds approximately to the power needs of about 130 thousand households. Thus, this intake tower is a critical structure for the area and the company.

FIGURE 1: Actual site of the intake tower.

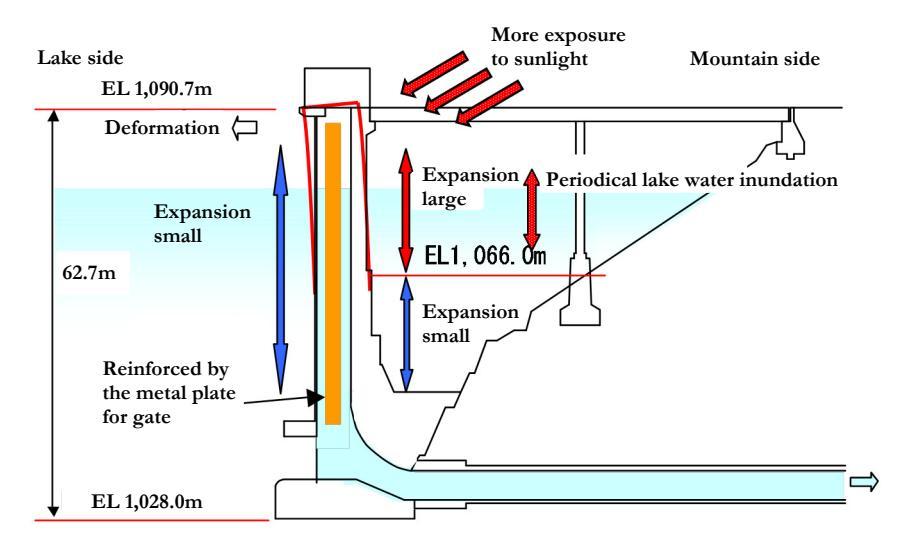
In this way the comparative differences between the concrete environments and the different degrees of reinforcement on the mountain side and lake side result in unequal amounts of ASR expansion on opposite sides of the tower. This is the fundamental cause of the towers increasing inclination in the direction of the lake. Figure 3 is a summary outline of the primary causes of the ASR.

FIGURE 3: Summary outline of the primary causes of the ASR.

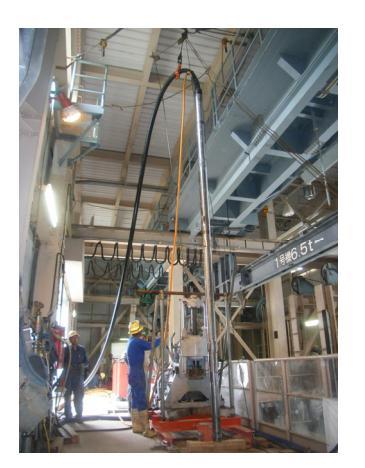
FIGURE 6: Insertion work status of the anchor.

Concerning the specifications of the PC steel wire, the tension-adjustable SEEE anchor A type, 360TA ($19 \times \Phi 12.7$ mm, yield point load of 2964kN, drilling diameter of $\Phi 165$ mm), which was the maximum size available, was adopted. Figure 6 shows the insertion work status of the anchor. Figure 7 shows the construction location plan view, and Figure 8 shows the drilling depth view. Drilling on the mountain side was, as much as possible, evenly spaced with 10 places, each place spaced at a distance of about 2m from the next. Furthermore, in order to balance the whole structure, two anchors were placed on the lake-side. The anchors' base positions of immobilization are set at near EL1045m close to the bottom portion of the tower structure, and in this way tension was applied to the entire structure. Thus, 45.7m drilling depth was needed.

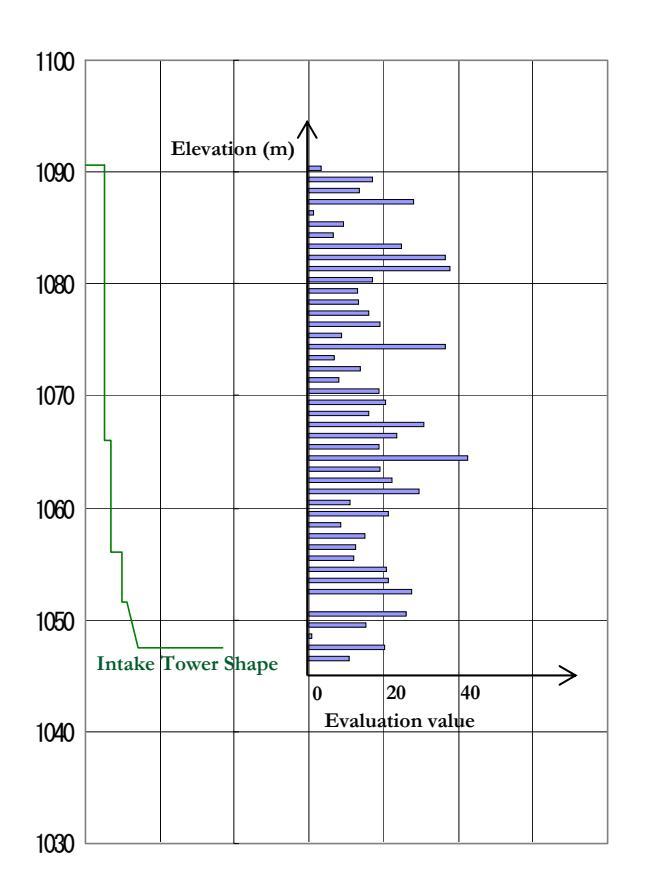
The observation based on the DRI method was carried out (this item is shown Table 2) by the visual observation of the coarse aggregate at the side of the cores (Φ 165mm, extension 45.75m), and the numbers corresponding to the items were counted every 1m, then the number was weighted. This number has been discussed with respect to the progress of the ASR [10]. Figure 12 shows the evaluation result. As a result, the phenomenon caused by the ASR has been confirmed across the intake tower. In addition, near EL1090m there is a section that is not submerged, and the compressive strength was large and the evaluation index for that location was low. However, for other sections the evaluation index varied, but there was no apparent association with compressive strength, so a static elastic modulus was not found. The reason there was no clear tendency is that this evaluation was made using only observations of coarse aggregate. However, the fine aggregate also exhibited significant reactions as revealed by the polarizing microscope observations, so it is not possible to draw final conclusions until the factors from all kinds of aggregate are taken into consideration.

FIGURE 12: Evaluation result based on the DRI method.

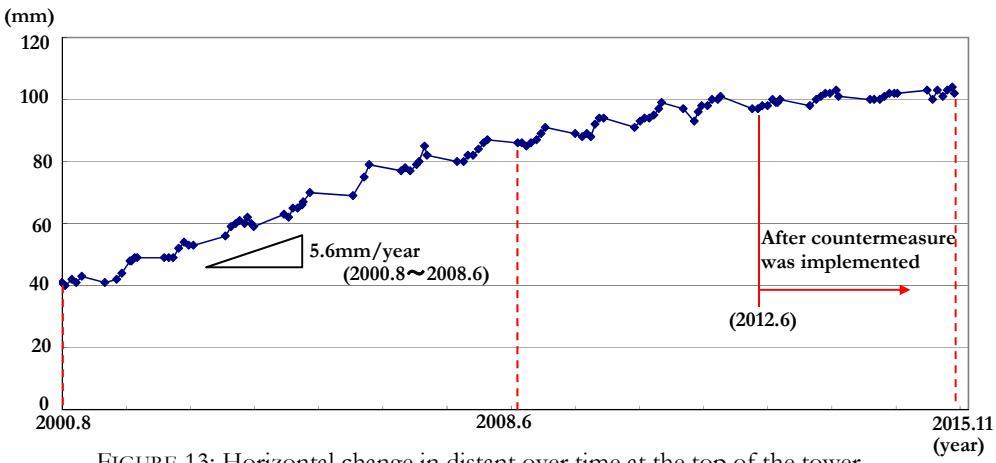
Figure 13 shows the horizontal change in distant over time at the top of the tower, and Figure 14 shows the vertical change over time at the top of the tower, which horizontal and vertical measurements were both conducted from 22 years after construction. During the 8-year period of 22 to 30 years following construction the rate of horizontal change at the top of the tower was 5.6mm per year. Assuming that the average rate of change was the same prior to the commencement of measurements and taking into account the currently measured change of 86mm, we estimate that the beginning of this deformation started about 15 years following construction. During the same 8-year period, the rate of vertical change was calculated to be 2.1mm per year. Thus, assuming that the deformation along the vertical axis of the tower also began 15 years after construction and assuming that the rate of deformation was uniform over time, we estimate that the overall height of the tower at its top has increased by 33mm on the side of the connecting bridge.

Figure 13 shows the horizontal change in distant over time at the top of the tower, and Figure 14 shows the vertical change over time at the top of the tower, including after the countermeasure was implemented. Changes to the top of the intake tower after the countermeasure was implemented have decreased. Therefore, the effect of the countermeasure has been confirmed.

FIGURE 13: Horizontal change in distant over time at the top of the tower.

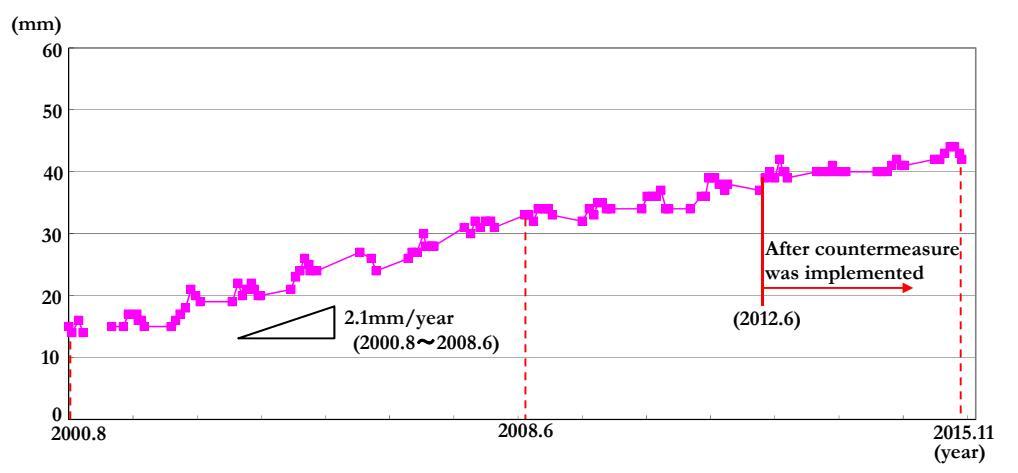
FIGURE14: Vertical change in distant over time at the top of the tower.

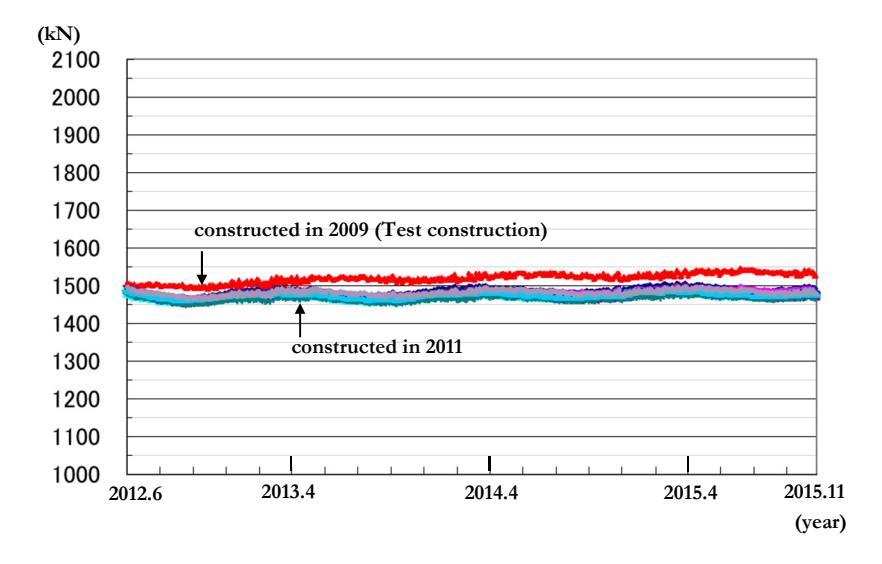
Figure 15 shows changes of tension over time that were measured by a load cell. As shown in the figure, although some variation over a year's time was seen, drastic load change was not seen. Therefore, we have confirmed that tensions had been stably controlled.

FIGURE 15: Changes of tension over time that were measured by a load cell.
