FIELD AND LABORATORY EXAMINATIONS OF AN ASR-AFFECTED BRIDGE – VARIATION IN CRACK EXTENT AND WATER CONTENT

Eva Rodum*, Bård M. Pedersen, Ragnhild Holen Relling

Norwegian Public Roads Administration, Trondheim/Bergen/Ålesund, NORWAY

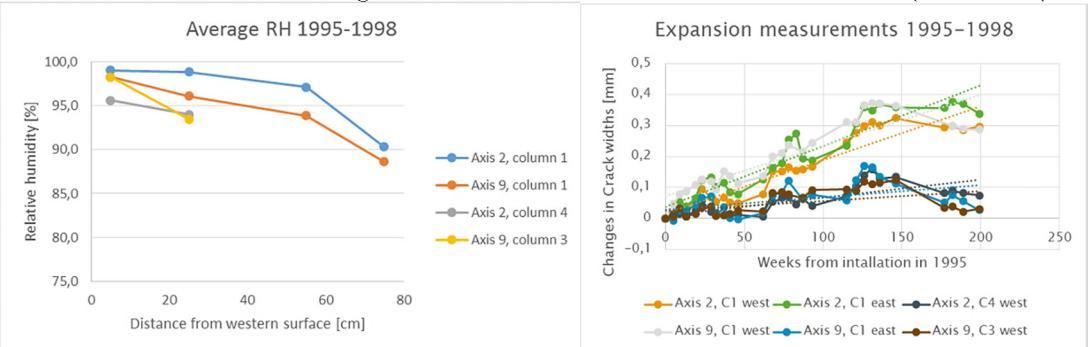
Average RH values over four years (February 1995-December 1998), measured in four depths from the western surface (5, 25, 55 and 75 cm), are shown in FIGURE 4 (left) for column 1 and 4 in axis 2 and column 1 and 3 in axis 9. The RH is high, above 85 %, in all locations. The humidity is higher in the concrete exposed to the west compared to east and decreases from depth 5 to 75 cm for all columns. The average RH in the different depths from the western face is for the western columns (C1, which are most exposed to rain): 98.7, 97.5, 95.5 and 89.5 % and for the more sheltered columns (C3 and C4): 97.0 and 94.8 % (depths 5 cm and 25 cm, respectively).

Based on the plotted crack increase and slope of trend lines, the expansion rate may be divided into two main groups: The highest expansion rate (approx. 0.4 mm/4 years) is measured on the rainexposed faces of both western columns and on the eastern face of one of the western columns (C1 in axis 2). The lowest expansion rate (approx. 0.1 mm/4 years) is measured on the western face of the sheltered columns (C3 and C4) and on the eastern face of one of the western columns (C1 in axis 9). Except for the behavior of the eastern face of the western column in axis 2, the correlation between measured RH and increase in crack widths seems good.

FIGURE 4: To the left: Relative humidity measured with the wooden stick method [5] in columns in axis 2 (column 1 and 4) and axis 9 (columns 1 and 3). Average values of 5-10 yearly measurements from February 1995 to December 1998. To the right: Expansion measurements over single cracks [4].

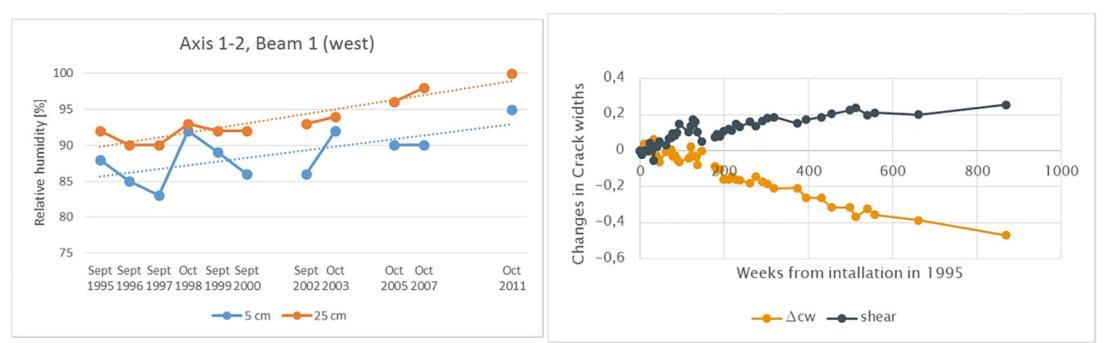
The beams have been under supervision due to ASR since 1990. The western beam between axes 1 and 2 (western face) was instrumented in one location by Jensen [4] in 1995, for measuring of relative humidity and expansion (changes in crack widths). The results from measurements over the period 1995-2011 are shown in FIGURE 5. The RH has increased over the years from 88/92 % to 95/100 % in depths 5/25 cm from the surface. The expansion measurements show closing of the crack (-0.5 mm), but slightly increased shear movement along the crack (0.26 mm).

FIGURE 5: To the left: Relative humidity measured with the wooden stick method [5] in west face of western beam between axis 1 and 2, in depths 5 and 25 cm from surface. [4]. To the right: Expansions over the crack (Δ cw) and along the crack (shear) [4].

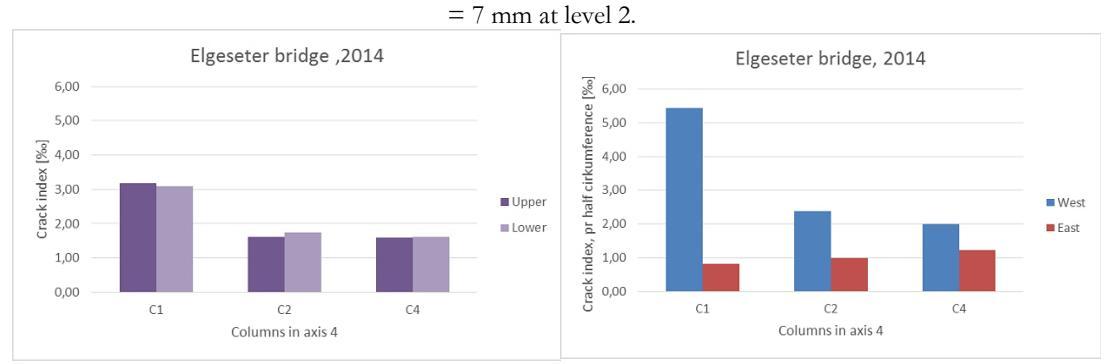
The maximum crack widths were 4.0, 1.4 and 0.8 mm for column C1, C2 and C4 respectively. The surface crack indexes (average of two levels) were 3.1, 1.7 and 1.6 ‰, calculated according to Eq. (1). The average crack indexes were calculated separately for the two half circumferences (west, east) demonstrating the more extensive cracking on the western side, especially for the western column (C1: 5.4 vs 0.8 ‰, C2: 2.4 vs 1.0 ‰ and C4: 2.0 vs 1.2 ‰). The surface crack indexes are shown in FIGURE 7.

FIGURE 7: Surface crack indexes measured in two levels (internal distance 0.6-0.9 m) of the columns 1, 2 and 4 in axis 4. To the left single values for two lines (upper, lower), to the right crack indexes calculated separately for the two half circumferences (west, east), based on average values for the two measuring lines.

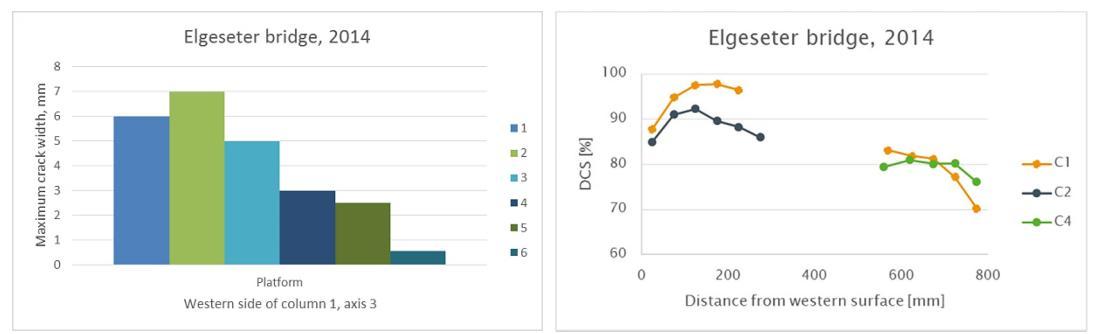
The results (FIGURE 8, right) show a slight increase in DCS from the western face to the highest levels (97.5 and 93.2 %) at a depth of approx. 125 mm, thereafter decreasing through the columns to approx. 70-75 % near the eastern surfaces.

Measurements of maximum crack widths on the western face of column 1 in axis 3 were performed from each scaffolding platform levels 1-6 (FIGURE 6), showing a decrease in max. crack width with increasing height above the protection sleeve (FIGURE 8, left).

FIGURE 8: To the left: Maximum crack widths on western side of column 1 in axis 3, on different platforms above the river. To the right: Water content, as DCS-profiles, in column 1, 2 and 4 in axis 4

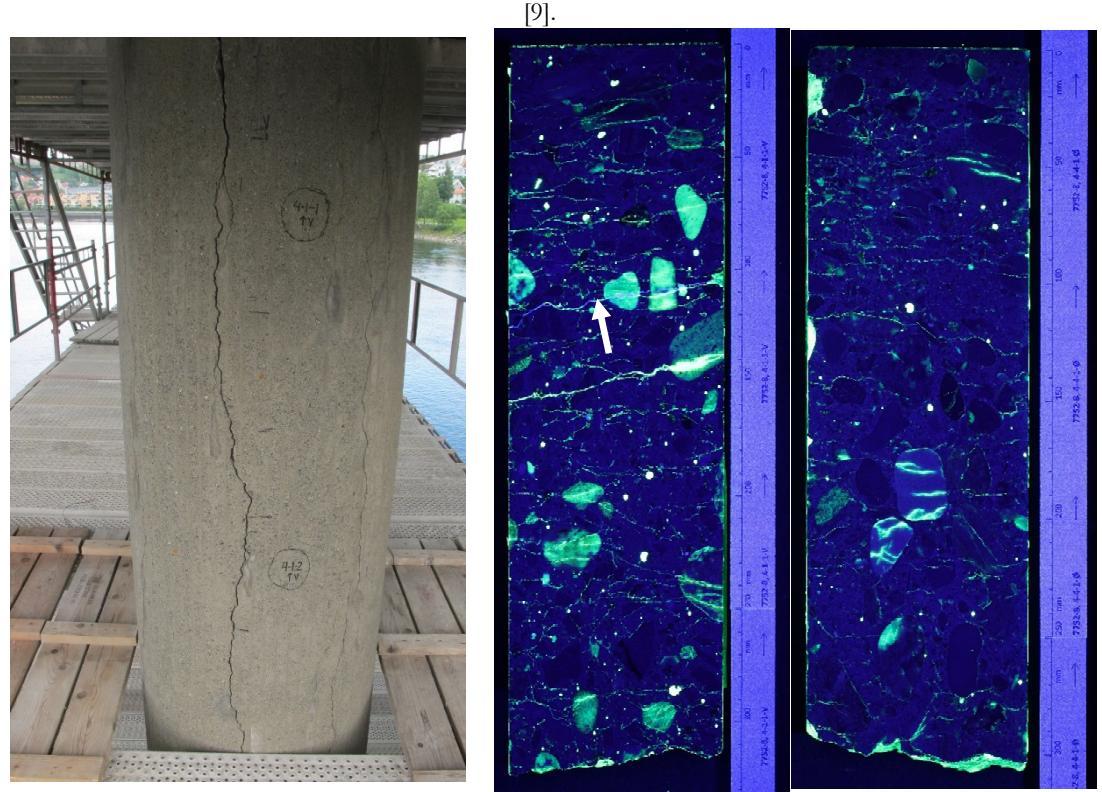
Examinations of plane-polished sections were performed by subjective visual evaluation (no crack counting or image analyses). It was concluded that the internal cracking in the western side of column C1 and C2 is more pronounced than the cracking in the eastern side of column C4, corresponding with the DCS profiles [9]. The main crack formation is parallel to the surface. See photos in FIGURE 9.

FIGURE 9: Left picture: The west face of the western column (C1) in axis 4, with location for coring marked on the surface. Large vertical crack, measured to 4 mm. Surface crack indexes are measured in two levels corresponding with the core locations. Average SCI for the two lines is 3.1 ‰. Right pictures [9]: Plane-polished sections from west side of column C1 (left) and east side of column C4 (right). C1 is delaminated in depth 110 mm (white arrow) and severely cracked in depth 150 mm. In addition, several fine cracks parallel to the surface. C4 has much less and finer cracks, mainly with surface parallel orientation.

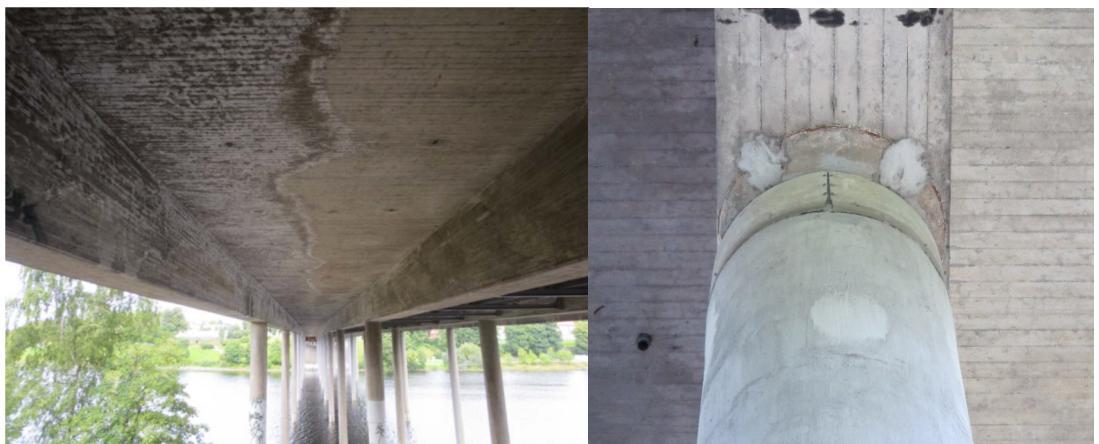
The visual situation on the underside of the deck, with white precipitation on certain surfaces (FIGURE 10, left), indicated that the earlier extension of the pavements had punctured the membrane in the outer parts of the deck, leading to increased water ingress and leakages through the concrete.

FIGURE 10: Left picture: The western part of the underside of bridge deck. White precipitation are visible from the cantilever and beyond the western beam, indicating severe defects in the membrane in these parts [3]. Right picture: Top of column in axis 9. Previous deflection of columns is visible on the beam. The column top is moved approx. 150 mm.

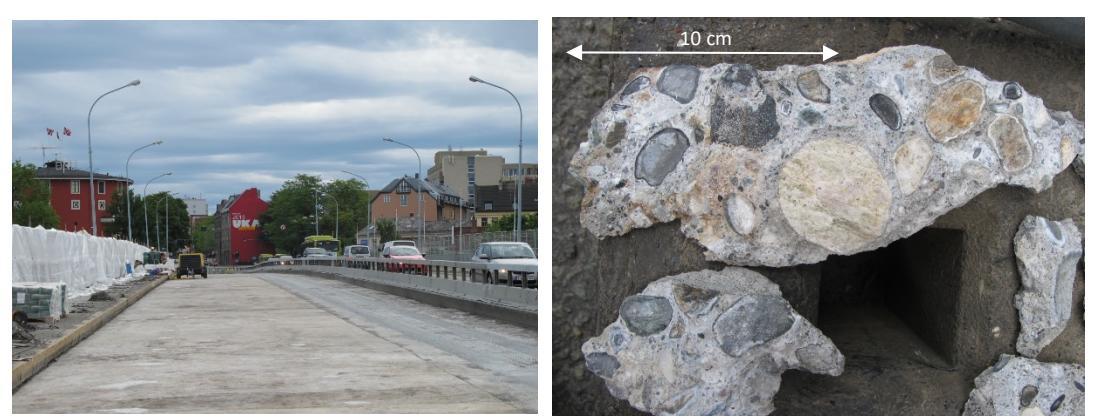
After removal of asphalt and membrane from the bridge deck in 2014, the concrete surface revealed clear signs of ASR damages. Fractured surfaces showed dense rims around the aggregate particles (FIGURE 11), and delamination were detected in some areas of the deck, especially near the bridge joint in the northern part of the bridge and close to the end beams (sidewalk areas).

FIGURE 11: The eastern part of the bridge deck after removing the asphalt, membranes etc. Notches for former tramcar rails were filled with concrete (near the traffic barrier). The right picture shows fracture pieces from upper parts of the concrete deck with clear signs of ASR (white reaction rims).

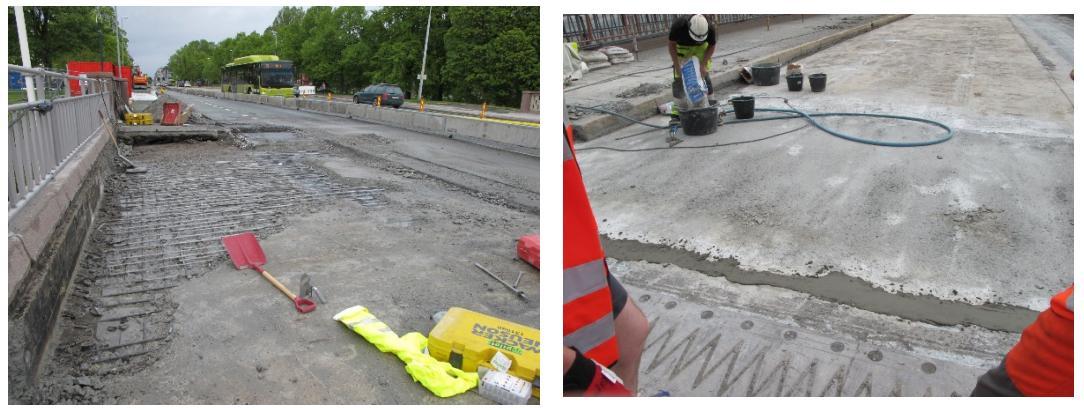
FIGURE 12: The left picture show the western part of the bridge deck after removing delaminated concrete near the joint. The right picture show the mid/eastern part of the deck near the joint, after repair.

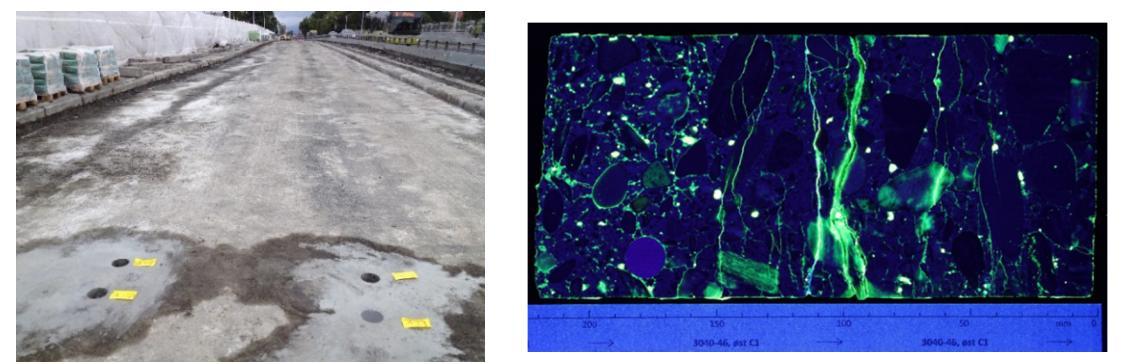
The visual examinations of the plane-polished sections (see example in FIGURE 15, right) indicate that the internal crack extent corresponds with the water content. Based on subjective evaluations (no crack counting or image analyses), more intense cracking is observed in location 1 vs. 2 and in location C-2 vs. A-2/B-2. This also corresponds with the location of the largest delamination areas during patch repair, which was observed close to the joint in axis 10 (FIGURE 12). In addition to ASR, frost action may have contributed to the cracking in the concrete most exposed to water.

FIGURE 15: The left picture show the coring locations A-1 and A-2, two cores per location. The right picture (photo: SINTEF) show the plane-polished section from location C-4, from top surface (to the right) through the deck (thickness 220 mm). Delaminated in depth 100 mm, several cracks parallel to the surface.

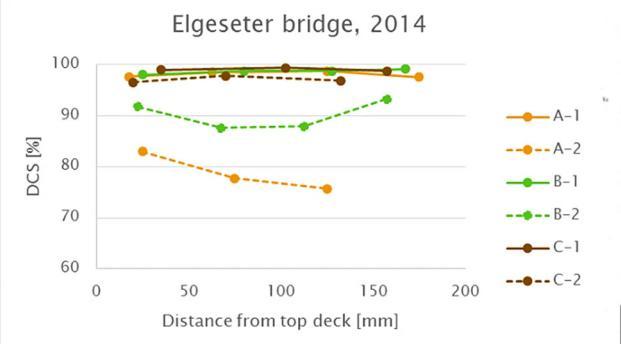
The water content was determined in approx. 5 cm slices successively split from the top surface of the drilled cores. The DCS values were calculated according to Eq. (2). The results confirm the assumptions that the water content is very high (98-99 %) in the western part of the deck (location 1), higher than in the middle part (location 2). Further, the water content in location 2 increases from location A to C (A: 76-83%, B: 88-93 % and C: 97-98 % in depths 0-150 mm). See FIGURE 16. It should be noted that severe cracking in several cores might have led to extra water uptake in the cores during drilling, thus to some extent overestimating the water content.

FIGURE 16: DCS profiles measured in the bridge deck. Water content is increasing from location A to C and from location 1 to 2.
