11th International Conference on Alkali-Aggregate Reaction 11^e Conférence Internationale sur les Réactions Alcalis-Granulats

A CASE STUDY OF ALKALI-SILICA REACTION IN HIGH-DENSITY CONCRETE

Gilles Escadeillas, André Carles Gibergues, Eric Massias Laboratoire Matériaux et Durabilité des Constructions, INSA 135 Avenue de Rangueil, 31077 TOULOUSE Cedex04, FRANCE

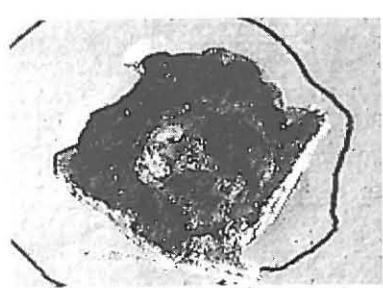
- presence of many craters and pop-outs visible on the parts corresponding to the highdensity concrete (walls and ceiling). Swelling zones, from 2 to 4 cm in diameter, corresponded in the majority of the cases to the formation of a cone which separated easily. At the bottom of the crater (depth ranging between 2 to 10 mm) appeared a bloody red aggregate (photo 1). In certain cases, translucent gels were associated with the pop-out (photo 2);
- presence of some cracks on the walls (horizontal crack in high partly for a wall and in median partly for the other) and on the ceiling by which exudations of gel ran out locally. Their openings generally exceeded 200 μm;
- no visible defect on the parts made with ordinary concrete.

Photo 1 : Bloody red aggregate at the bottom of the crater

1 - A hydration of hematite which is being converted into goethite and into limonite with increase in volume (increase being able to reach 600%, Dolar-Mantuani 1981). This swelling reaction generates stress which result in the appearance of pop-outs with the systematic presence of a reddish aggregate at the bottom of the crater (color due to the high degree of hydration of the iron ore).

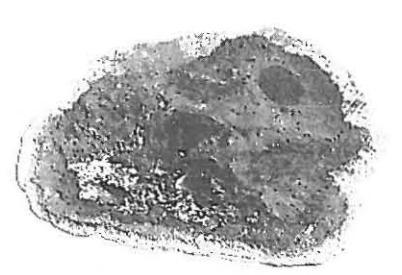
Photo 2 : Gel visible on the crater

2 - An alkali-reaction which had already caused formation of gels, starting from siliceous inclusions of hematite aggregates. Those had been able, by places, but in a very limited way, to run out outside the walls. This gel had an initially silica-alkaline composition, and seemed to be non expansive, but it appeared evolutionary and tended to crystallise by including calcium in its structure. Some formations of needles of ferruginous ettringite had also been highlighted. This alkali-silica reaction involved aggregates classified as not reactive (they contain on average less than 2 % in mass of quartz, but taking into account the differences in density, the volume proportion in reactive silica is high) and occurred in a low alkali concrete (lower than 3 kg/m³). It will thus be advisable to think, when one deals with very variable density aggregates, light or high-density, as well with the mass contents as volume proportions.

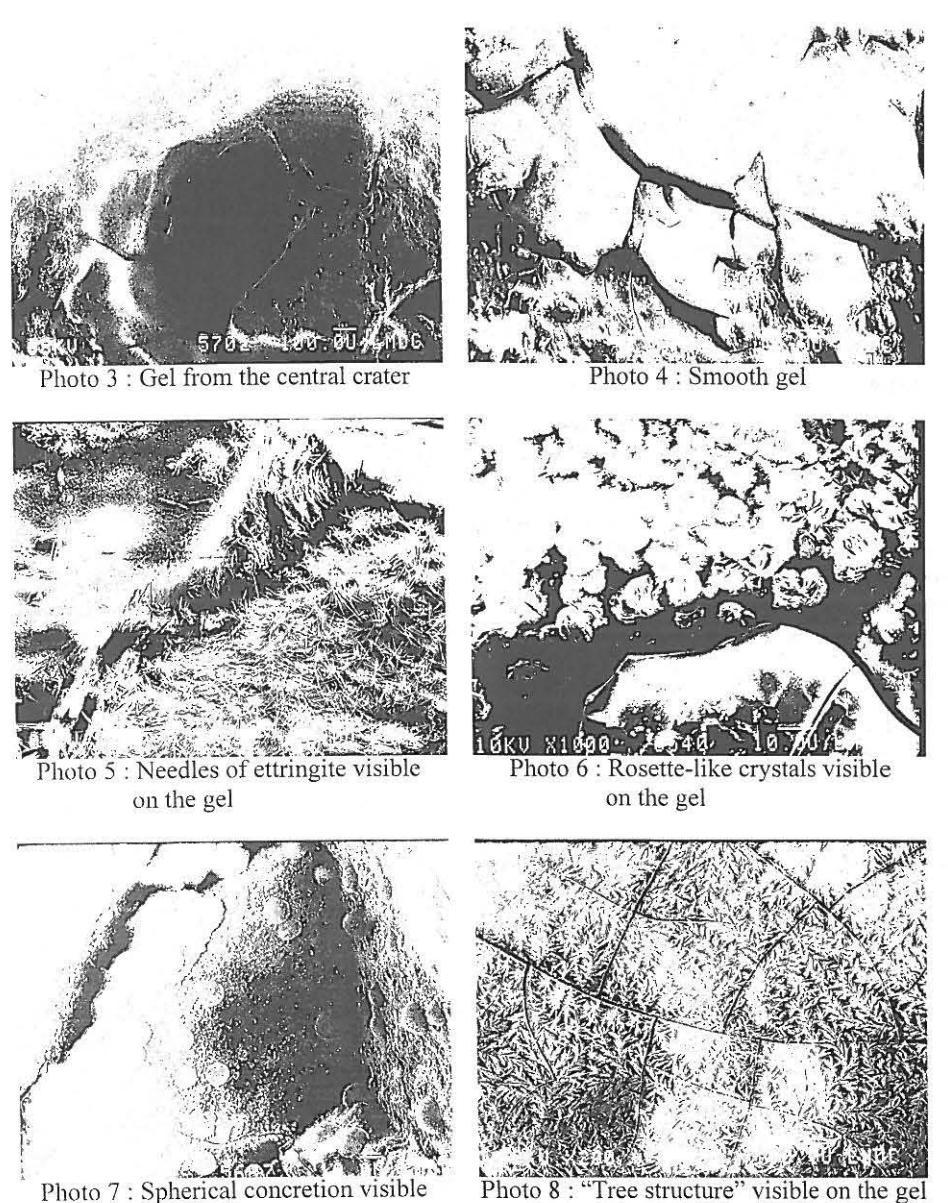
<u>Microscopic Aspect and Chemical Analysis of the Defects</u> - On the fresh surface of pop-out, it systematically appeared smooth gel, a thickness greater than 20 μ m, which seemed to run out starting from the central crater (photos 3 and 4). Moreover, some particular crystallisation in shape of massive needle, more fine needle, rosette-like crystals, spherical concretion or of « tree structure » are visible on gel (photos 5, 6, 7, and 8). Qualitative chemical analysis carried out by spectrometry X (EDS) showed that the gel contained primarily silicon and potassium, whereas concretions (spheres and rosette) contained also calcium. The composition of the needles corresponded to a ferruginous ettringite (Table 1).

Photo 8 : "Tree structure" visible on the gel

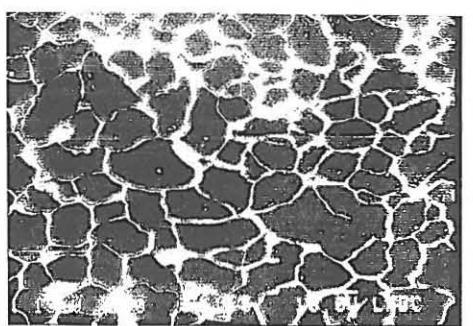
<u>Analysis of Swelling Aggregates</u> -This analysis had made it possible to note that the aggregates present in bottom of crater could contain 3 to more than 63% of iron and 46 to less than 5% of silicon. The microscopic observation of a polished section of one of these aggregates, in backscattered electron mode (BSE), made it possible to distinguish the hematite ranges (in black) separated by a siliceous interstitial phase (in white) (photo 9). The volume percentage of silica finely crystallised, was, in this case, very significant.

Photo 9 : Observation of a reactive aggregate (silicon in white, hematite in black)

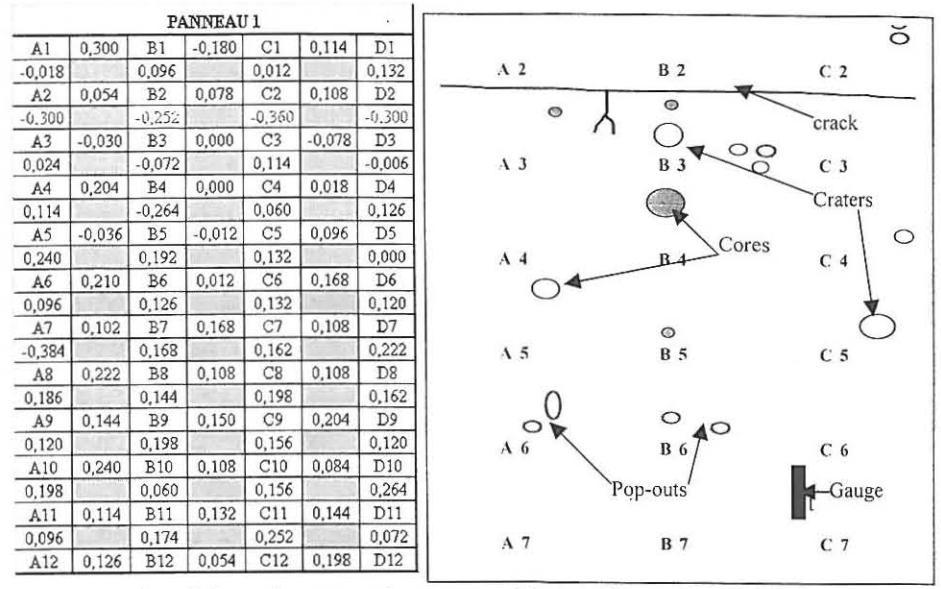
Fig. 1 : Surface deformation en µm/m

Fig 2. : Observations of defects

<u>Dimensional Variations on the Surface</u> - Measured variations are weak and not very evolutionary. Maximum departure from the initial state of 1994 was -0.45 to +0.45 mm/m in 1995, -0.38 to +0.84 mm/m in 1996 and -0.41 to +0.98 mm/m in 1999.

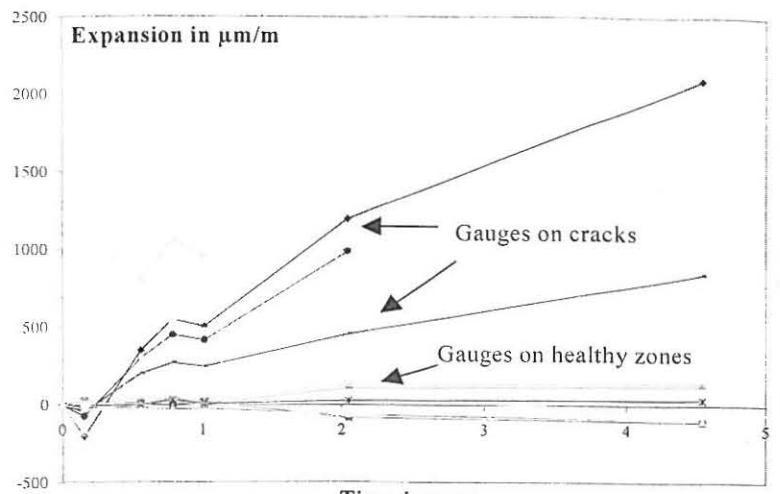
<u>Dimensional Variations of Defects and Cracks Opening</u> - The follow-up of the deformations realised by the gauges show that the defects located on the wall are stabilised but that the cracks continue to open regularly (+ 200 µm in two years) (Fig. 3).

Fig. 3 : Gauges deformations

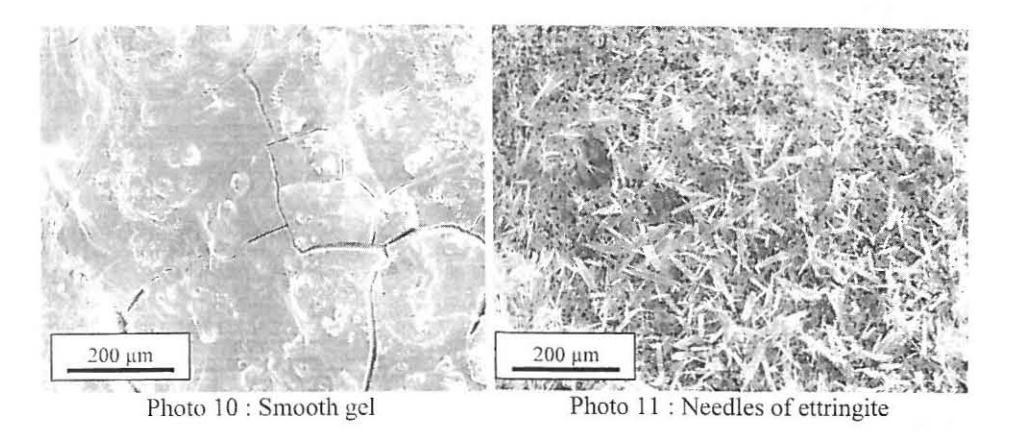
<u>Microscopic analysis of the defects</u> - The microstructures of the new pop-outs observed are apparently the same ones as those observed in 1991. An enrichment of gel in calcium is however notable (photo 10) just as a greater proportion of ettringite is observed (photo 11).
