11th International Conference on Alkali-Aggregate Reaction 11^e Conférence Internationale sur les Réactions Alcalis-Granulats

MANAGEMENT OF A WATER INTAKE AFFECTED BY ALKALI-AGGREGATE REACTION

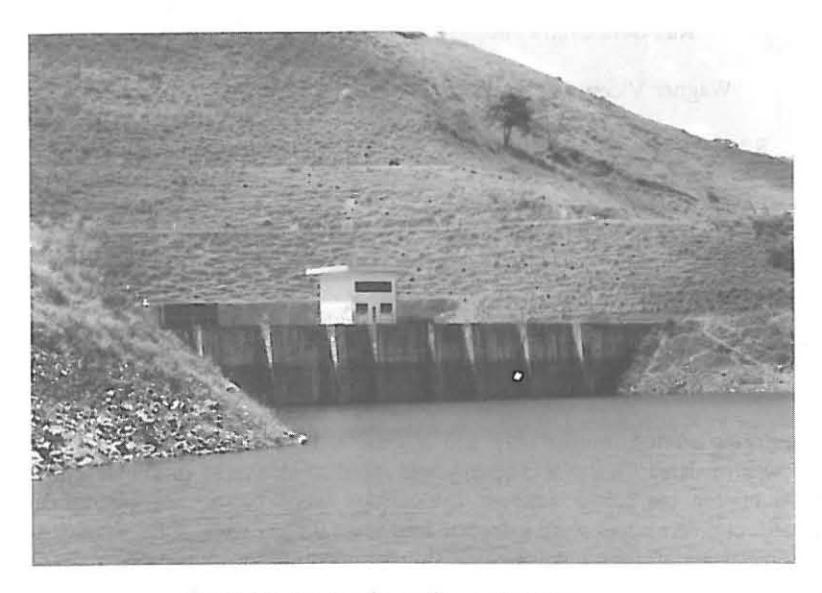
Fig. 2: Upstream view of tunnel intake.

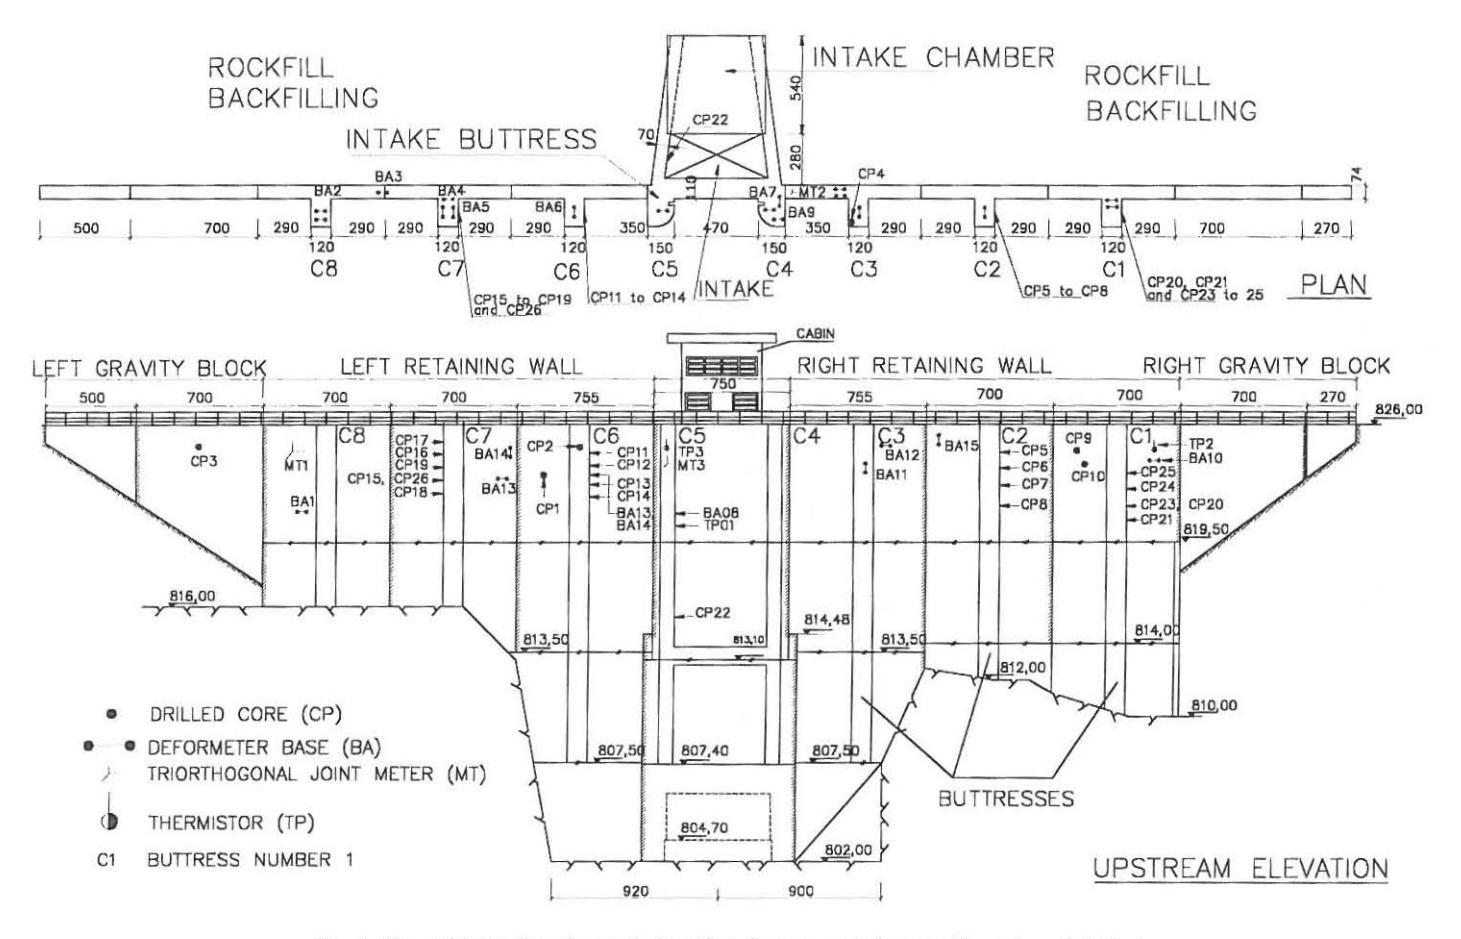
Fig. 1: Tunnel 6 intake: plan and elevation, instrumentation, and location of drilled cores.

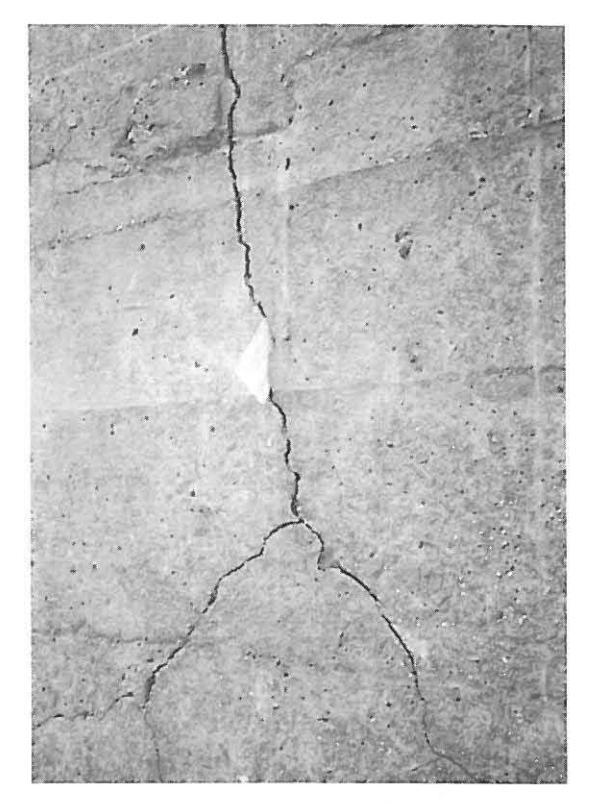
Several cracks (Figure 3) were discovered in 1989 at the concrete intake. Monitoring revealed a general tendency of these cracks to increase in length and width. Themag was hired in 1996 to make a diagnosis and assessment of the situation and to formulate alternatives for corrective actions that should be taken. The first step was to get all available information about the project, the design, the construction; to look for field data, install instrumentation, collect local materials and to inspect the structure. The second stage consisted of: analysis of the civil structures and of the intake equipment; laboratory testing of drilled cores and of local rocks.

Fig. 3: Typical vertical crack at buttress (width of 5mm).

- Walls between buttresses present open horizontal cracks with maximum values of up to 6mm. In places where there is reinforcement there are no visible cracks. There are no significant vertical cracks in these walls probably due to the lateral confinement provided by the abutments thus deriving horizontal compressive stresses;
- Buttresses show a general and intense cracking pattern, typical of AAR (map cracking with the gel appearing at the crest of each buttress). Cracks can reach values of circa 10 mm. Where there is reinforcement, even a small amount, the cracks are thinner. It is important to point out that the buttresses are not confined and can, therefore, continue expanding;

Increase installed instrumentation and monitoring. There is no immediate danger of collapse of any part of the structure although crack widths are expected to slowly increase. The two concrete buttresses of the Intake can be repaired when necessary.

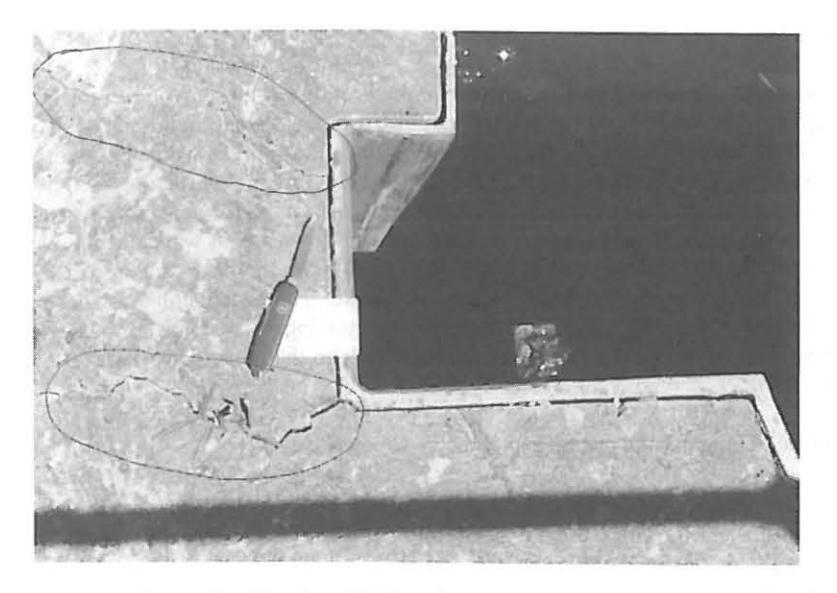
The sector gate and the steel lining are in good shape with no signs of corrosion or visible displacements. The sector gate has been operating since construction showing no problems whatsoever. However, it can be affected in the future if the concrete expansion continues. Each stop-log consists of a rectangular hollow prism made of steel with 5315 mm in length, height of 2005 mm and width of 53 mm. To close the water intake each stop-log is lifted by a crane, positioned between the steel guide plates and, slowly, slides down. Three stop-logs are necessary to completely close the opening. Stop-logs are also behaving well and the trashrack shows no signs of irregularities. The only parts that require immediate intervention are the steel guide plates that show some dislocation from the concrete near the crest, probably due to the concrete expansions and cracks (Figure 4). They also present some corrosion pits and cracks at the welded parts that are underwater. Probably the misalignment discovered by the divers was partly caused by the concrete expansion.

Fig. 4: Cracks near the steel guide plate. Notice the small gap due to dislocation of the steel

Require immediate actions: repairs on the corroded parts and some adaptations to fit the new shape of the wheeled bulkhead;
