11<sup>th</sup> International Conference on Alkali-Aggregate Reaction 11<sup>e</sup> Conférence Internationale sur les Réactions Alcalis-Granulats

#### ASSESSMENT AND MONITORING OF POINTE DU BOIS G.S. POWERHOUSE

David MacMillan and Gordon McPhail Principal and Senior Hydrotechnical Engineer KGS Group, Winnipeg, Manitoba

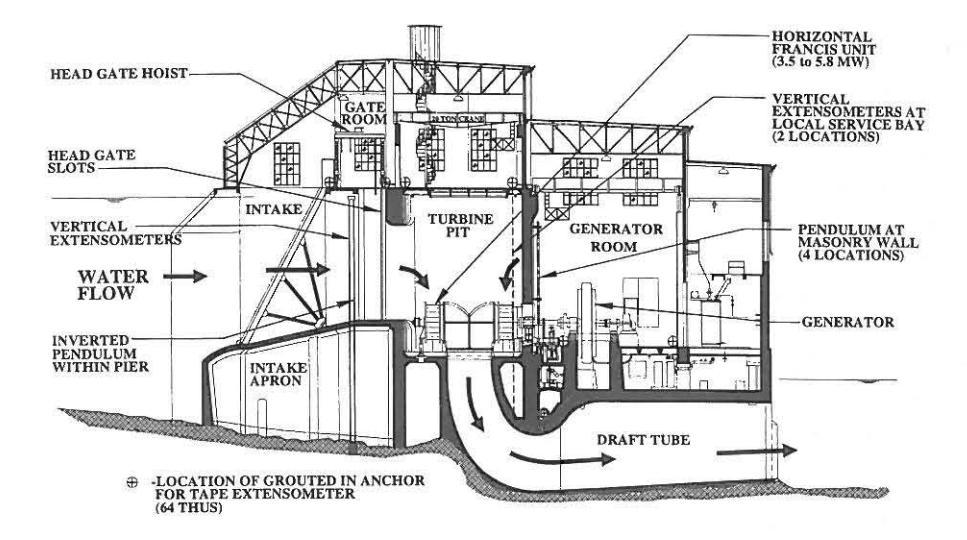
Fig. 1: Cross-section through existing unit with AAR monitoring system

Concern with cracking and movements within the powerhouse date back to before the 1940's. Reports completed in the 1950's and 1980's document cracking of the gate room floor, cracking of generator room crane rail supports, movement of the superstructure, cracking and leakage from the downstream turbine pit walls into the apron gallery and generator room, and misalignment and breakage of the turbine and generator shafts. Thermal forces, inadequate reinforcing, foundation problems and poor construction joint treatment were postulated as the cause of the structural distress observed.

As one aspect of their dam safety monitoring, in 1990 Winnipeg Hydro implemented a survey of the rails of the overhead crane above the generators as well as a crack mapping program. The crane rail surveys indicated that the upstream rail (which is located on the downstream face of the turbine pit) was arched up to 65 mm above its original elevation and translated 30 mm downstream from vertical. These results in conjunction with the observed distress throughout the powerhouse resulted in Winnipeg Hydro initiating a study to determine the probable cause of the movements and distress.

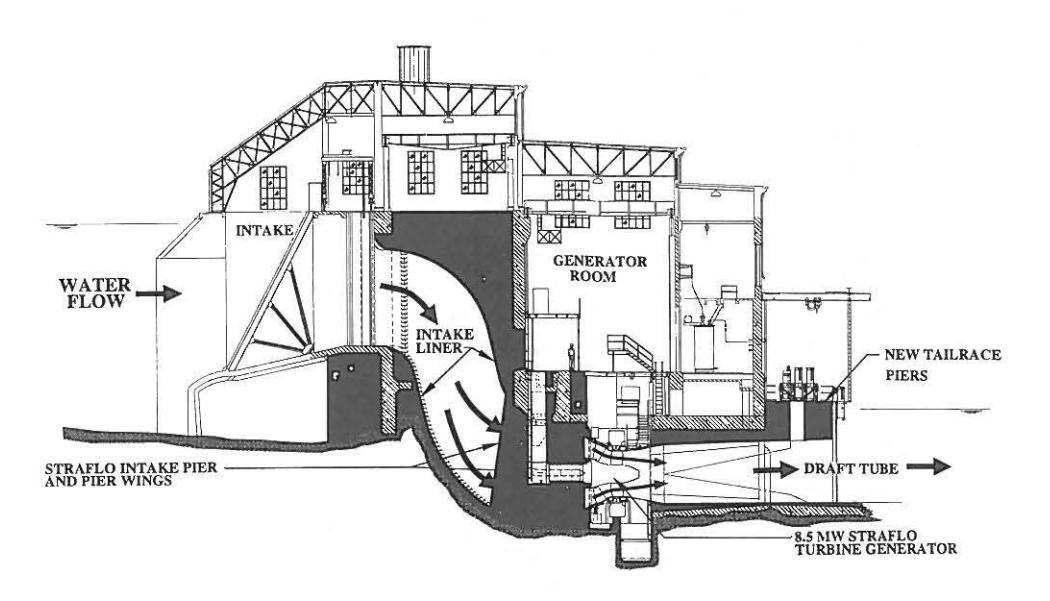
Fig. 2: Cross-secton through "Straflo" unit no. 1

To visualize the level of strain observed, at the time of testing Unit No. 5, the cast iron wall casing embedded in the downstream wall of the turbine pit (see Figure 2) for the head cover was cracked and had been leaking for several years. As a steel reinforcing bar that had been exposed above the embedded casing was being cut, the bar compressed so much that the blade was pinched off and the bar had to be recut before a stress measurement could be taken. Under normal conditions with no concrete growth, this bar should have been in zero to low tension rather than the high compression observed. In 1994, this wall casing was replaced.

The modeling and monitoring information gathered to date was used extensively during the rehabilitation of the Pointe du Bois Turbine Unit No. 1. Due to aged mechanical components and continued operational difficulties associated with AAR induced movements, work commenced in 1997 on replacing the 87 year old double Francis 3.5 MW turbine/generator. The replacement unit was selected to be a new 8.5 MW Sulzer Straflo axial flow turbine/generator. This type of unit maximizes the turbine flow capacity for a given size of water passage by placing the generator poles directly around the rim of a propeller turbine (see Figure 2).

To limit the potential impacts on the new turbine/generator from the effects of continued AAR in the existing concrete, the new unit is founded directly on bedrock and the unit is supported from a post tensioned steel and concrete pier separated from the surrounding concrete. The upstream water passage between the pier and the intake is a steel liner while the new draft tube is reinforced concrete anchored to the underlying bedrock. The new concrete used low alkali cement and aggregate that had been tested for reactivity in accordance with CSA.

The work commenced in 1997/98 with underwater concrete placement and construction of the new tailrace piers necessary for dewatering the existing drafttube (see Figure 1 and 2). Demolition work in the draft tube commenced in 1998 with diamond wire saw cutting of the highly stressed draft tube elbow while the surrounding concrete and units were monitored. The saw cut took three attempts after the wire was pinched twice following cutting shutdowns due to equipment problems. Once the wire slot cut was completed, slot closure was monitored and closed up to 8 mm locally over three days. Demolition then proceeded in a conventional manner using a backhoe mounted concrete breaker as well as controlled blasting. First power of the Straflo unit was in November of 1999.
