CRACKING BEHAVIOR AND DETERIORATION SUPPRESSION EFFECT OF PROTECTIVE SURFACE COATINGS ON ASR-AFFECTED STRUCTURES

Koji Utsunomiya ^{1*}, Hiroaki Uenakada¹, Kiyoshi Sakiya², Tsutomu Niina², Yukio Adachi²

¹Hanshin Expressway Engineering Company Limited, Osaka, Japan

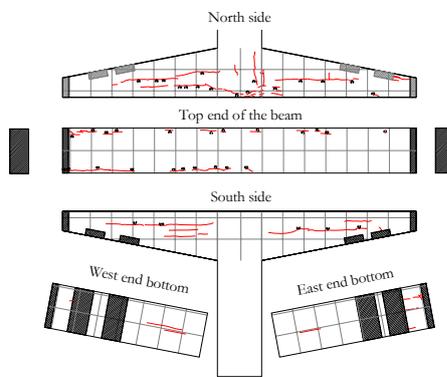
FIGURE 4: Cracks in the coating on Pier I

Figures 4 and 5 show drawings of cracks found in the coating and those found in the pier structure of Pier I.

Table 6 shows crack extensions and other results from the investigation. Pier I had a pre-removal crack extension of about 60 m and a post-removal crack extension of about 180 m. Crack injection was conducted in 1990 for a length of about 140 m prior to application of water repellent coating. Crack propagation amount after 19 years from the repair was therefore about 40 m. Pier II had a pre-removal crack extension of about 50 m and a post-removal crack extension of about 570 m. Crack injection was conducted in 1980 and 1983 for a total length of about 360 m in combination with protective surface coating, and crack injection was again conducted in 1994 for a length of about 30 m prior to the application of waterproof coating. As a result, total injected crack extension amounted to about 390 m, and crack propagation amount after 15 years from the last repair was about 180 m.

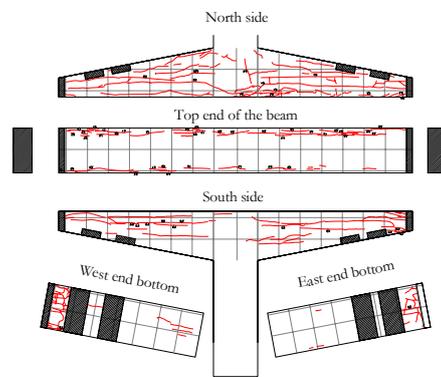
FIGURE 5: Cracks in the structure of Pier I

Cracking behavior factor (ratio of crack propagation amount to pre-removal crack extension) was calculated from the investigation results shown in Section 3 in the manner described in Section 2.3 as Analysis 1. Table 7 shows the calculation results. Crack propagation amount in Pier I was 40 m, while pre-removal crack extension was 60 m. That is, extension of cracks generated in the pier structure after the last application of protective surface coating (= crack propagation amount) was smaller than that of those appearing in the coating (= pre-removal crack extension), resulting in a cracking behavior factor of 0.7. In contrast to this, crack propagation amount in Pier II was 180 m and was larger than pre-removal crack extension which was 50 m, resulting in a cracking behavior factor of 3.6.

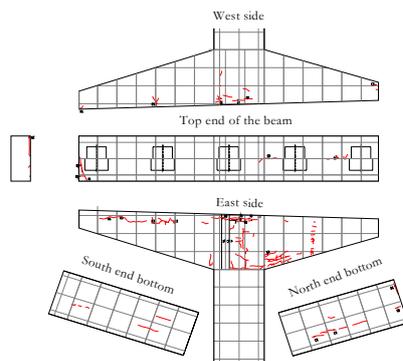
FIGURE 6: Cracks in the coating on Pier II

Figures 6 and 7 show drawings of cracks found in the coating and those found in the pier structure of Pier II.

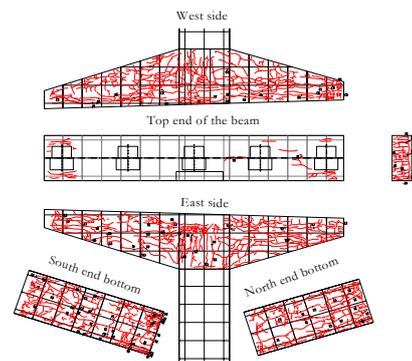
FIGURE 7: Cracks in the structure of Pier II

These analysis results suggest that the amount of cracks generated in the water repellent coated pier structure would be slightly smaller than or almost equal to that appearing in the coating. In contrast, the amount of cracks generated in the waterproof coated pier structure would be larger than that appearing in the coating.

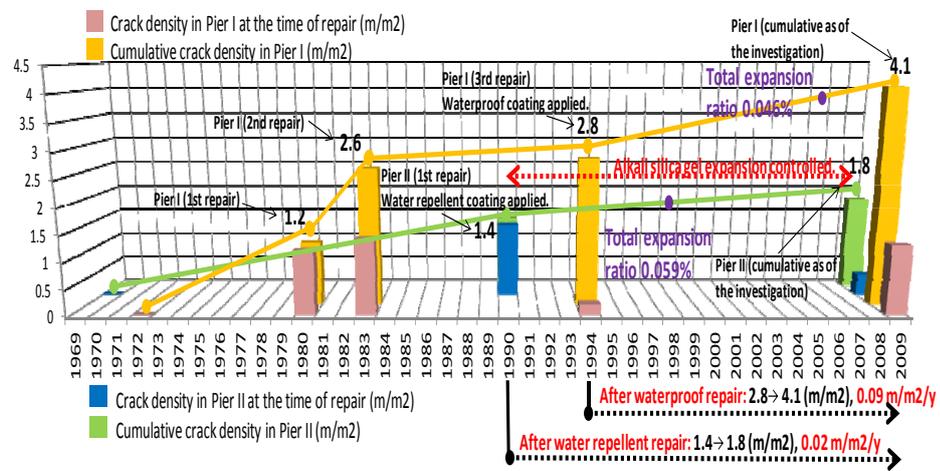
FIGURE 8: Changes in crack development and cumulative crack density

Since the sample piers of this investigation had similar ASR expansion potential and similar natural environment, alkali silica gel must have been generated in both piers. It was assumed that the water repellent coating which contained silane prevented water penetration and reduced alkali silica gel expansion in Pier I. This process is demonstrated in Figure 8 which shows change in crack development and cumulative crack density together with total expansion ratios measured during detailed inspections.
