REVISITING AN HISTORIC CASE STUDY: MONITORING AND ASSESSMENT OF ASR IN A DECOMMISSIONED LOCK STRUCTURE

The Old Oliver Lock is a decommissioned lock structure on the Black Warrior River in Tuscaloosa, Alabama, USA. Constructed between 1937 and 1939, it was one of the first concrete structures in the eastern United States where ASR was identified as a cause of distress. A new lock went into service in 1992, but the old lock was not demolished and remains accessible for study.

The team selected four monoliths from the south wall of the lock with distinct variations in the degree of cracking for study. Core samples were also taken from each monolith under study and DEMEC targets for expansion monitoring were installed. This paper presents an overview of the study and selected results from petrography of the cores.

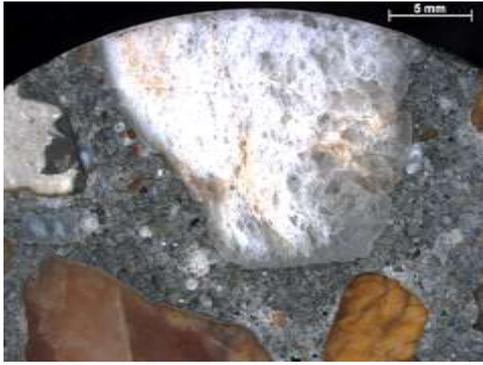
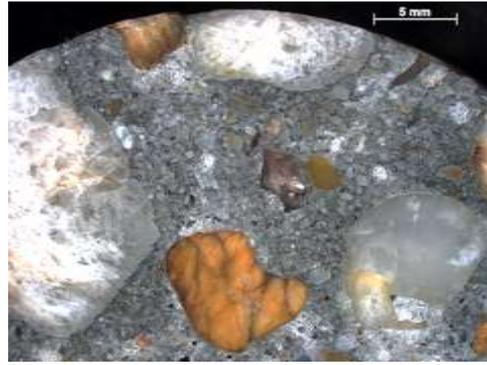
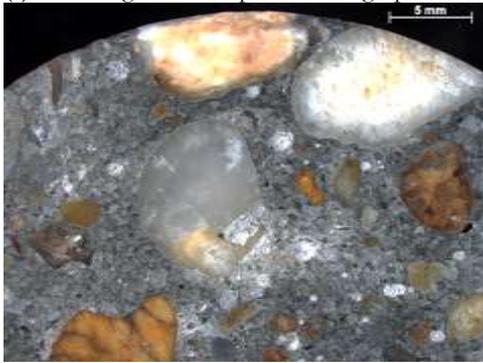
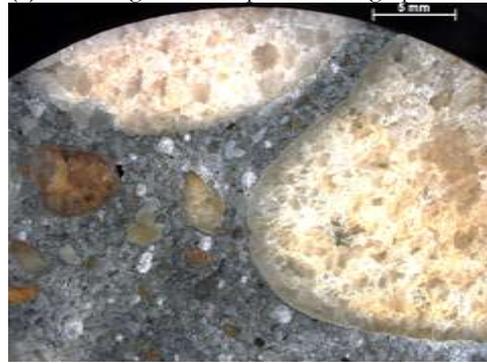
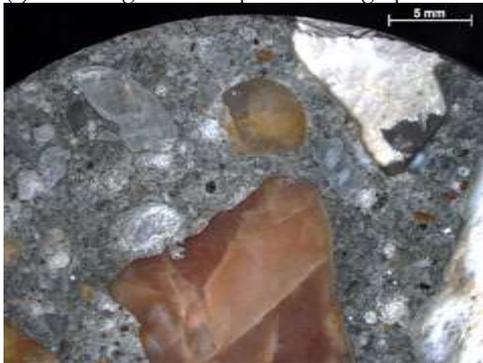
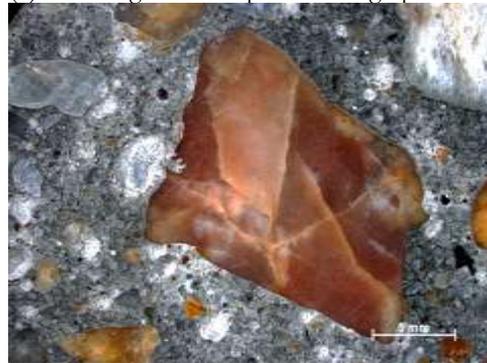
Low-magnification photomicrographs of M3-1 can be seen in Figure 5. Most of the air voids have ASR gel deposits, with reaction rims around the coarse aggregates. Limited aggregate microfracturing is observed primarily in coarse aggregates. However, cracking observed in aggregates did not appear to extend into the mortar fraction of the concrete. Low-magnification photomicrographs of M20-3 can be seen in Figure 6. Most of the air voids have ASR gel deposits, with reaction rims around the coarse aggregates. There are coarse aggregates that have a high degree of internal fracturing. Fracturing in the coarse aggregate particles extends throughout mortar fraction with cracks infilled with ASR gel. A majority of the fine aggregates also exhibit microfracturing and extensive degradation.

FIGURE 5: Low-magnification photomicrographs of sample M3-1 from monolith 3.

Petrographic examination of cores from these monoliths are consistent with the macro-scale observations of cracking during the visual surveys, with significantly more internal micro-cracking, gel deposits, and cracks extending from aggregates into the paste found in sample M20-3 than M3-1.

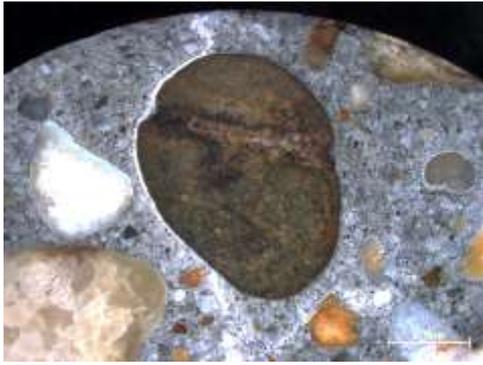
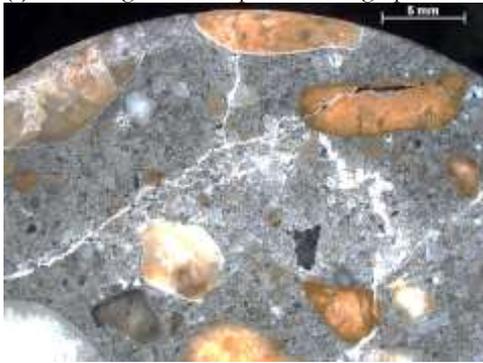
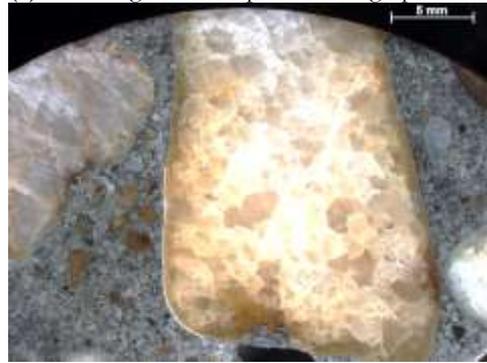
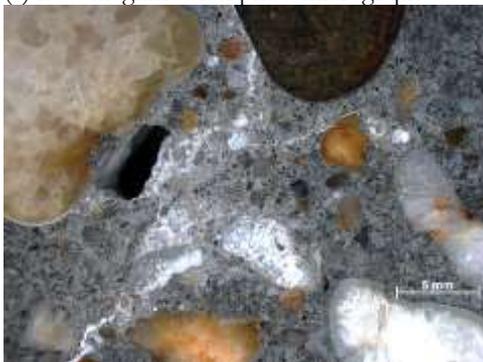
FIGURE 6: Low-magnification photomicrographs of sample M20-3 from monolith 20.
