DIAGNOSIS OF ALKALI-SILICA REACTION IN AIRPORT PAVEMENT IN JAPAN

Naoya Kawamura^{1*}, Yuichiro Kawabata^{2,3}, Tetsuya Katayama⁴

Petrographic examination and accelerated expansion tests were performed to clarify the causes of cracking due to alkali-silica reaction (ASR) in concrete pavement in a Japan airport. The deterioration was due to *pessimum* proportion effects caused by early-expansive ASR. ASR gel was observed in sand aggregates containing highly reactive minerals that exhibit *pessimum* proportion effects. Estimation of alkali contents in concrete confirmed the occurrence of ASR even when the total amount of alkali in the cement used was below 3.0 kg/m³, which is the current regulated threshold for preventing ASR in Japan.

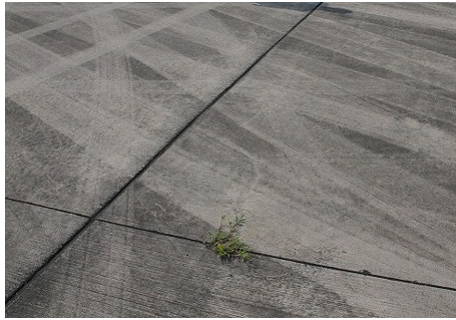
FIGURE 1: Sound concrete slab

Figures 1–3 show pavement surfaces in the survey area. Figure 1 shows the apparently sound slabs: cracks were not found on the surface. Figures 2–3 show cracks in the corners of the deteriorated slabs. Some cracks were only found at the corners of the slabs (Figure 2), and others propagated along the slab joint from the corner, which is commonly termed D-cracking (Figure 3). The extent of cracking differed in every adjacent slab. These results suggest that the extent of degradation differed from one slab to another. Figure 4 shows a close-up view of the pavement surface. Reaction products from cracks and pop-outs of concrete were also found.

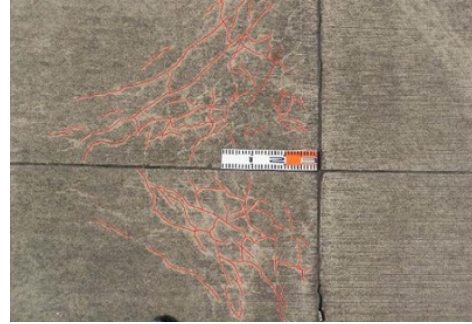
FIGURE 2: Cracks on the corner of pavement slab

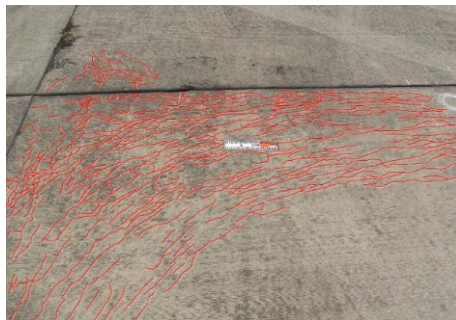
FIGURE 3: Cracks propagated along the slab joint

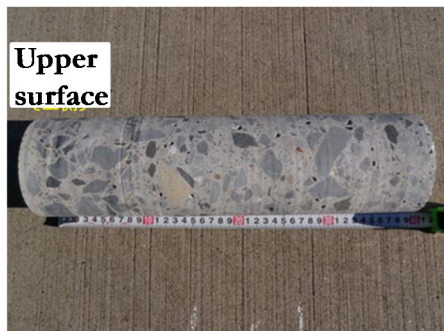
a) Cover shot of the core sample

b) Reaction products detected after concrete was wrapped with plastic film for one day

FIGURE 5: Core taken from the sound slab

Figures 5–6 show cores taken from a sound pavement slab and a cracked one, respectively. Cracks could not be detected on the lateral surface of the core taken from the sound slab (Figure 5(a)), but ASR gel and reaction rims were verified around fine aggregates located on the lateral surface (Figure 5(b)). On the other hand, cracks were easily found in the bulk of the cores taken from the cracked slab (Figure 6(a)). The macrocracks were mainly horizontal and found at depths where both the steel wire mesh and dowel bars were located. The lower part of the core did not retain its original shape because of a high degree of damage. ASR gel, reaction rims, and pop-outs were found on the lateral surface (Figure 6(b)). ASR occurred in both sound and cracked slabs because the reaction products detected on both slabs have ASR-specific characteristics.

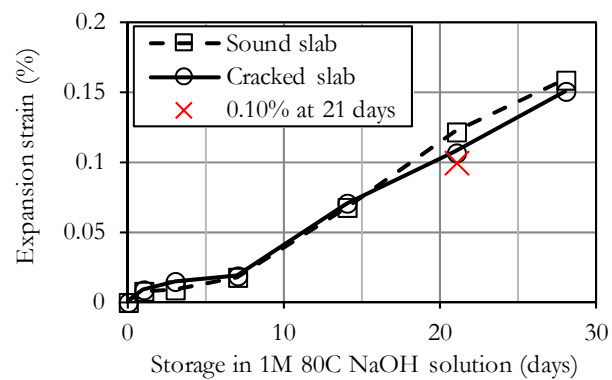
Figure 9 shows the results of the accelerated concrete core expansion test using a NaOH solution. After 21 days, concrete cores taken from the cracked and sound slabs showed expansions of 0.12% and 0.11%, respectively. Both cores exceeded the deleterious limit in this test (0.10% at 21 days [2]). This suggests that both types of pavement slabs still contain large amounts of reactive minerals, and hence, have high potential for producing expansion.

FIGURE 9: Accelerated concrete core expansion test using NaOH solution

There is a possibility that expansion and cracking occur on the surface of sound pavement slabs because the concrete still has a high potential to produce residual expansion.

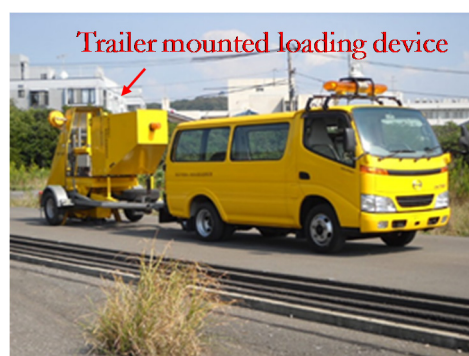
Assessing the current structural performance of ASR-affected pavement is one concern when judging whether pavements should be repaired. FWD (shown in Figure 10) is commonly used as a non-destructive test procedure for analysing the load-bearing capacity of pavements. This test consists of a trailer-mounted device that operates by dropping a weight on to the pavement and measuring the resulting pavement deflections. An FWD test can be a promising way to evaluate the integrity of the pavement under examination, but there were few opportunities to apply the test method to the affected pavement. Therefore, the test was performed on the corner of the cracked and the sound slabs in order to demonstrate applicability of the test for integrity evaluation of the affected pavement. The load used for the FWD was 150 kN; this load was applied to the pavement through a circular loading plate (diameter 300 mm) and surface deflection was measured at the centre of the plate.

FIGURE 10: Falling weight deflectometer

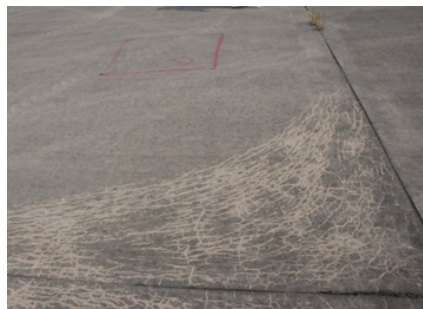
Field exposure tests were performed on five concrete blocks (1000 mm × 1000 mm × 380 mm) that were cut from the airport pavement slabs investigated in this study. The blocks were called B1, B2, B3, B4, and B5 in order of their level of cracking. The slab from which B1 was taken suffered severe D-cracking (Figure 12), whereas the one from which B5 was taken presented a slight reaction but no apparent cracking. After cutting, the blocks were moved to the Port and Airport Research Institute (PARI) and stored outdoors (Figure 13). To measure expansion of the blocks, the blocks were fitted with stainless steel pins glued on to the upper surface (span 200 mm); these pins were used as measurement bases to set a digital extensometer.

FIGURE 12: Slab where B1 was taken (red frame in the image is the cutting position)

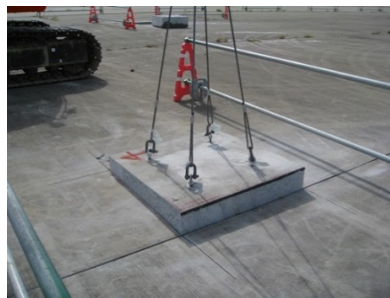
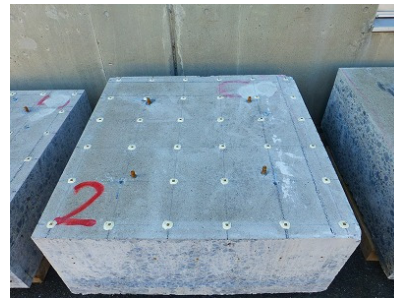
FIGURE 13: Exposure block
