# THOROUGH EVALUATION OF BRIDGE COLUMNS AFFECTED BY ALKALI-SILICA REACTION (ASR)

Leandro Sanchez<sup>1</sup>, Benoit Fournier<sup>2</sup>, Josée Bastien<sup>2</sup>, Denis Mitchell<sup>3</sup>, Martin Noel<sup>1</sup>

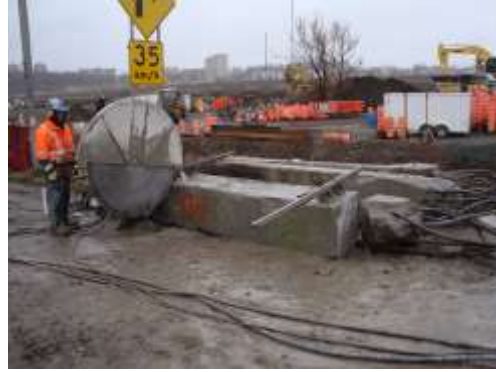
B - Sawing and preparation of the columns

FIGURE 1: RBC pictures: A) overall structure; B) Sawing and preparation of the columns; C) Non-exposed column and; D) Exposed column.

Prior and during the demolition of the RBC bridge in 2010/2011, two 3-meter sections of the reinforced columns (one coming from an exposed site and the other from a non-exposed one) were sawed (Figure 1b) and stored in the laboratory at Université Laval (Quebec, Canada) (Figure 1c and d). Then, several cores were drilled along the three main directions (Longitudinal, Vertical and Traversal) from each of them. Therefore the condition assessment of the columns was performed as proposed by [4-8]. Moreover, at designated locations, the concrete cover of the columns was removed for assessing the stress-state of the stirrups, since earlier studies in Japan showed the potential of rupture of stirrups in concrete structural elements affected by ASR [9].

Two 3-meter sections of RBC reinforced columns (one coming from an exposed site (E) and the other from a non-exposed one (i.e. under the bridge deck - NE)) were sawed (Figure 1B) and stored in the laboratory. It is important to mention that due to the severity of its deterioration, the E column has been wrapped with FRP sheets back in 2000 (Figure 1D). Several cores were drilled along the three main directions (Longitudinal, Vertical and Traversal) from each of the above columns and mechanical testing (i.e. SDT, modulus of elasticity and compressive strength) performed on those cores. Moreover, at specific locations, the concrete cover of the columns was removed and the stress-state of the columns stirrups was analysed. The following sections present the description of the test procedures used for this work.

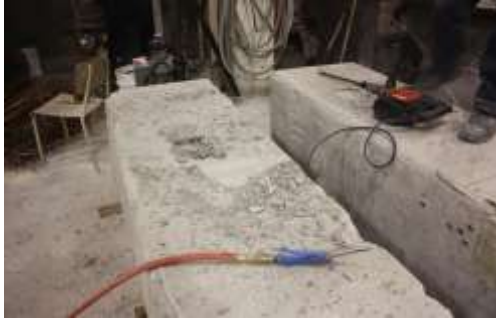
A – Removal of concrete cover

FIGURE 2: RBC columns pictures: A) concrete cover removal and preparation of the surface underneath the stirrups; B) Stirrups with strain gauges glued for measurements of stress-relief white cutting.

Besides the above mechanical assessments, evaluations were also performed on the stress-state of the stirrups of both columns (NE & E). Therefore, at designated locations, the concrete cover was removed and the concrete surfaces underneath the stirrups were prepared (Figure 2a). Then, strain gauges were glued on the stirrups in order to measure stress relief after cutting (Figure 2b). Six stirrups were selected for testing at each column, as illustrated in Table 1.

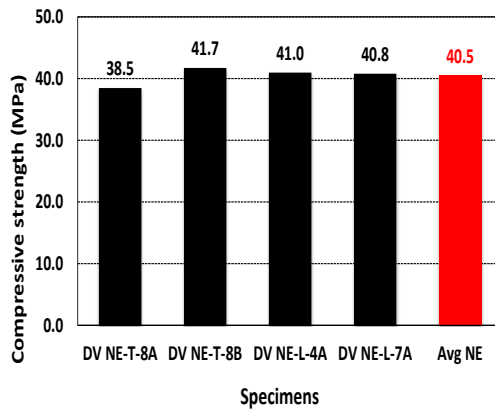
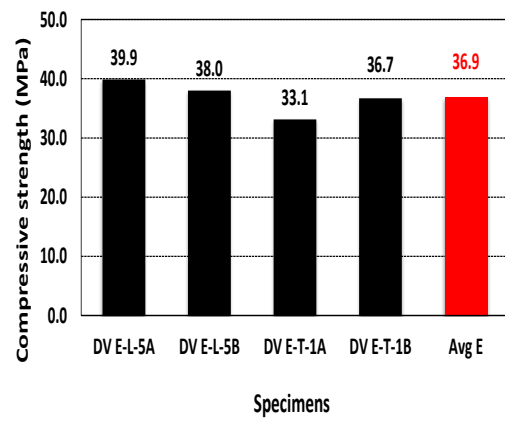
FIGURE 3: Compressive strength values measured on the two columns: a) Non exposed column; b) Exposed column.

The compressive strength results for all the concrete cores tested are illustrated in Figure 3. They ranged from 38.5 to 40.8 MPa for the NE column (average of 40.5 MPa), and from 33.1 to 39.9 (average of 37 MPa) for the E column. As expected, a lower average strength but a higher variability of the test results were obtained from cores extracted from the E column.

Regarding the data of both compressive strength and modulus of elasticity determinations for both columns, one verifies that, as stated in the literature, compressive strength is not really a concern for the AAR affected concrete [4]. As observed in the case of concretes undergoing unrestrained ASR expansion, cracking at low and moderate expansion levels (up to about 0.10-0.12%) is mainly found in the reactive particles with limited extension into the cement paste, thus inducing limited reductions in compressive strengths. Thus, as stated in [1], concretes of RBC columns should likely have a 28-day strength  $\geq 28$  MPa, which was confirmed from core testing (Figure 3). First of all, this means that the concrete used for the columns probably presented strength greater than 28 MPa at 28 days. However, the E column seems to have lower values of compressive strength compared to NE column, yet they are still greater than their 28-day values.

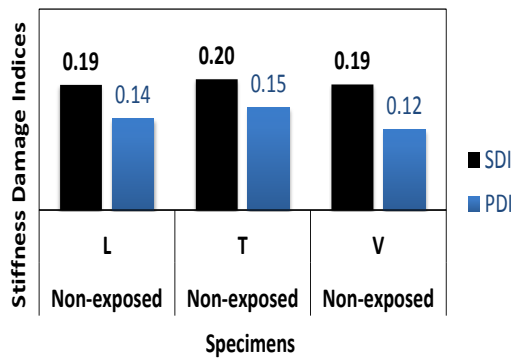
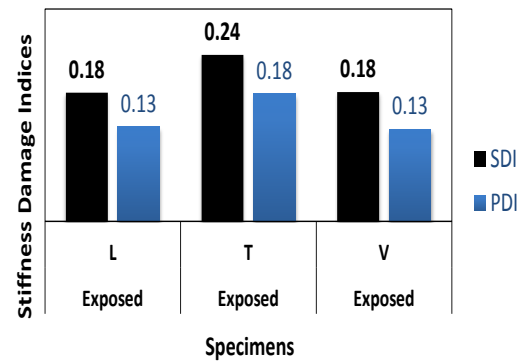
FIGURE 4: SDT indices measured in both non-exposed and exposed columns.

Figure 4 presents the average results of two SDT output parameters, as described by [4-8]: the *Stiffness Damage Index* (SDI), a measure of the dissipated energy caused by the closure of cracks under compression loading, and the *Plastic Deformation Index* (PDI), which quantifies the slipping across surfaces while the internal cracks close under compression loading. Both indices are a function of the extent of inner cracking present in a given material [4-8]. Table 2 presents all the data obtained in this research (i.e. NE vs E columns; Longitudinal vs. Transverse vs. Vertical cores).

The average SDI values for the NE column ranged from 0.19 to 0.20, whereas from 0.18 to 0.24 for the E column. The average PDI values ranged from 0.12 to 0.15 in the NE column and from 0.13 to 0.18 in E column. Moreover, higher results were obtained in the transverse direction in both columns (direction of less reinforcement, Figure 5).

It is clear from the testing data that the concrete condition (or the indices) changes as a function of the direction of coring. Indeed, in the case of the NE column, cracking seemed somewhat homogeneously oriented/distributed since similar average SDI values (0.19-0.20) were obtained from cores extracted in the three directions. Similar average SDI values were also obtained from cores extracted in the longitudinal and vertical directions in the E columns (0.18-0.19), while cores extracted transversally suggested a higher degree of damage (average SDI of 0.24). This is very likely linked to the asymmetric geometric shape and reinforcement detailing of the columns in the field, which likely influenced the stress-state and consequently the direction and development of the cracks in the E column undergoing higher ASR expansion because of more intense exposure to moisture. Such a phenomenon was actually reported by [10] where heterogeneous 3D restraint in structural members may enhance expansion in the direction of least restraint.

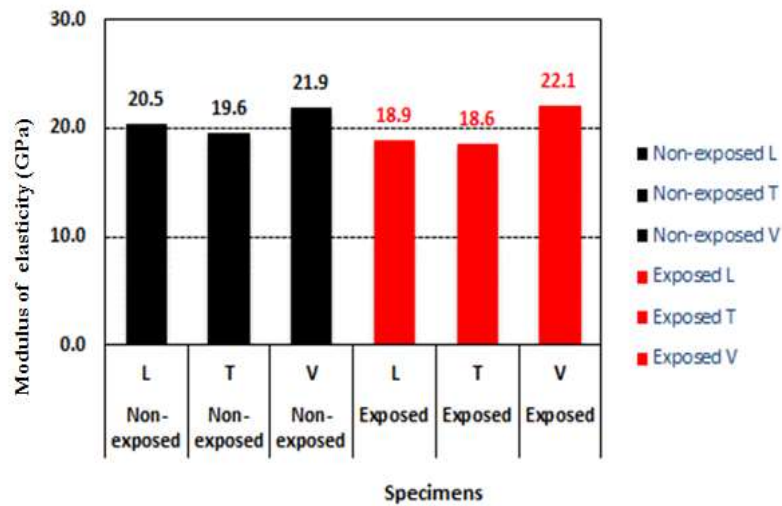
FIGURE 6: Secant modulus of elasticity values measured on the two columns: a) Non-exposed column; B) Exposed column.

Figure 6 illustrates the modulus of elasticity values obtained in the analyses of both columns. These correspond to the average values measured from the 2<sup>nd</sup> and 3<sup>rd</sup> cycles of stiffness damage testing [4-8]. The average values from NE column varied from 20.5 to 21.9 GPa, whereas they ranged from 18.6 to 22.1 GPa for the E column. E column showed greater damage and thus lower modulus of elasticity compared to the NE, as expected. Moreover, higher variability of the elastic modulus results was found for E column.

Fairly low elastic modulus values were obtained for the E column, indicating the presence of microcracking due to AAR, especially within the aggregate particles, as by [4, 7]. However, it should be noted that unrestrained uniaxial values of modulus of elasticity cannot be directly applied in the condition assessment of AAR affected structural members due to 3-D stress-states always found in the field. Therefore, these results can just be treated as indicators of inner cracking caused by AAR, similarly to the SDI and PDI indices.

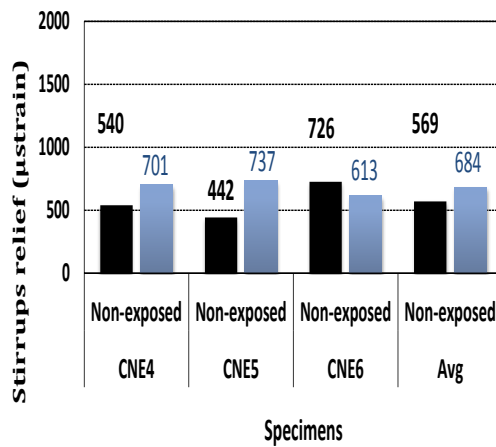
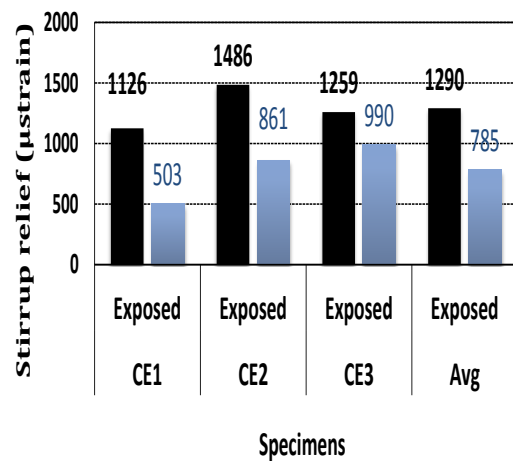
FIGURE 7: Stress-relief measured on the two columns after stirrups cutting: a) Non exposed column; B) Exposed column. Blue bars represent cuts at the stirrups edges (Figure 5 - Location E) and black bars at the middle of the cross section (Figure 5 – location M).

Figure 7 illustrates the stress-relief ( $\mu$ strains) following the cutting of instrumented stirrups from both columns. It is important to mention that the columns were stored in the laboratory for several weeks before testing (i.e. no more live loads applied to the structural members); so, it is fair to consider that the deformations resulting from stress-relief from the stirrups are entirely (or at least largely) related to ASR expansion.

The stirrups cutting analyses were performed in two ways. First, after cover removal, stirrups were cut at their edges (Figure 5 - location E, due to logistics reasons). However, since the stirrups are normally bent at the edges, sometimes attached and close to the columns ends, analyses were also performed in the middle of the column's cross section (Figure 5 – location M) in order to verify whether higher (and more reliable !) values could be obtained.

E column stirrups presented greater deformation values compared to NE stirrups (as expected), especially when the analyses were performed at the middle of the cross section (Figure 5, location M). Actually, comparing data from the edge cuttings (blue bars) and cuttings in the middle of the cross section (black bars), higher values were found at location M for E column whereas almost similar values were found for NE stirrups. This suggests that better results / more reliable are obtained from cutting in the middle section of the stirrups. The average values obtained after cutting in the middle stirrup sections of the non-exposed and exposed columns were respectively 1290 and 570  $\mu$ strain.

Beyond that, one of the critical issues in ASR-affected structural members is the progressive swelling that may cause yielding and rupture of the reinforcement bars [9]. In this work, the multi-level approach proposed by Sanchez and discussed in the previous section was used to estimate the expansion attained by both NE and E columns, with values between 0.05%-0.12% for NE column and between 0.12%-0.20% for E column. In addition to the above material's testing, six stirrups were selected and cut from each column, in order to understand their stress-state. Results showed that E column presented higher (and almost double) values than NE column (1290 and 570  $\mu$ strains, respectively), agreeing with the results from material's testing, especially in the transversal direction. The results obtained for E column seem fairly high, especially because the columns were stored in the laboratory before testing and thus no live loads were still acting on the members when the stirrups were cut. Therefore, those values might be directly linked to AAR and highlight a potential concern
