# INVESTIGATION AND ASSESSMENT OF ALKALI AGGREGATE REACTION (AAR) IN THE PIRAPORA DAM

Marcela B.S. Sollero<sup>1\*</sup>, Lilian Q.G. Baima<sup>1</sup>, Heloisa Bolorino<sup>1</sup>

<sup>1</sup>CONCREMAT Engenharia e Tecnologia S.A.,  
São Paulo, SP, BRAZIL

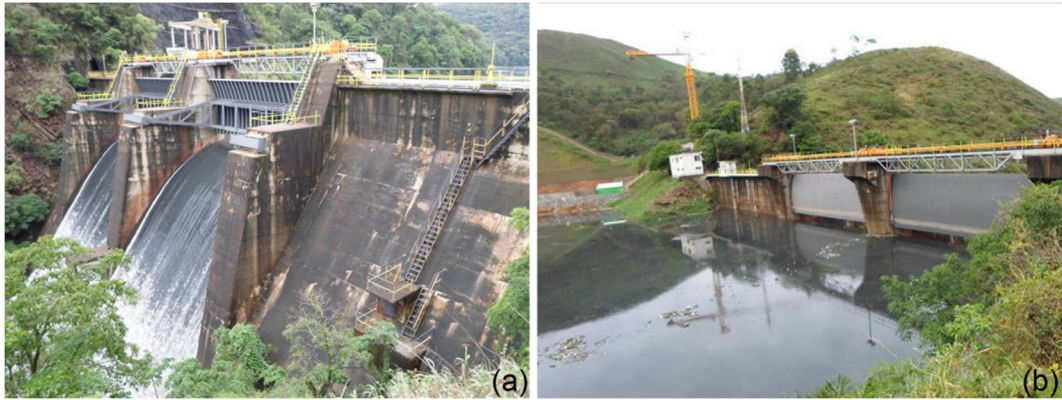
The Pirapora Dam, located in Pirapora de Bom Jesus, SP, Brazil, was built in 1956 to retain the flow of the Juqueri River and to harness it for power generation in the Henry Borden Power Plant, in Cubatão, SP. It is a gravity dam built from reinforced concrete, containing of buttresses and a wide base wall that incorporates a spillway with two openings. The dam is approximately 85 m long in the crest and 25 m in height. Figure 1 illustrates the Pirapora Dam.

FIGURE 1: Downstream side (a) and upstream side (b) of Pirapora Dam.

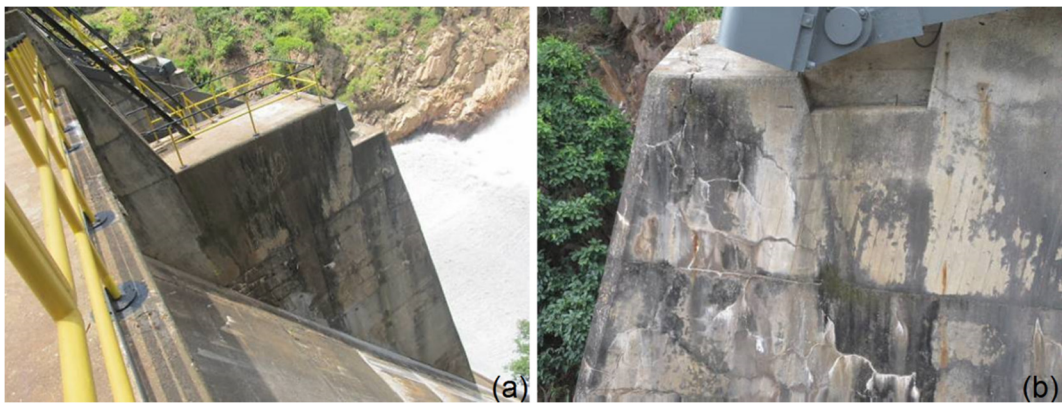
Among the anomalies possibly caused by the expansive reactions in concrete, the exudation of whitish-efflorescence materials and/or products of the reactions were observed. The mapped cracks showed a maximum opening between 0.3 and 2.0 mm, and spalling of concrete was observed, arising from the development of cracks, as illustrated by Figures 2, 3 and 4.

FIGURE 2: Map cracking and efflorescence of the buttress side (a) and trunnion beam area (b).

Thus, it is understood that interventions to mitigate widespread or highly complex expansive reactions will not be necessary for the Pirapora Dam because they could be limited to the most affected areas – the buttress. Furthermore, logically, it is necessary to apply protection systems with chemical and high abrasion resistance given the exposure conditions and steam permeability, allowing the evaporation of the water present inside the elements, but preventing liquid water from entering the elements. This measure is important given that both AAR and DEF depend on the presence of water for their development.

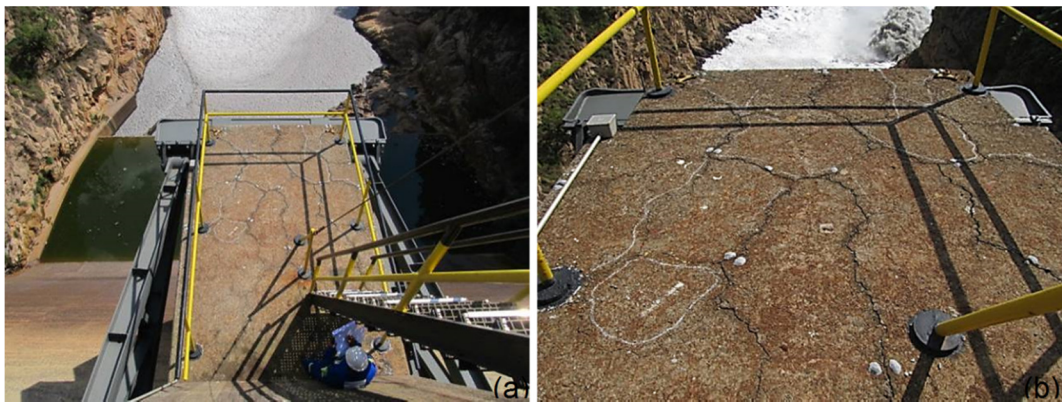
FIGURE 3: Map cracking chalk lined on the buttress top - (a) and (b).

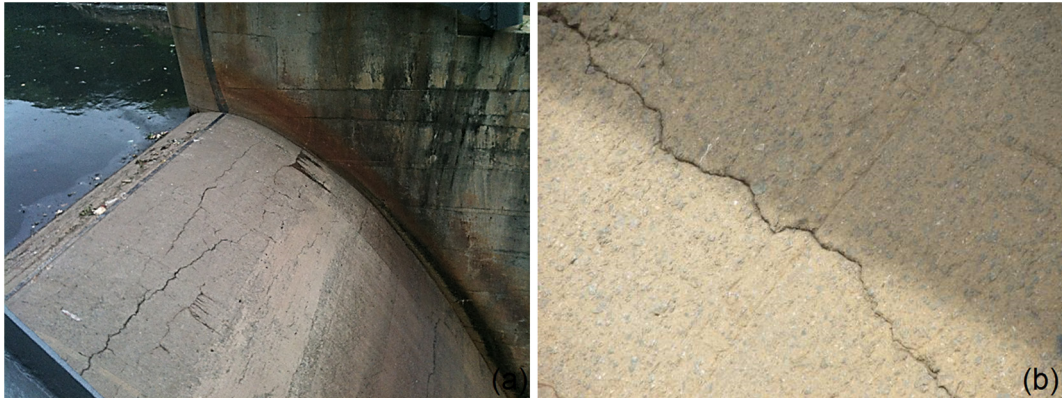
FIGURE 4: Cracks on the dam spillways – (a) and (b)
