PETROGRAPHIC INVESTIGATION OF ALKALI-REACTIVE
SILICATE ROCKS IN SEVERAL STRUCTURES

L. Dolar-Mantuani

Example 1: Quartz Arenite

Example 2: Sandstones

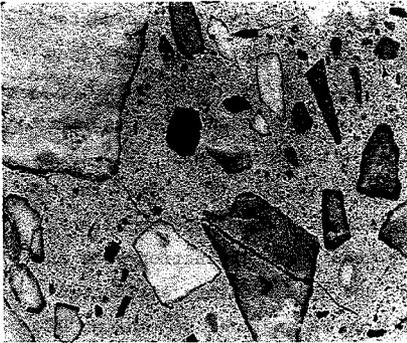
FIG. 1

Cracked coarse, fine aggregates
and cement past (1.1x)

Figure 1 shows the coarse and fine aggregate particles in the concrete with cracks crossing the aggregates and extending along the aggregate-cement paste paste interfaces into the cement paste. The aggregate rock is whitish to greyish, less frequently slightly brownish. A narrow rim (0.3 mm in the average), usually one or two quartz grains deep, is developed in most particles. The border of the rim toward the inside of the aggregate is gradational. Gel occurs in cracks but is lost

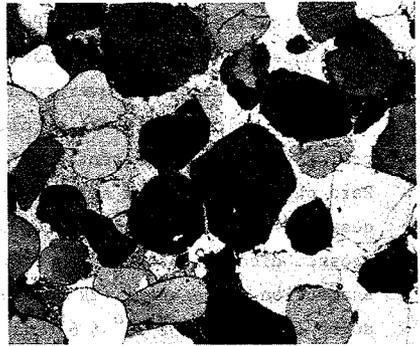
Quartz wacke with calcitic cement
(65x), T.S. crossed nicols

The aggregate is a uniform quartz arenite according to the classification by Pettijohn, Potter and Siever (14), with rounded to subrounded, well sorted to moderately well sorted quartz grains. They are mostly cemented by overgrown silica, far less frequently with secondary calcite (FIG. 2) or clayey material. The size of the quartz grains varies in different particles, the most frequent size is 0.25 mm. Rare particles contain stripes of much smaller grains (FIG. 3). The quartz grains are usually homogeneous (see FIG. 2 and 3 taken with crossed nicols). Few grains show slight undulatory extinction with an extinction range angle (ER angle) of 13° and an undulatory extinction angle (UE angle) of 30° (6); grains with an ER angle of 26° and an UE angle of 53° are exceptions. Cracking of larger quartz grains is frequent in some areas (FIG. 4) but few are broken into smaller pieces or are separated into small grains by the calcite cement.

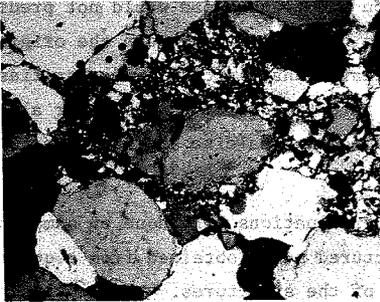
FIG. 3

Quartz arenite with fine-
grained quartz and clay inter-
stices (62x), T.S. crossed nicols

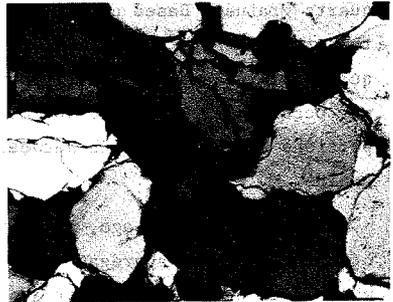
FIG. 4

Cracked quartz grains in arenite
(65x), T.S. crossed nicols

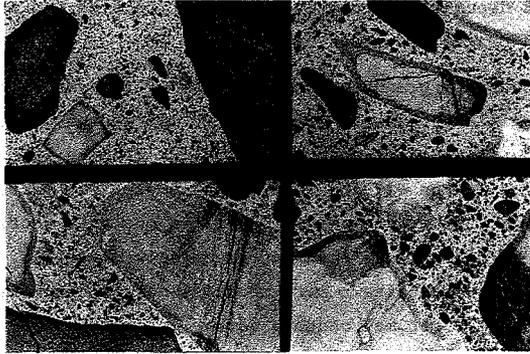
FIG. 5

Red argillaceous wacke and greenish quartz wacke both with rims and cracks (0.94x)

The 40 year old concrete used in hydraulic locks and bridges show extensive cracking, scaling and spalling and typical pattern cracking in some locations. Many coarse aggregate and several particles of the coarse sand fraction show dark rims measuring 1 to 4 mm. in width with little variation in a given particle (FIG. 5).

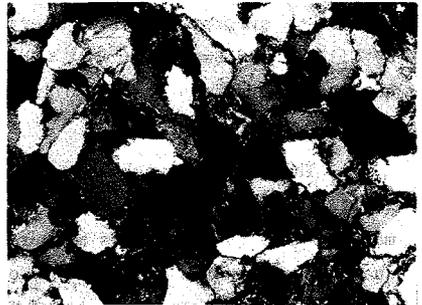
FIG. 7

Quartz wacke grading to arenite with mica scales at quartz borders (65x) T.S. crossed nicols

The greenish wacke consists of angular to subrounded uniform quartz grains, much less abundant feldspar grains and a scarce clayey matrix. The quartz grains measure about 0.20 mm. in size and show frequent quartz overgrowth. This variety of the sandstones with some similarity to quartz arenites is also reactive forming reaction rims with gel deposits.

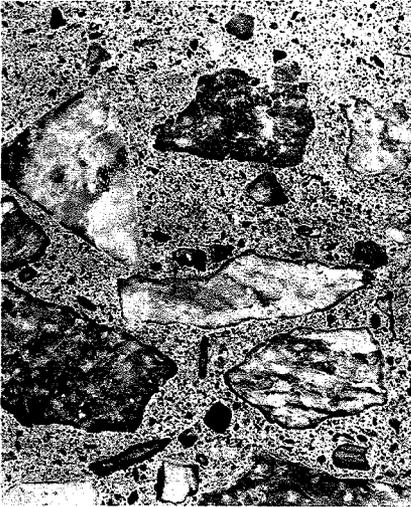
FIG. 8

Segregation of cracked aggregates and cement paste. Life size.

The concrete is used in a bridge which shows distinct cracking in the piers and typical pattern cracking in the sidewalks. The coarse aggregate particles showed narrow rims, 0.1 to 0.9 mm. in thickness (FIG. 8). Gel and calcite deposits were abundant on cracks and in air voids in some concrete pieces but were scarce in other pieces that were available for examination.

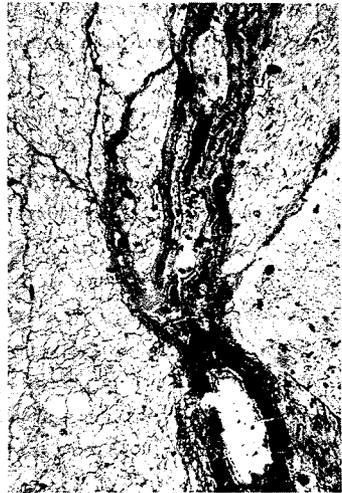
FIG. 11

Branching crack with gel and desiccating cracks in microcrystalline groundmass (78x) T.S. polar. light.

The most characteristic feature of the rock is the distinct deformation, which increases its heterogeneity. It is least evident in the feldspar phenocrysts which show a patchy extinction or they are broken into several pieces. The cracks do not always follow cleavage planes. Quartz phenocrysts show a distinct wavy extinction (FIG. 10) and cracks separating them into smaller grains. The average ER angle is 7° and the UE angle 30° . Shearing planes and microfolding are visible in the groundmass. Lenses and accumulations of muscovite scales represent what seems to be former mafics. Aggregations of quartz coarser than the groundmass are developed in the shadows of the feldspar and quartz phenocrysts. Some quartz may have been introduced later as were pyrite grains which are disseminated in some particles. Calcite occurs in rare patches. Distinct cracks are developed in the concrete aggregates. They follow the mica rows but also cross the groundmass irregularly. In two thin sections gel was preserved in the cracks, in both instances in areas of the groundmass (FIG. 11).

The distinctly deformed and devitrified dacite presents special problems. It is known that a devitrified groundmass of acid volcanics is alkali reactive. Cracks in the cryptocrystalline (grain size less than 0.01 mm (13)) and microcrystalline groundmass are filled with gel. Some cracks occur within mica-rich lenses but traverse the mica lineation in areas with fewer micas. This rock is secondarily altered but judging from the presence of cracks and gel the alteration has not significantly diminished the reaction, if it has influenced it at all. The extent to which this would apply to other rocks is not known.
