REPORT ON REACTIVE CONCRETE AGGREGATE
FROM THE CAPE PENINSULA, SOUTH AFRICA

R.E. Oberholster
M.P. Brandt
National Building Research Institute
Council for Scientific and Industrial Research
Pretoria, South Africa

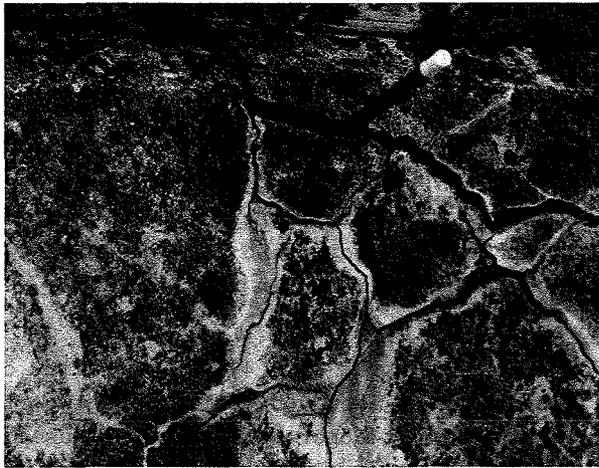
FIG. 1

Recent inspection has revealed deterioration of the components associated with the heightening of the wall. The raised portion of the wall is leaning forward by an amount varying from 16 mm in 1 m to 42 mm in 1 m (5). Cracks, similar to those shown in Figure 1, were seen in the southern wall and other tie heads. The 100 mm-thick reinforced walkway slabs are under considerable compression; it is not clear whether this is due to dimensional change of the walkways or to dimensional change of the tie heads on which they rest.

Cracking in right flank terminal
tie head, Steenbras Dam

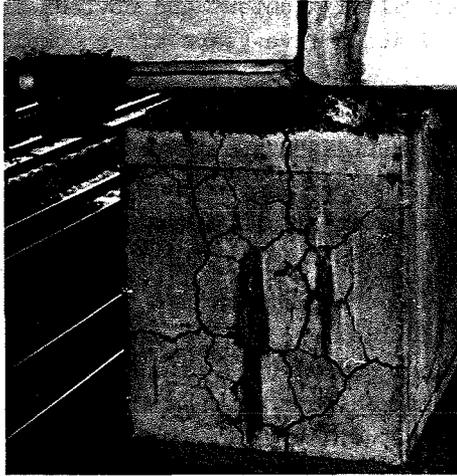
FIG. 2

Construction of the Pirow Street Bridge took place between February and July 1961. The piers, transoms, longitudinal beams and deck were all cast in situ. The coarse aggregate used was Malmesbury shale, the fine aggregate Cape Flats sand and the cement was one with a low alkali content, i.e. less than 0,60 per cent alkali calculated as Na_2O . Cracking of the transom beams became noticeable in 1965 and the bridge deteriorated to such an extent that remedial action had to be taken only nine years after its completion. Figure 2 shows the cracks in the end of a transom beam. It is important to note that the stringer (longitudinal) beams of two adjacent spans rest on the transom beam and that water from the deck finds its way down between the joints of the deck and the stringers and collects on the surface of the transom beam.

South-west end of transom beam showing serious cracking, Pirow Street Bridge

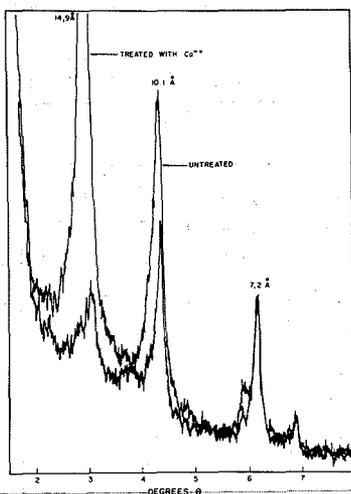
FIG. 4

A characteristic feature of the Malmesbury shales is the presence of illite which gives a peak on the X-ray diffractometer trace at approximately $10,1 \text{ \AA}$. After treatment with calcium containing solution, the height of the illite peak is greatly reduced and new or stronger peaks appear at approximately $14,9 \text{ \AA}$ and $7,2 \text{ \AA}$ (see Figure 4).

X-ray diffraction trace of $< 2 \mu\text{m}$ fraction of Malmesbury shale, untreated and treated

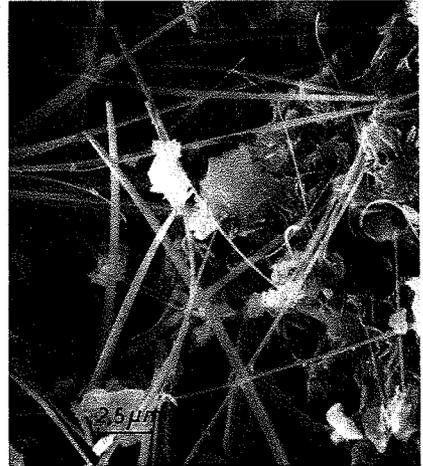
FIG. 6

Scanning electron micrograph of reaction product, Pirow Street Bridge

Figure 5 shows a polished specimen of concrete from the Pirow Street Bridge as seen under reflected light. A reaction product occurring between the contact of the aggregate and the mortar has a gel-like appearance and shows desiccation cracks. Figure 6 is a scanning electron micrograph of this reaction product.

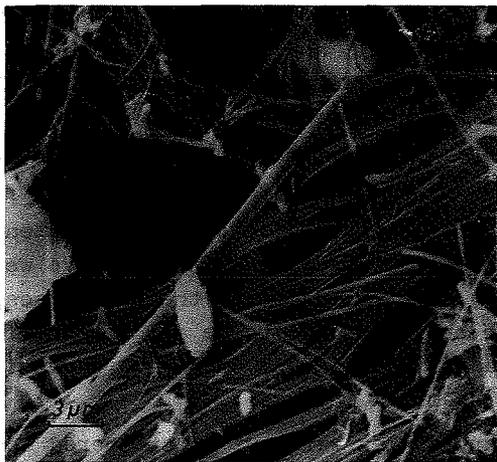
FIG. 7

Examination with the SEM of the reaction product produced by adding saturated lime water to Malmesbury shale showed a mat of long slender fibres occurring together with a gel-like mass (Figure 7). Calcium carbonate and an

occasional perfectly developed crystal resembling hydrogarnet were also present.

Scanning electron micrograph of reaction product of Malmesbury shale with $\text{Ca}(\text{OH})_2$
