EXPANSION OF CONCRETE CONTAINING
NEW ZEALAND ARGILLITE AGGREGATE

D.A. St John

L.M. Smith

Chemistry Division
Department of Scientific and Industrial Research
Petone, New Zealand

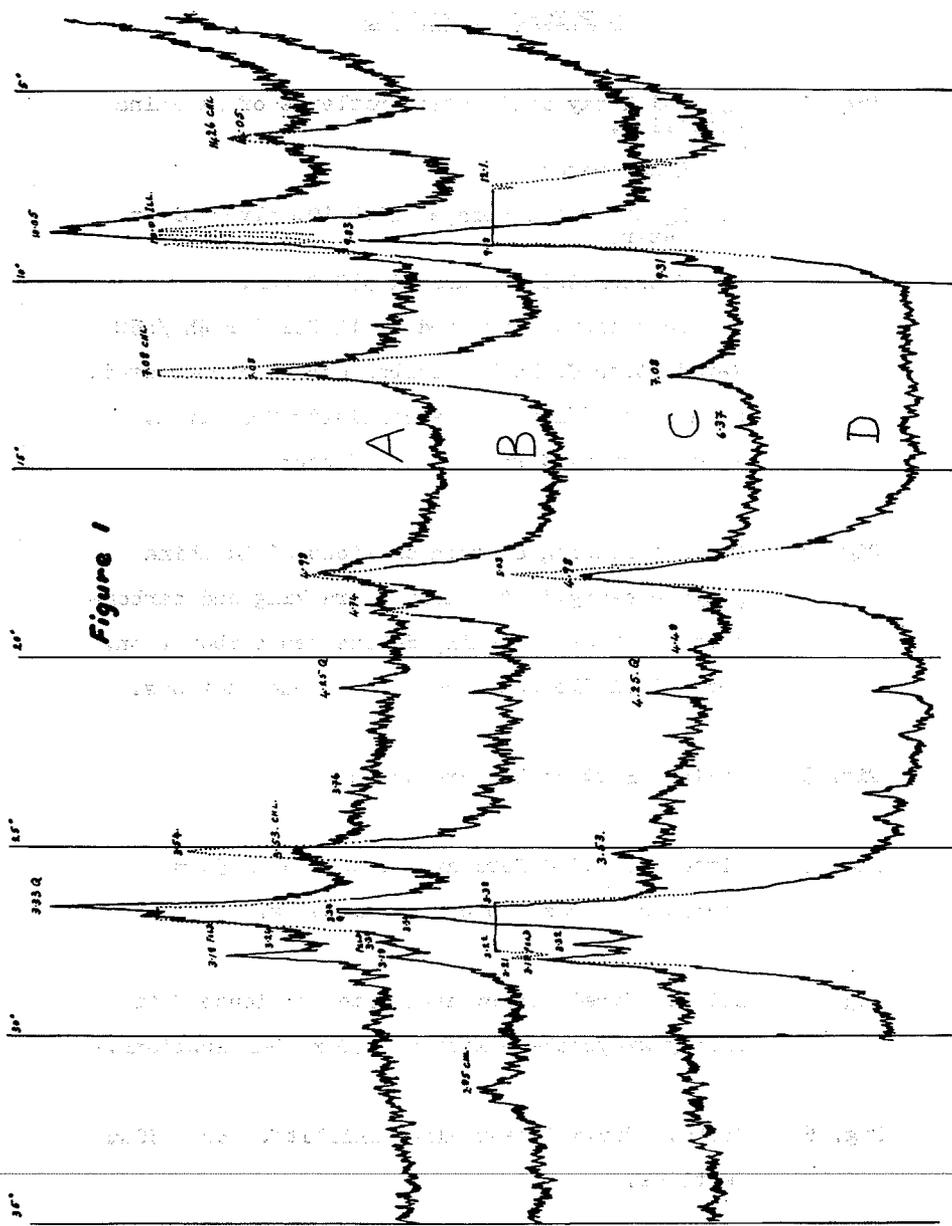
- Fig. 1 Typical X-ray diffraction patterns of Matahina argillite.
- a. K saturated
 - b. Mg saturated sprayed with 10% glycerol in water.
 - c. K saturated and heated 550 C/4hr.
 - d. No cation. Digested in 1N HCl for 4hr/85C
- X-radiation Cu Ka Carbon monochrometer used.
Scan rate $\frac{1}{2}^{\circ}$ /min sensitivity 200 c.p.s.
Time constant 4 sec. Scale factor 1
- Fig. 2 Outline drawing of thin sections of Matahina greywacke-argillite showing cracking and carbonation. Cross hatching delineates carbonation. End and middle sections. 75 x 75mm sections.
- Fig. 3 Ditto. Hutt Valley greywacke
- Fig. 4 Ditto. Fired Oxford argillite. 50 x 50mm sections. See table 2 for details.
- Fig. 5 Ditto. Fired Oxford argillite and dense Hutt Valley greywacke mixtures. 50 x 50mm sections.
- Fig. 6 Ditto. Fired Patent Slip argillite. 50 x 50mm sections.

Samples of greywacke and argillite were handpicked from the Matahina greywacke-argillite used for the concrete tests, crushed to pass a 52 mesh sieve and shaken for sixteen hours in water at pH 9. The minus 2 um fraction was removed by centrifuging and the fractions were analysed by powder X-ray diffraction, thermal analysis and infra red spectroscopy. Similar procedures were applied to the Oxford and Patent Slip argillites both in the raw and fired states. In addition Whites microscope test for free lime was applied to some of the fired argillites.

(a) Results of the analyses showed the handpicked greywacke and argillite fractions of the Matahina aggregate to be almost identical apart from some minor details. Approximately 10% and 7% of the minus 2 um fraction were recovered from the greywacke and argillite respectively. The minus 2 um fractions were principally quartz, feldspars, iron chlorite and either illite or finely divided micaceous material. The chlorite peaks were destroyed by digestion in 1 N HCl at 85C for 4 hr and many of the chlorite peaks were removed or flattened by heating at 550C. Attempts to expand the clay structures, both with 10% glycerol in water and ethylene glycol in the vapour phase at 60C, with and without Mg as the cation were unsuccessful. A typical set of XRD results are shown in figure 1. The 2 to 300 um silt fractions consisted of quartz and feldspars with some residual clays present. The above results were confirmed by thermal analysis and infrared spectroscopy.

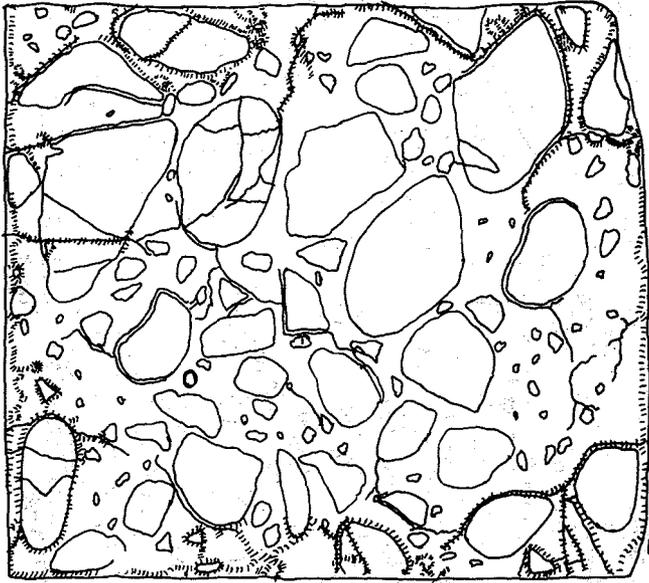
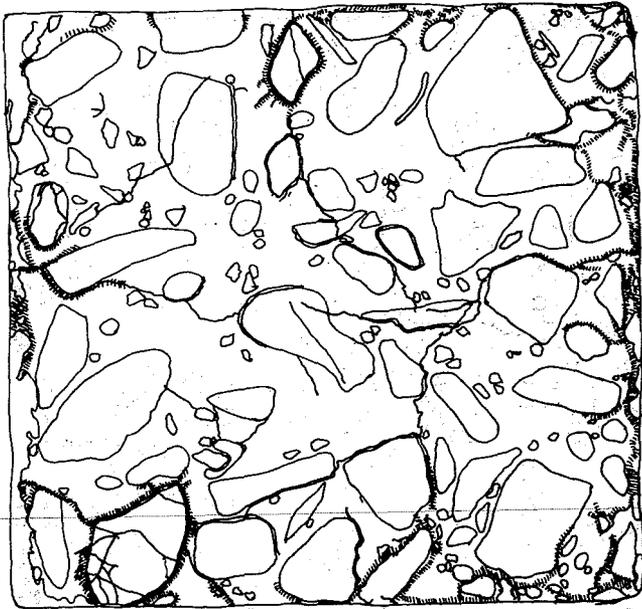
Fig. 2.

For the purposes of microscopic examination thin sections were cut from beams 15A and 17A from the middle and near one end in each case. Drawings of the sections cut from 15A are shown in figure 2. Cracking is indicated by black lines and carbonation areas by cross hatching.

The cracking in figure 2 is extensive in some areas and almost absent in others. Main cracks are approximately 40 μm

in width with smaller cracks ranging down to 10 um. Cracks generally skirt particles of aggregate but in a number of cases run through them. General carbonation of the cement paste extends to depth of 2-3 mm around the edges and this layer is not noticeably leached. In many of the larger cracks carbonation extends to a depth of 20 mm. Considering the cracking present the limited penetration of the carbonation suggests that drying of the specimens under the exposure conditions has not at any time been extensive.

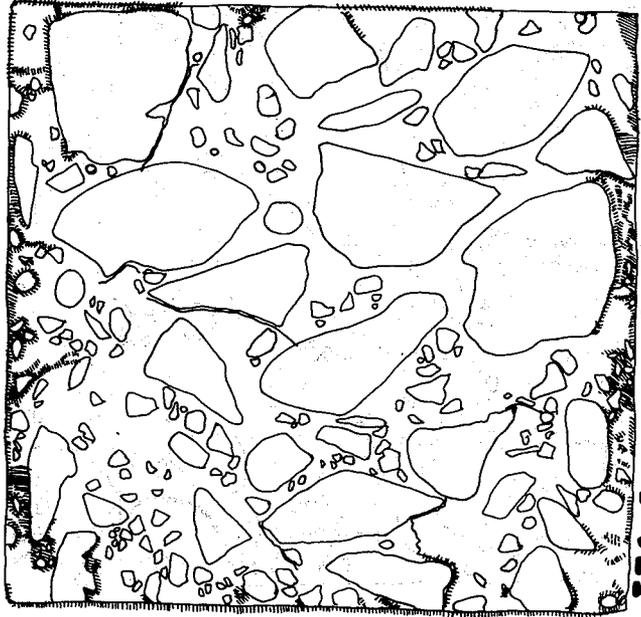
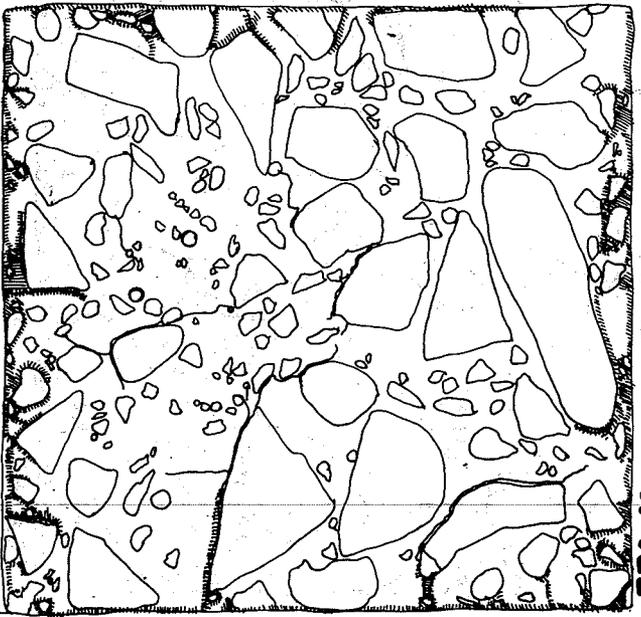
I7A-E
Fig. 3

The cracking and carbonation is outlined in figure 3. There is less cracking than in beam 15A and it is of a different character. Most of the cracks are shorter and do not extend far into the fabric of the concrete. Where cracks are present in the interior they are mainly discontinuous and much narrower than those present in beam 15A. Apart from this, the general state of the hardened cement paste is

similar to beam 15A except that the band of paste deficient in calcium hydroxide surrounding many aggregate particles is much less pronounced.

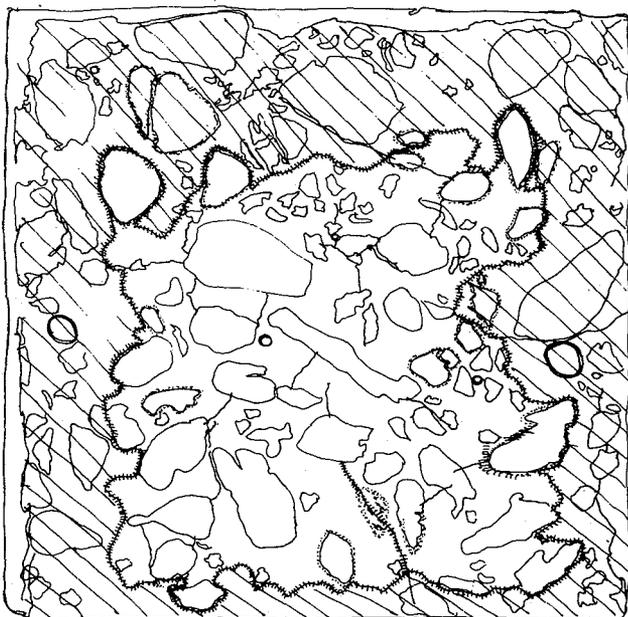
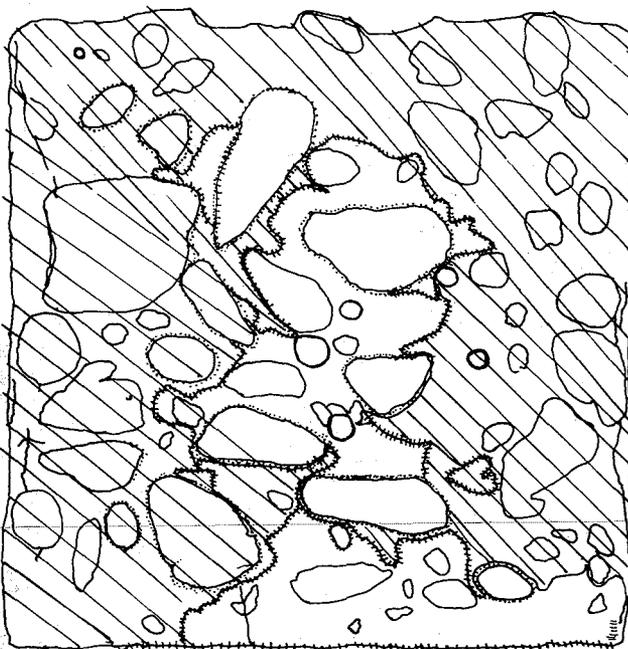
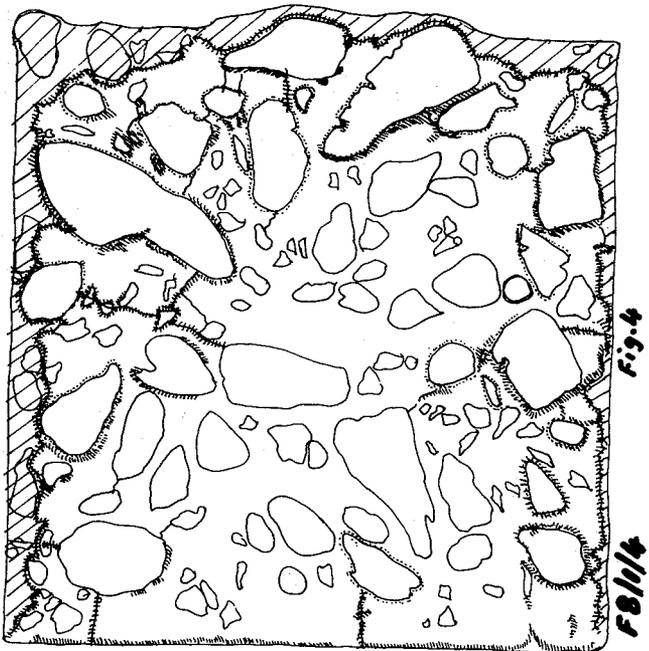
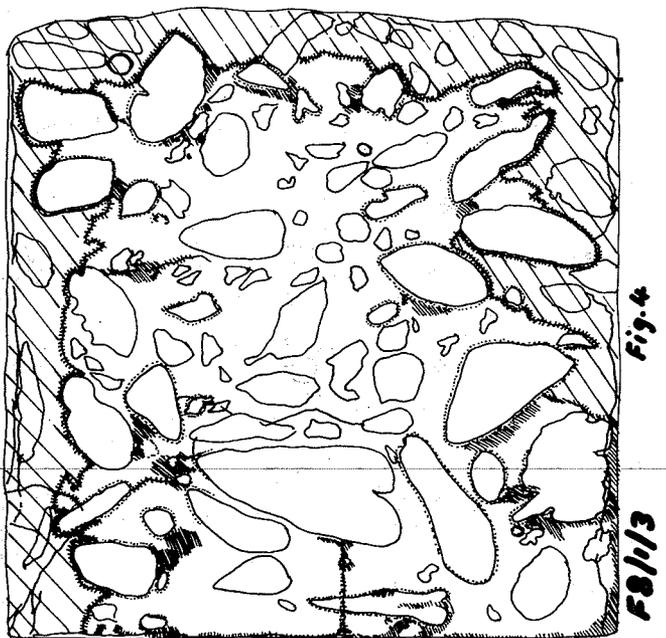
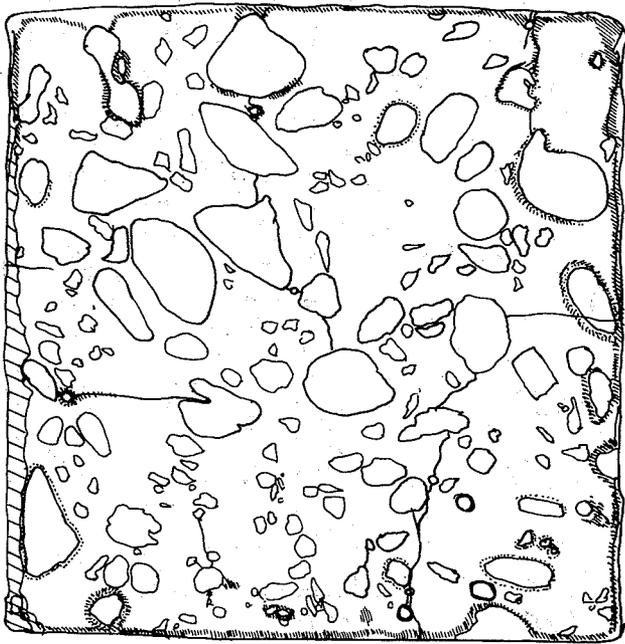
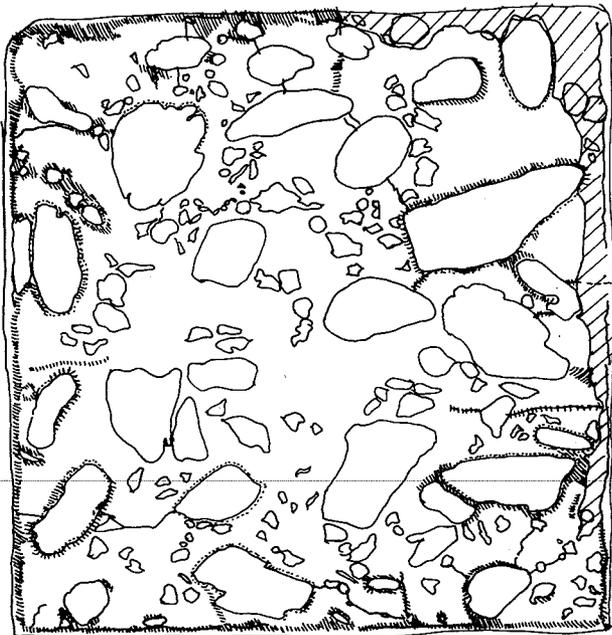
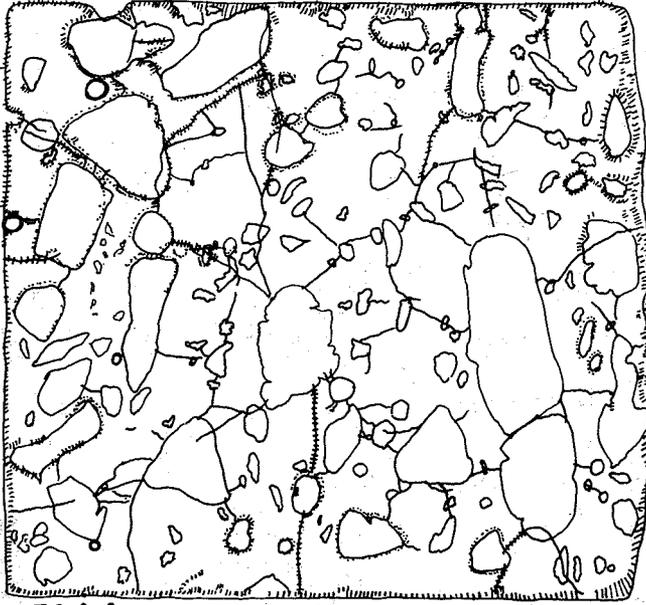
Fig.4

The cracking and carbonation is shown in figure 4. There is a marked change in the texture of the hardened cement fabric of these beams as the cement content increases. At the lowest cement content, carbonation is intense and leaching is apparent but cracking is almost absent. Weathering and carbonation is sufficiently severe to have weakened the fabric and many of the larger particles of aggregate have been penetrated by carbonation products. In beam FS/1/3 carbonation is more normal and less leached. At the higher cement contents the hardened cement fabric is typical of dense concrete and penetration of aggregates by carbonation products is absent. However cracking in these samples is severe both in the cement fabric and also in many fragments of aggregate. The transition zone between carbonated and uncarbonated cement paste is abrupt even in the most intensely carbonated beams. Around many of the larger fragments of aggregates the zone of cement paste deficient in birefringent crystals was noted suggesting a movement of calcium hydroxide into the aggregate particles concerned.

The surfaces of the beams with low cement contents were soft with little aggregate exposed. Pattern microcracking was visible on the surface of the beams from F8/1/3 to 7 and displacement of these cracks was evident in beams F8/1/6 and 7, where some discolouration of crack edges occurred. Many of the cracks were filled with calcite. Examination of fracture surfaces in pieces broken from the beams did not reveal the presence of any rims around aggregate particles or any other signs of deleterious reactions. The same trends were found with beams F8/1/12 and 13 and F10/4 and 9.

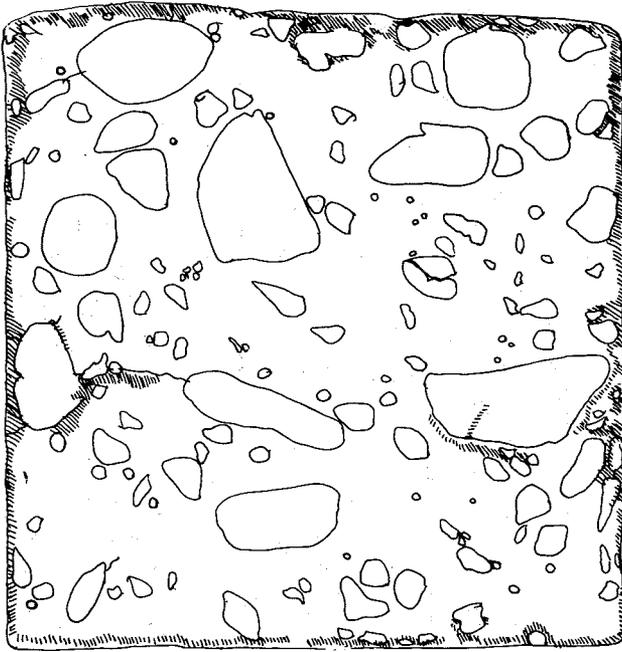
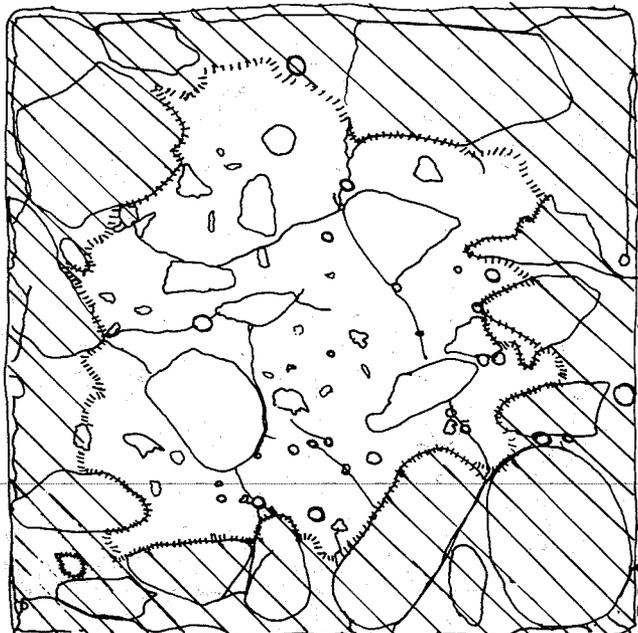
Fig. 5

The cracking and carbonation is shown in figure 5. The concrete in beam F8/1/12 appears similar to beam F8/1/3 or 4 in degree of carbonation and cracking. The replacement of the fired coarse aggregate by dense Hutt Valley greywacke has had little effect. In contrast, where the fired fine aggregate has been replaced in beam F8/1/13 the effect is dramatic. The concrete now has all the appearance of a normal dense concrete interspersed with lumps of fired argillite. This beam has weathered extremely well.

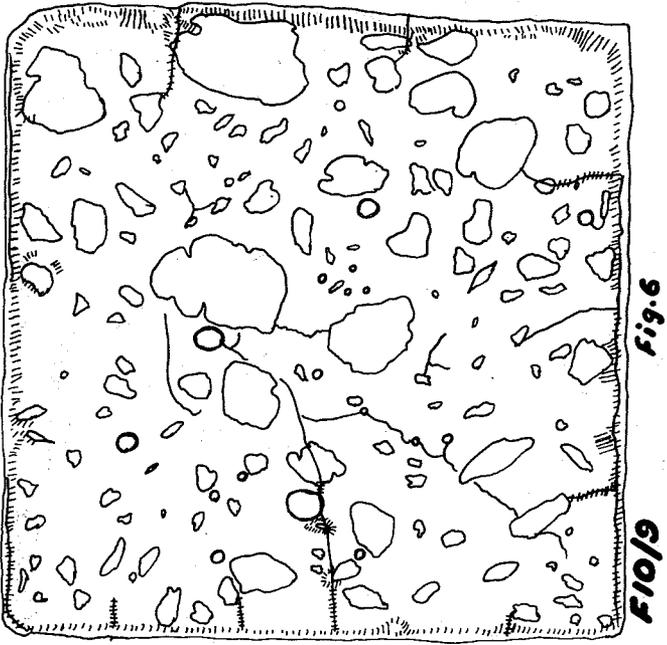
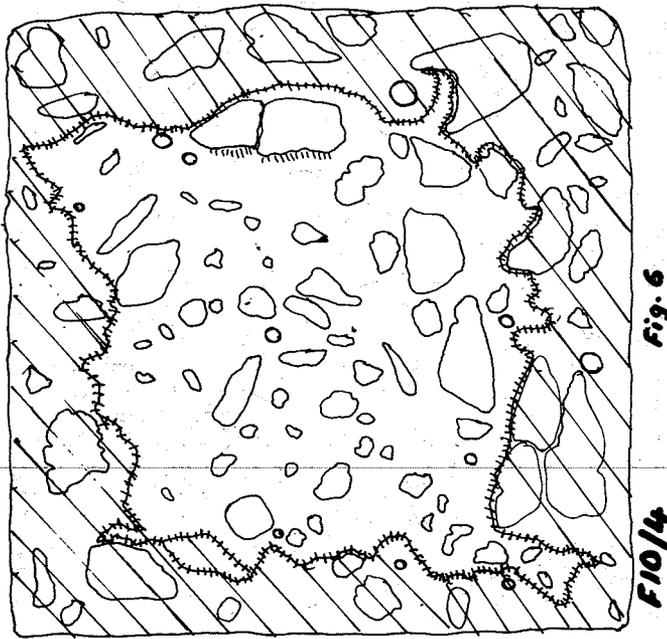
Fig. 6

Cracking and carbonation are shown in figure 6. Both these beams showed the same trends as the F8 series. The degree of cracking in beam F10/9 appears greater than warranted by the expansion of 0.009%, but cracks are much narrower than for beam F8/1/5.
