**THE EFFECTS OF ALKALI-AGGREGATE REACTION ON REINFORCED CONCRETE STRUCTURES  
MADE WITH WITWATERSRAND QUARTZITE AGGREGATE**

by Prof G E Blight\*, Prof JR McIver\*, Mr W K Schutte\*\* and Mr R Rimmer\*\*\*

Conference on alkali-aggregate reaction in concrete  
Cape Town - South Africa  
March 30 - April 3, 1981

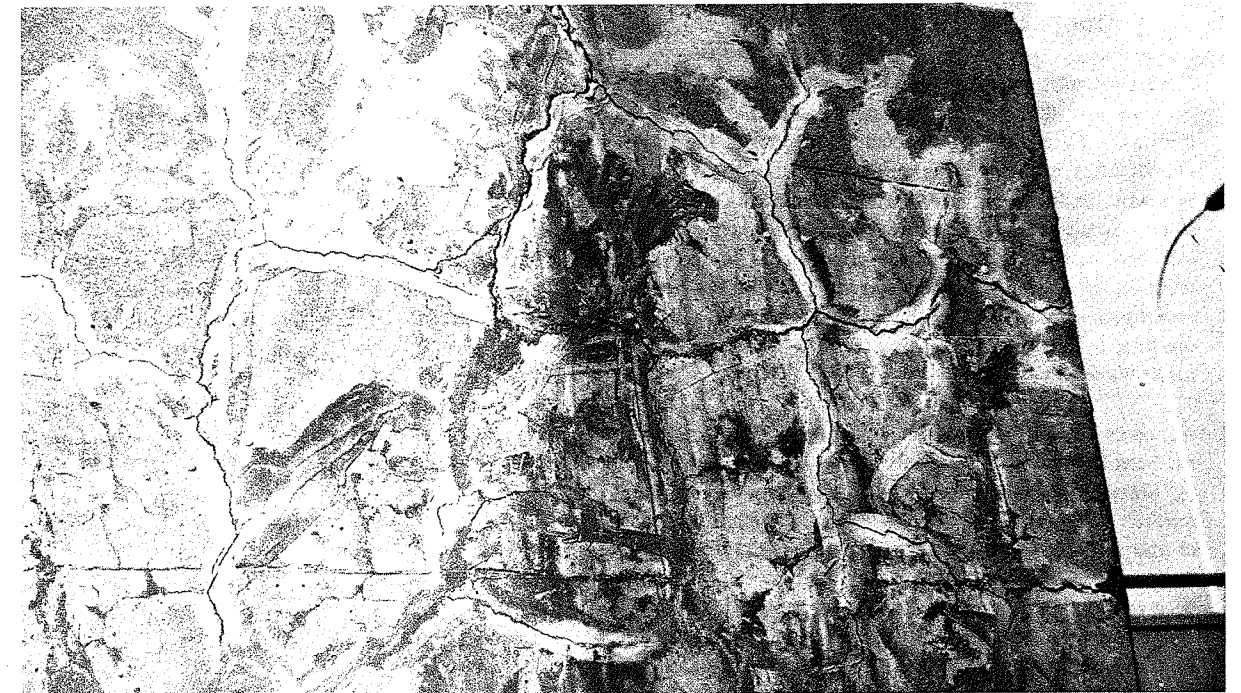
Figure 1 (a) Extensive cracking of exposed bridge portal. Attempts to seal the cracks by means of epoxy resin have failed.

FIGURE 1 : Examples of damage to structures constructed with Witwatersrand quartzite aggregate

Figure 1(a), page 2, illustrates the extensive surface cracking that has affected a number of bridge structures on the Witwatersrand. In the example shown, an attempt has been made to seal the cracks using an epoxy resin, but continuing expansion of the underlying concrete has reopened the cracks. The scale of the figure is indicated by two pairs of Demec targets on 100 mm centres stuck to the concrete and visible at the top centre and lower left of the photograph.

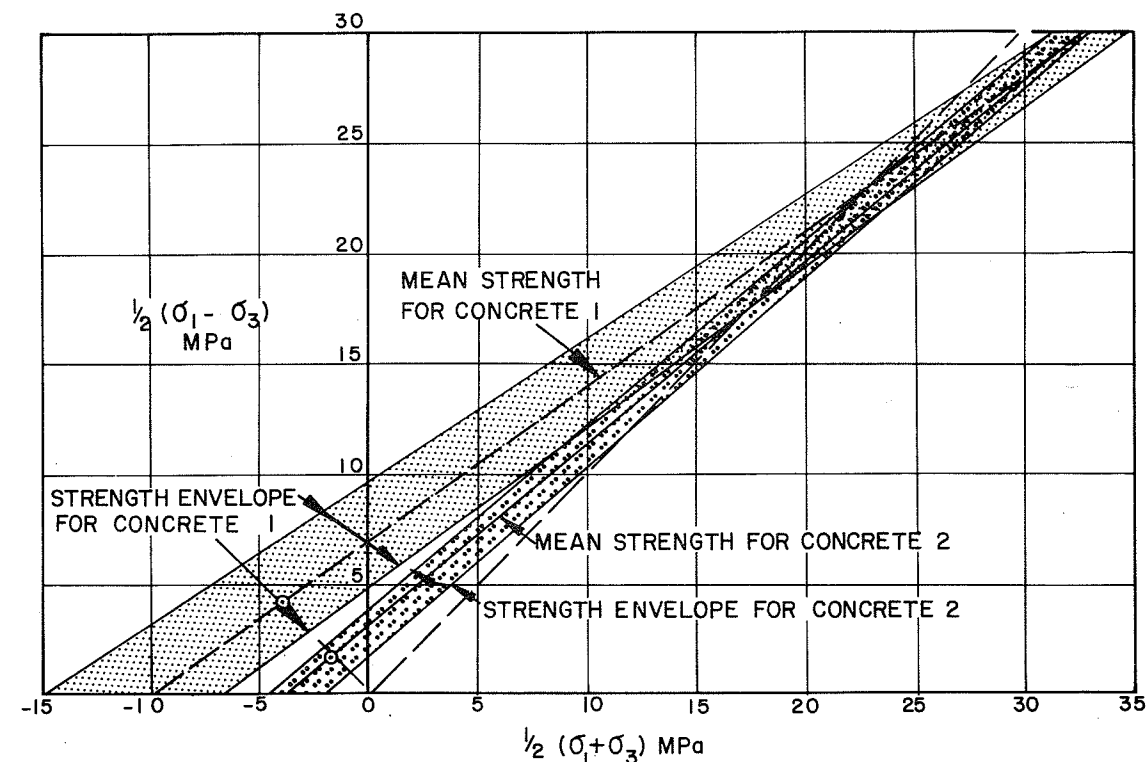
FIGURE 7 : Strength envelopes established for two deteriorated concretes by means of compression and indirect tension test.

The results of two suites of tests are summarized in Figure 7. Crushing strengths plot along the dashed line at a slope of  $45^\circ$  to the right of the origin, while indirect tensile values plot along the mirror image line at  $45^\circ$  to the left of the origin. In both cases, the nominal strength of the concrete was 30 MPa, and it will be seen that the lowest compressive strength recorded was 12 MPa. The values of tensile strength recorded in Figure 7 are, in a sense, fictitious as the strength measured across a fissure cannot differ very much from zero. Hence the assessment of the strength margin of a deteriorated structure or the design of strengthening measures for such a structure, must, of necessity, assume that the concrete has zero tensile strength.

The maximum design stress in the concrete at the junction of the column and the upper beam of the structure is 7.6 MPa on the inside of the column. A maximum stress of 2.1 MPa results at the outside of the column from the remedial prestressing. The maximum design stress is, however, virtually unaffected by the prestress. The maximum design stress is well within the strength of the deteriorated concrete as illustrated in Figure 7.
