EVALUATION OF A CONCRETE PAVEMENT AFFECTED BY THE ALKALI-AGGREGATE REACTION USING A HEAVY VEHICLE SIMULATOR

by C R Freeme* and B Shackel*

Conference on alkali-aggregate reaction in concrete
Cape Town - South Africa
March 30 - April 3, 1981

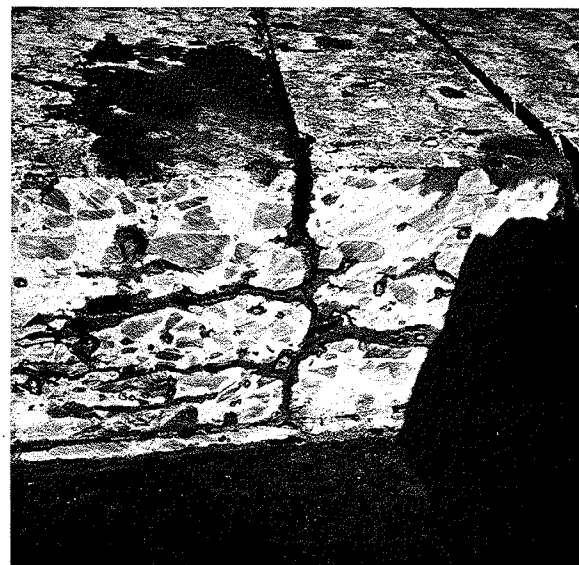
Excavation of the pavement at failed transverse joints established that there was a continuous network of both horizontal cracks and of cracks extending vertically throughout the entire thickness of the slab. This is illustrated in Figure 4. The effects of HVS trafficking were to develop these cracks in the vicinity of the transverse joints so that the slab tended to disintegrate into a number of separate blocks each roughly 15 to 200 mm square and about 60 to 100 mm thick. Inspection of these blocks showed clear evidence of the alkali-aggregate reaction

FIGURE 4: Evidence of vertical and horizontal cracking at a transverse joint.

along the fracture planes. In this respect it was observed that the concrete normally developed cracks and failure planes through the aggregate rather than through the cement matrix of the concrete. The disintegration of a slab adjacent to a transverse joint into discontinuous blocks was manifest initially by the pavement yielding an increasingly hollow sound when tapped with a hammer. As HVS trafficking progressed individual blocks began to break loose from their neighbours and to move visibly under each passage of the HVS test wheels. Eventually such blocks could be rocked from side to side by gentle hand pressure alone. Once the blocks had broken loose from the parent slab they began to develop faulting or stepping movements of up to about 5 mm relative to their neighbours. This was accompanied by the appearance of a powdery material at the surface which was believed to be finely ground concrete produced by the individual blocks grinding against one another. The removal of this finely ground concrete was facilitated by the presence of surface water. This led to the development of permanent vertical deformations in the concrete slabs adjacent to the transverse joints.

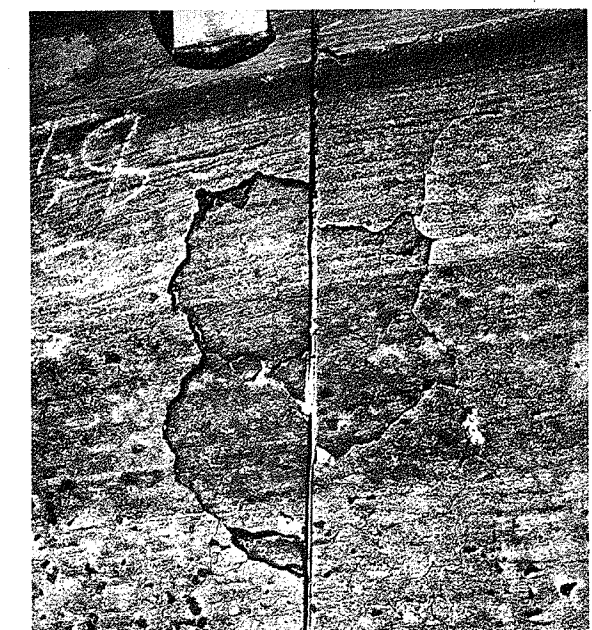
ii) *Spalling at the transverse joints.* The appearance of the pavement after failure is illustrated schematically in Figure 2 and photographically in Figure 3. The spalled areas extended along both sides of the joints (the numbers marked on the areas indicate the order in which they broke from the parent slabs). In general, the spalled concrete was restricted to a zone not more than ± 250 mm on either side of each joint. As trafficking proceeded, corner and longitudinal cracks sometimes developed in the pavement (cracks 5 and 6 in Figure 2).

FIGURE 3: Typical appearance of a transverse joint after HVS testing.

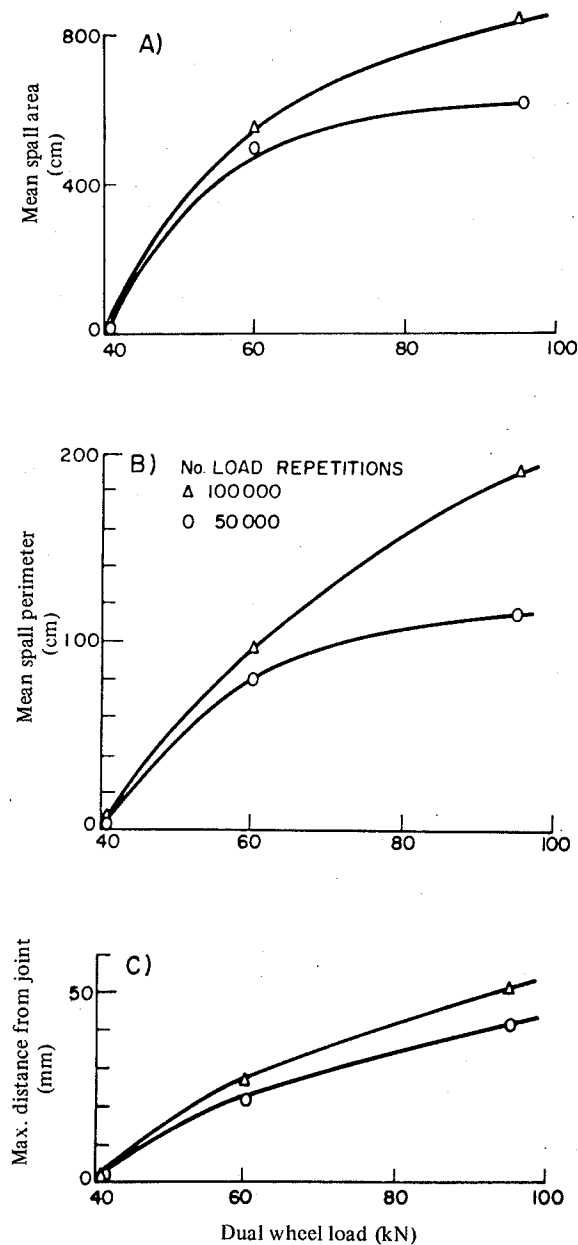
The data in Figures 7 and 8 establish that, in respect to the development of spalling and disintegration adjacent to the transverse joints, the concrete road is particularly sensitive to any overloading especially within the range 40

FIGURE 7: Rate of development of spalling at transverse joints.

to 60 kN. Here, the initial degree of cracking or the previous history of normal traffic loads does not appear to be of much significance. This is in contrast to the structural behaviour of the road where overloads above 60 kN appear to have the most detrimental effect.

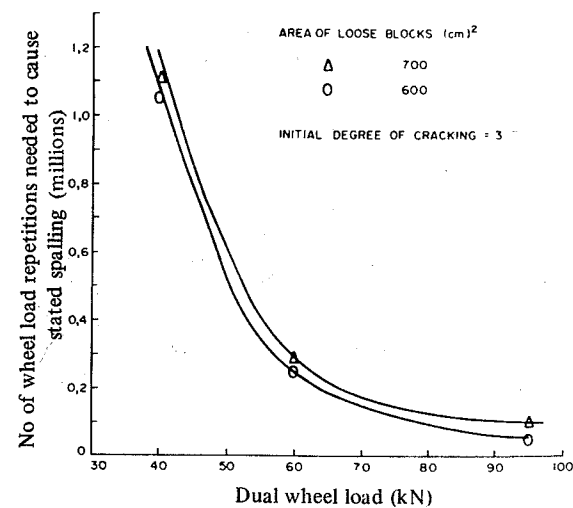
FIGURE 8: Effect of wheel load and number of repetitions on the spalling of the concrete.

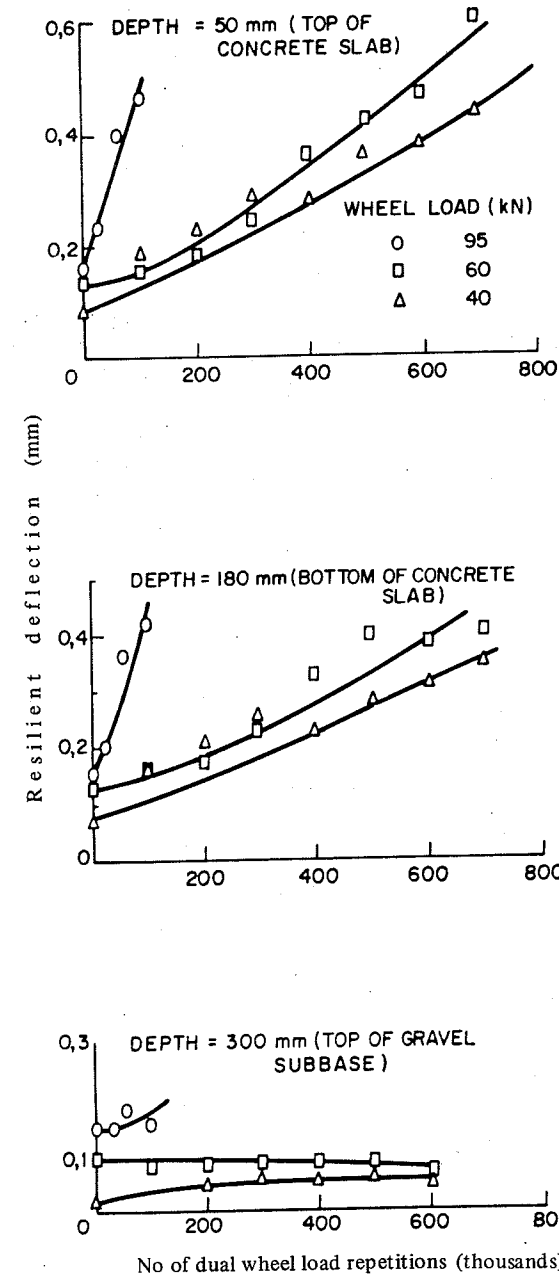
It was determined that, as shown in Figures 5 and 6, page 6, both the deflection and deformation of the pavement increased during the HVS tests with an increase in either the number of load repetitions or the magnitude of the wheel load. This type of behaviour was observed at both the top and bottom of the slab and at the bottom of the subbase. The effects of HVS accelerated trafficking were to produce rapid increases in pavement deflection until, near the onset of spalling, values of deflection of 0,3 mm or more were observed. In general, however, it was determined that spalling did not begin until the pavement deflections were greater than about 0,2 mm, ie approximately twice as large as the values ruling at the start of the HVS tests.

For a designated number of wheel load repetitions it was determined that the relationships between pavement deflection and wheel load were distinctly non-linear. The degree of non-linearity was more pronounced for the concrete slab than for the cement-treated subbase.

FIGURE 5: Deflection of the pavement at different wheel loads and depths.

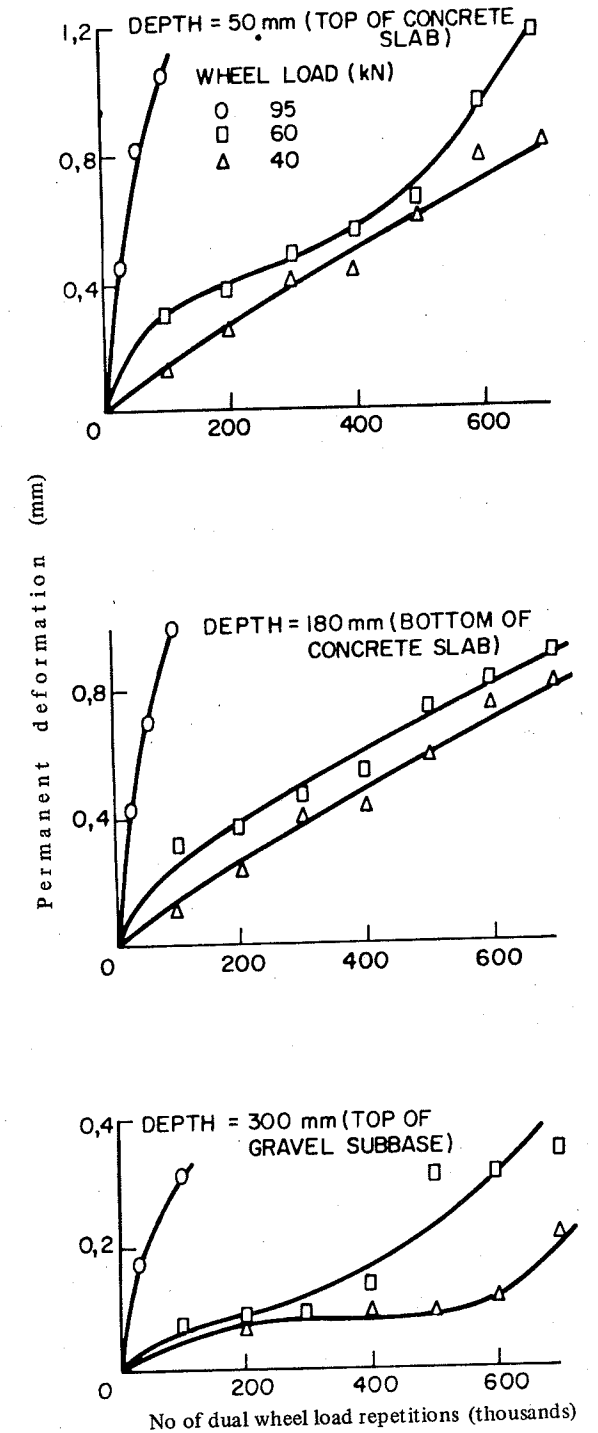
In addition to studying the deflection and deformation of the pavement as a whole, the movement within the slab and subbase layers was also investigated. It was found that these layer deformations and deflections also increased, in a non-linear fashion, with increase in the wheel load.

FIGURE 6: Deformation of the pavement at different wheel loads and depth.
