**Diagnosis of
Alkali-Aggregate Reaction
in Concrete**

DIAGNOSIS OF THE CAUSE OF CRACKING IN FOUR STRUCTURES IN WHICH ASR IS OCCURRING

D W Hobbs
British Cement Association
Century House
Telford Avenue
Crowthorne
Berkshire
UK RG45 6YS

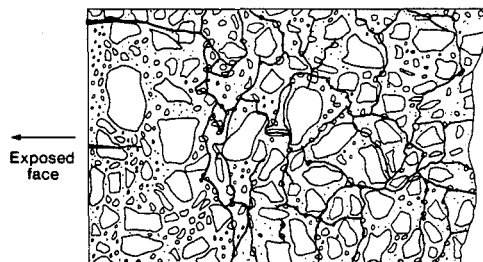
Fig. 1 Internal crack pattern which can be caused by ASR: reactive silica content in the coarser end of the sand fraction.

A comparison of the fine crack widths in regions where it was suspected that ASR had occurred, with regions in which it was suspected that ASR had not occurred, showed no material difference. A comparison of Fig. 7 with Fig. 1 shows that the fine cracking in the web is untypical of that induced by ASR. The fine cracking has the appearance of being induced by a physical process, the limestone particles either expanding by more than the mortar matrix or alternatively contracting less than the mortar matrix. Such differential movement would induce tangential tensile stresses around the limestone particles and could, if the differential movement was of sufficient magnitude, induce the fine crack pattern shown in Fig. 7.

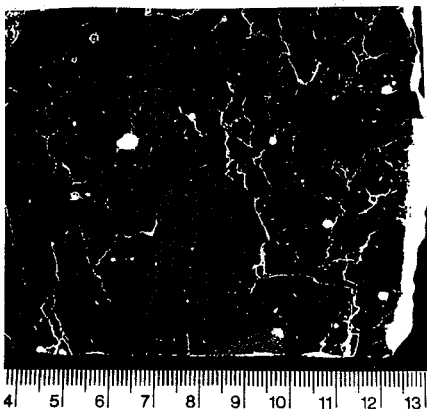
Fig. 3 Crack distribution in section taken from below rock fill level.

The field and test observations are summarized in Table 1. Photographs of the internal crack distribution in a core taken from above the rock fill and in a section of core taken from below the rock fill level, are shown in Figs. 2 and 3 respectively. In the final two columns of Table 1, the question is considered as to whether or not the observations or test results are compatible with alkali-silica reaction or freeze-thaw attack being the mechanism which has led to the general deterioration of the concrete core wall above the rock fill level. It is concluded that the deterioration of the concrete in the exposed part of the core wall is due primarily to freeze-thaw attack and that ASR is unlikely to be a secondary cause of deterioration.
