# PRESENCE OF ALKALI-SILICA REACTIVE AGGREGATES IN KOREA

## ABSTRACT

Forty different aggregates commonly used in ready-mixed concrete plants in Korea were tested for their alkali-silica reactivity by petrographic examination, chemical method and mortar bar method, respectively. Test results indicate that several aggregates be alkali-silica reactive. And alkali-silica reaction(ASR) products are also confirmed to be present in the cement composites of these aggregates by scanning electron microscope (SEM) and electron dispersive spectroscopy(EDS).

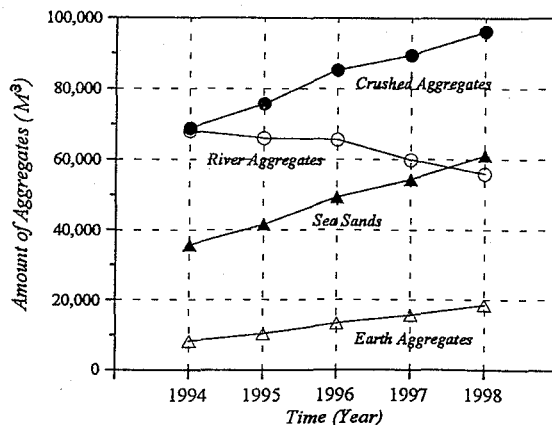
Fig. 1 Aggregates consumption in Korea

The natural river aggregate was exhausted in the latter of the 1980's in Korea. And 200 million tons of aggregates had been consumed due to the rushed construction demand for housings and infra-structures, use of crushed aggregates was legally permitted. Therefore, the risk of AAR has been increasing in Korea due to the rapid increase in crushed aggregates consumption. Figure 1 shows a pattern of several aggregates consumption to be expected in Korea until 1998.

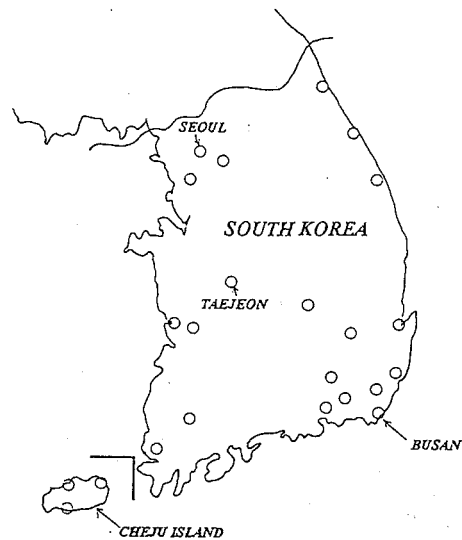
Fig. 2 Location of sampling aggregates in Korea

Forty samples of crushed stone being used at the ready-mixed concrete plants in Korea (see Fig. 2) were tested by petrological method using X-ray diffractometer (XRD), SEM and polarized light microscope, chemical method and mortar bar method to identify whether they are alkali-silica reactive or not.

Forty crushed aggregates in this study were used in the ready-mixed concrete plants in Korea. The location of sampling aggregates are shown in Fig. 2.

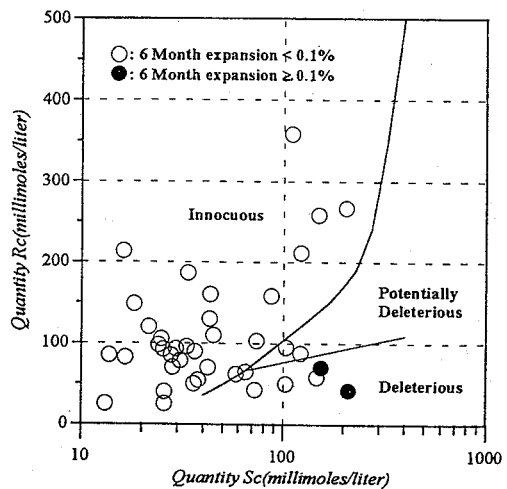
Fig. 4 Chemical method result

As shown in the Fig. 4, most part of aggregates is innocuous, however, several aggregates of Cheju island are deleterious, or potentially deleterious to be alkali-silica reactive.

Crushed, washed and dried to 0.15~0.30mm aggregate particles were reacted with 1N NaOH solution at 80°C for 24hours to get the reduction in alkalinity and dissolved silica content as in ASTM C 289.
