THE OCCURRENCE OF AAR IN A CONCRETE STRUCTURE IN ITALY

Giulia Baronio* and Mario Berra**

2. CASE OF CONCRETE STRUCTURE DETERIORATION

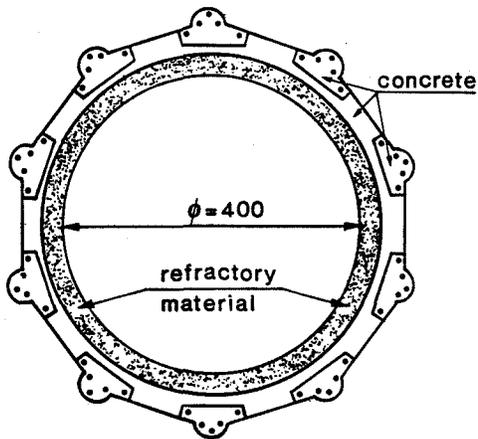
Fig. 1 Chimney cross-section

An Italian chimney, having reinforced concrete framework and brick masonry walls, and built at the beginning of 60's near the sea-shore, showed the first signs of deterioration at the end of 70's. Map cracking along the vertical columns and transverse beams was observed, sometimes accompanied by white exudations and pieces of concrete falling away. Figures 1 and 2 show a typical chimney cross-section and some examples of cracks and exudations respectively.

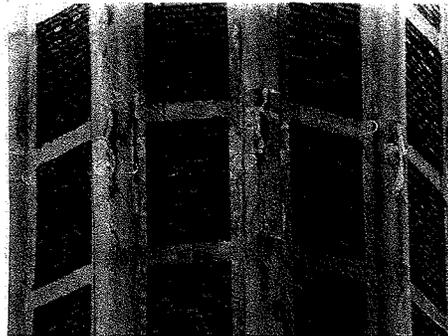
Fig. 2 Cracks and exudations in the chimney concrete

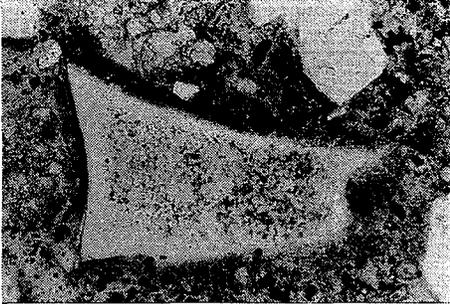
On examining thin sections under the polarized-light microscope, chert, calcedony and strained quartz particles were found both in the fine and the coarse fractions of calcareous aggregate with inclusion of clay mineral. In some particles extensive corrosion was observed: the alteration has progressed inwards and the exact location of the edge was obscured (fig. 5). In other cases very fine-grained silica diffused out and Ca(OH)₂ penetrated into the reacting pebbles (fig. 6).

Fig. 5 Edge alteration in a pebble (80x)

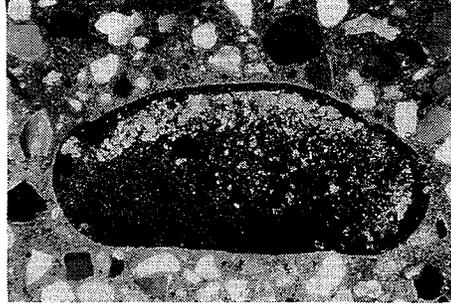
Fig. 6 Silica of a pebble replaced with calcium carbonate (20x)

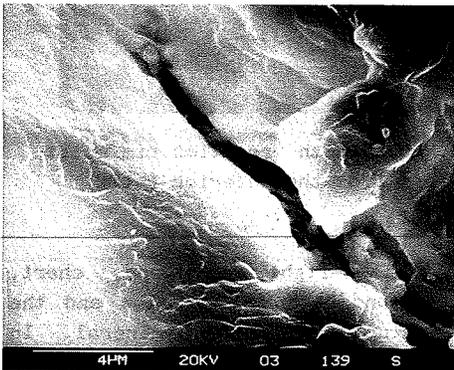
2.2.4 SEM Analyses The SEM analysis revealed that massive gels, sometimes overlaid with crusts of crystalline reaction products, had formed near the aggregate particles, inside and along fracture surfaces. A typical example of massive gel is shown in fig. 7. Different morphologies of crystalline products were observed.

Fig. 7 Massive gel

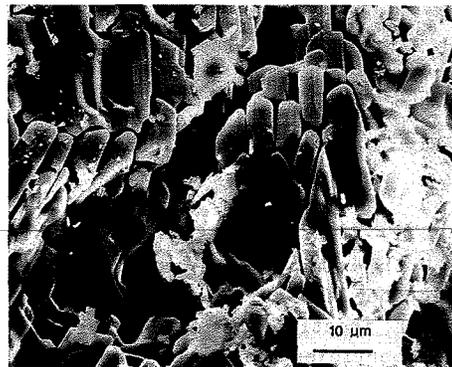
Crystals of the type shown in fig. 8 were sometimes observed and the EDS analysis clearly indicated that they consist of Sulphur and Calcium.

Fig. 8 Gypsum crystals

To quantify the contribution of this reaction to the decay of the concrete under examination is, however, a difficult task: disruptive expansions, in fact, could also be due to the sulphate attack and in particular to the formation of secondary gypsum.
