**PROPERTIES OF CONCRETE SPECIMENS DAMAGED BY ALKALI-AGGREGATE  
REACTION, LAUMONTITE RELATED REACTION AND CHLORIDE ATTACK  
UNDER MARINE ENVIRONMENTS**

Hidenori Hamada<sup>\*</sup>, Nobuaki Otsuki<sup>\*\*</sup> and Tsutomu Fukute<sup>\*</sup>

- <sup>\*</sup> Structural Division, Port and Harbour Research Institute,  
Ministry of Transport, Yokosuka 239, Japan  
<sup>\*\*</sup> Dept. of Civil Engineering, Tokyo Institute of Technology,  
Meguro-ku, Tokyo 152, Japan

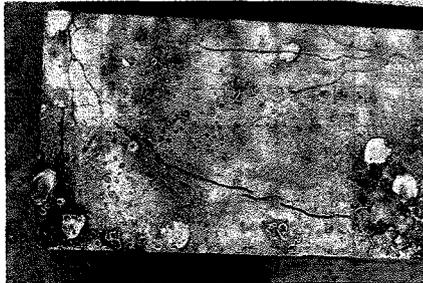
Photo 1 Damaged beam specimen  
(Exposed at Sakata)

Photos 1 and 2 show the conditions of the damaged PC beam and cylinder specimens respectively. In the PC specimens, deterioration of concrete is clearly observed, but in the RC specimens no deterioration is recognized.

In the damaged beam specimens, the end parts are damaged severely, however, the other parts are not damaged. In the damaged cylinder specimens, some obvious cracks and expansion were observed on the surface.

In the specimens exposed at Sakata, deterioration is observed in the PC specimens, but not in the RC specimens. The major differences of the concrete for the PC and the RC beams are the unit amount of cement (PC:410 kg/m<sup>3</sup>, RC:300kg/m<sup>3</sup>) and the curing method (PC:steam curing, RC:standard curing). High amount of cement and/or steam curing perhaps have a negative influence on the durability of concrete.

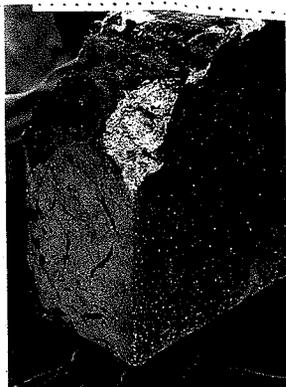
Photo 3 Damaged beam specimen

Photos 3 and 4 show the damaged beam and cylinder specimens respectively. Severe deterioration of concrete is recognized. In the damaged beam specimens, the end parts are damaged severely, however, the other parts are not damaged. In the damaged cylinder specimens, some obvious cracks and expansion are observed on the surface. In the worst case, as shown in Photo 4, the specimens cannot keep the original shape.

From the result of X-ray analyses of the aggregate used for the specimens, it is found that the majority proportion of coarse aggregate is laumontite. In the study by Ono et al [2], it is concluded that the concrete containing laumontite as aggregate is possibly to be damaged heavily in sulphuric or marine environments.
