**CRACKING AND EXPANSION DUE TO ALKALI-SILICA REACTION
IN THE UNITED KINGDOM**

D W Hobbs

British Cement Association, Wexham Springs, Slough
Berkshire SL3 6PL, United Kingdom

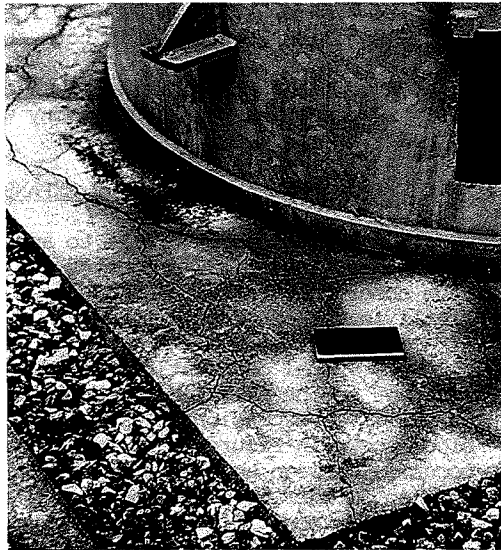
Figure 2. Cracking in a foundation block, age approximately 7 years. October 1976.

Figures 2 and 3 show cracking due to ASR in an unreinforced concrete foundation block and a reinforced concrete beam. The expansion and visual cracking due to ASR is greatest in the lightly stressed and lightly reinforced parts of affected structures. This is apparent from Figures 2 and 3 where it can be seen that the magnitude of expansion is very sensitive to applied or induced compression, little expansion occurring in the direction of restraint. This observation is supported by accelerated restrained expansion tests (see Figure 4).

From visual observations on several affected structures and monitoring of movement on one affected structure it is likely that at an age of 8 to 15 years the expansion is essentially complete. In the case of the foundation block shown in Figure 2, no significant further deterioration appears to have occurred between an age of 7 and 18 years. In the case of the Val-de-la-Mare dam, no further movement has been observed since about 1977, approximately 15 years after construction[2]. In the case of the beam shown in Figure 3, little further movement has occurred over the past 6 years indicating that expansion was largely complete at an age of 12 years.

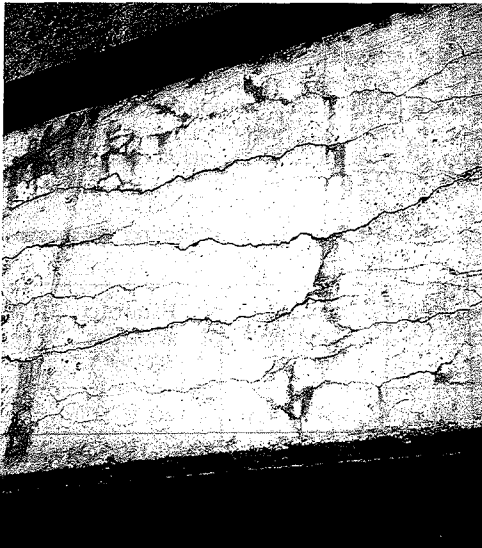
Figure 3. Cracking in a reinforced concrete beam.

(ii) Charles Cross Car Park, Plymouth, Devon (see Figure 3). Load tests were carried out on parts of this car park in 1981, 1982, 1985 and 1986[4]. 'The results indicated that all beams behaved reasonably well under the load test' and that 'the load tests confirmed that these beams were able to carry their design load and their actual service load plus a considerable margin'. Despite the conclusions resulting from the loading tests carried out in 1981, the structure was strengthened by adding a duplicate column and edge beam system.

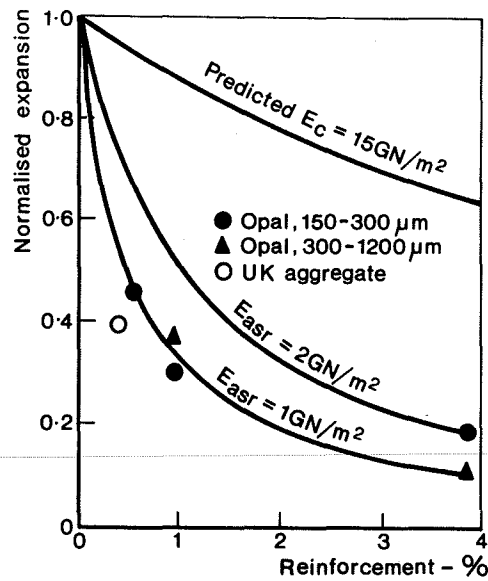
Figure 4. Relationship between normalised expansion and level of reinforcement.
