**ALKALI-AGGREGATE REACTION IN NEW BRUNSWICK, EASTERN CANADA
— PETROGRAPHIC DIAGNOSIS OF THE DETERIORATION**

Tetsuya Katayama and Toshiaki Futagawa

Cement/Concrete Technical Development Center, Sumitomo Cement Co., Ltd.
585 Toyotomi, Funabashi, Japan 274

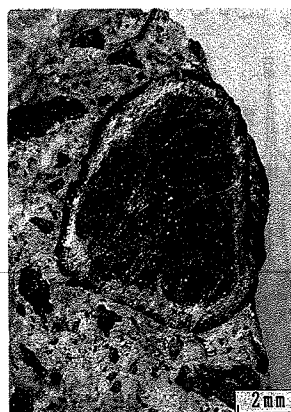
FIG. 1 REACTED SLATE WITH DARK OUTER RIM AND WHITE INNER RIM (M-81)

The coarse aggregate found from each structure is well rounded pebble, dominated in common by slate (near phyllite) and siltstone of Paleozoic age with minor amounts of sandstone, siliceous shale, quartzite, rhyolitic tuff and granite of miscellaneous origin (Table 1). Carbonate rocks were rarely found. Most of the slate and some of the siltstone and sandstone, show signs of reaction on the fracture surface in concrete. That is, a dark reaction rim, together with a white, broad rim just inside the former, is noted on the periphery of aggregate (Fig.1). These rocks contain coarse to fine-grained clastic quartz but the reacted portion is confined to the fine-grained matrix, composed of mosaic aggregation of cryptocrystalline to microcrystalline quartz. On the polished section only a dark reaction rim is visible. Siliceous rocks, like quartzite and rhyolitic tuff, only have the dark reaction rim. Illitic mica and chlorite are abundantly contained in the fine-grained matrix of slate. Vermiculite, which has been noted in the reacted, argillaceous rocks in Nova Scotia (5,6), was not recognized. The rock types most affected are common to those in Nova Scotia. Sand-grained fragments of sea shells and steel slag are occasionally contained in the concrete.

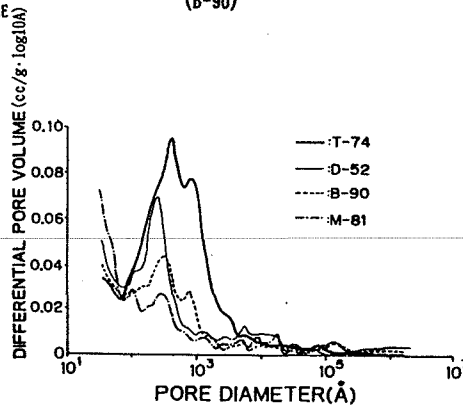
FIG. 5 PORE-SIZE DISTRIBUTION OF MORTAR FRACTION

The distribution of micropores in the mortar was measured using a mercury intrusion porosimeter (pore diameters 30 Å to 300 microns). All specimens have distribution peaks below the range of 10³ Å, which is far smaller than the size of entrained air voids, suggesting that none of them were effectively air-entrained concretes (Fig. 5). A vague correlation was noted between the results of this examination and the field diagnosis of deterioration. Mortar specimens, taken from structures showing evidence of freezing and thawing in the field, in addition to alkali-aggregate reaction, tend to be dominated by medium-sized capillary pores at around 10³ Å. This aspect was noted by Kamata (19) experimentally, who found that hardened cement pastes without entrained air voids but dominated by the capillary pores in the order of 10² to 10³ Å radii, are most susceptible to freezing and thawing. Careful interpretation should be made, however, in employing this method because pore-size distribution can be affected by the carbonation process (20), as well as by a water/cement ratio and hydration age of concrete. The results of DTA/TG measurements of the mortars showed that the degree of carbonation and the content of portlandite is not particularly different among samples (Table 3). Accordingly, this approach may be helpful in diagnosing freezing and thawing in concrete.

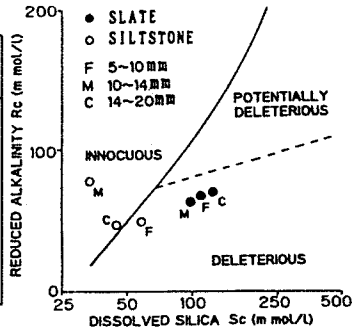
FIG. 2 ASTM C289 TEST OF THE SELECTED ROCK TYPES OF A LOCAL AGGREGATE

Potential reactivity of slate and siltstone selected from the local aggregate was tested according to ASTM C289 (Fig.2). The slate fell into the deleterious field with Sc 100-120 mmol/l and Rc 60-70 mmol/l, while the siltstone was marginal. The values of the slate nearly correspond with those of common Japanese Paleo-Mesozoic cherts which consist of microcrystalline quartz (7). The potential reactivity of the slate can be explained by the presence of fine-grained quartz in their matrix, while the marginal reactivity of the siltstone may be due to the result of dilution of the reactivity by dominating clastic quartz that is less reactive. Opal was not found in these rocks but this mineral does not likely exist, because opal deposited before the Tertiary ages recrystallizes through chalcedony to stable quartz during diagenesis (8). The reactivity of slate and phyllite has been noted (1,9,10), and the cause of the reactivity is attributed to chalcedony and microcrystalline quartz contained in these rocks (11). This particular evidence seems to suggest the strong possibility that such type of rock is capable of alkali-aggregate reaction under certain conditions.

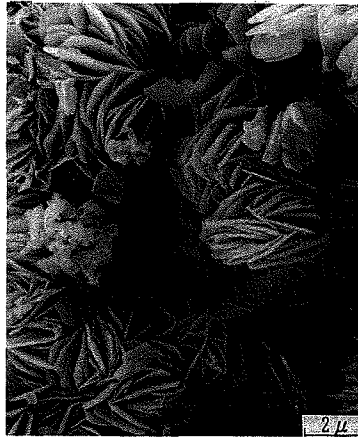
FIG. 3 ROSETTE-LIKE CRYSTALS IN THE WHITE INNER RIM DEPOSITS ON A REACTED SLATE AGGREGATE (B-90)

In the concrete, white gel-like deposits are found within reacted aggregates and rarely in the air-voids. The morphology of these materials varies greatly in the SEM order of observations. The fracture surface of the dark reaction rim on the aggregate is generally smooth but is full of desiccation cracks, indicating this part is composed of true gel material. Flaky crystals are sometimes embedded in this gel-rich layer. On the other hand, the white inner rim deposits occurring inside the dark reaction rim, are generally crystalline: they have a range of morphology from flaky to platy crystal habit to the rosette-like aggregation composed of platy crystals, together with sponge-like to filament-like materials of minor occurrence. Most of the morphology hitherto reported (12,13) can be seen in the deteriorated concrete from the same structure in this region. A qualitative EDX analysis indicated that alkalis, in particular K_2O , is concentrated in the rosette-type crystals on the aggregate (Fig.3). White deposits on the aggregate may contain portlandite and some calcium carbonates, such as calcite and vaterite as shown by micro XRD and EPM analyses.
