**INFLUENCE OF ALKALI CONCENTRATION DISTRIBUTION OCCURRING
IN CONCRETE MEMBERS ON EXPANSION AND CRACKING
DUE TO ALKALI-SILICA REACTION**

Kazusuke Kobayashi*, Ryouji Shiraki* and Kenji Kawai**

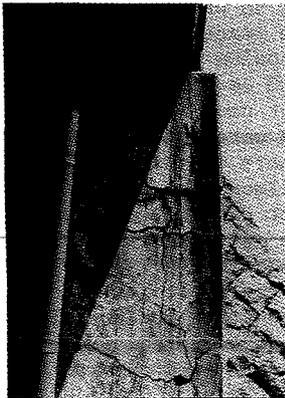
Fig.1 ASR cracking in an abutment
of bridge

Fig.1 shows ASR cracking in the abutment of a bridge, while Fig.2 shows ASR cracking in a retaining wall, which are commonly called "map cracking". Fig.3 shows the pattern of ASR cracking produced at the surface of a concrete prism ($7 \times 7 \times 40$ cm) stored in an environment of 20°C and 100 % RH.

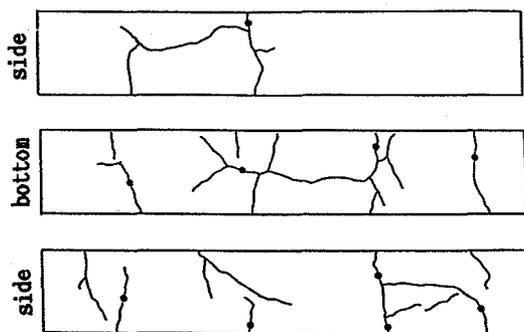
Fig.3 ASR cracking on a concrete prism
(W/C = 0.50, $R_2O = 1.46$ %, glassy andesite aggregate)

What should be noted in this figure are the direction of the cracks and the sequence of occurrence. At first, cracks perpendicular to the longitudinal direction of the prism occur, followed by cracks in the longitudinal direction connecting these first cracks. Such a cracking pattern is not of expansive cracking, but rather of shrinkage cracking.

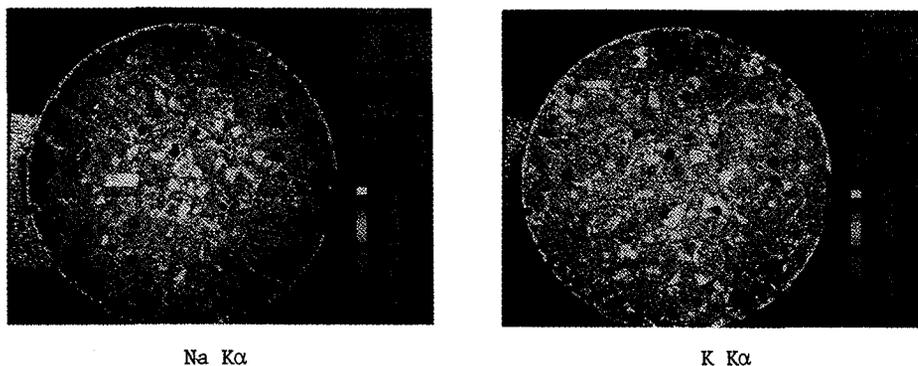
Fig.4 Stage-scanned image of mortar sample (55 × 55 mm)

Fig.4 shows the relative concentration distribution of sodium and potassium in the cross section of cylindrical mortar specimens 5 cm in diameter. The mix proportion of the mortar were $W : C : S = 0.5 : 1.0 : 2.25$, while as cement an ordinary portland cement of $R_2O = 0.57$ % to which NaOH was added to attain $R_2O = 1.56$ % was used. Chert was used as the reactive aggregate. Fig.5 shows the relative concentration distribution of sodium and potassium at the cross section of a cylindrical concrete specimen 10 cm in diameter. The concrete had a water cement ratio of 0.60, and cement used was an ordinary portland cement of $R_2O = 0.52$ % to which NaOH and KOH were added at the ratios of Na_2O and K_2O contained to obtain $R_2O = 1.46$ %. Chert was used as the reactive aggregate for both fine and coarse sizes. The specimens, upon holding in an environment of 20°C and 100 % RH for 24 hours after casting, were stored for 56 weeks in an environment the same as that of the acceleration conditions specified in ASTM C 227 (Mortar-Bar Method) in case of mortar, and 61 weeks in a fog room of 40°C in case of concrete, followed by element analyses by EPMA. These figures show that alkali concentration are lower at peripheral portions. The question is how such alkali concentration change occurred. The key for solving the problem is shown in the analysis results of the mortar specimens in Fig.4. It may be seen in the figure that there are parts of considerably high concentration of both sodium and potassium in the peripheral parts of the specimens. Chemical analyses for sodium and potassium show approximate agreement of the concentrations of these elements with the values calculated based on

the alkali contents of the cement and the mix proportions, and quantitative analyses by EDX if the alkalis in these peripheral portions are as much as 3 times the calculated values. The results of analyses for total alkali contents in the mortar specimens show that it is not possible alkali was leached out from the mortar. Based on the above results, we concluded that the decreases in alkali concentration at the surface portions were caused by precipitation of Na_2CO_3 and K_2CO_3 through reaction of sodium and potassium ion migrating from the interior to the surface portion by concentration diffusion to react with carbon dioxide in air and hydrogen carbonate ion in water supplied from the exterior. In the case of the concrete specimens in Fig.5, increases in alkali concentration at the peripheral portions can hardly be recognized as in the mortar specimens. This is thought to have been because the concrete specimens were stored in a fog room so that carbonates which had first been leached out. Such variations in the alkali concentrations at the cross sections of mortar and begin from around the age of 4 days, and at 7 days fairly distinct concentration distribution can be recognized. This suggests that occurrence of alkali concentration distribution is not restricted only to specimens in the " Mortar Bar Method ", but also can be found in cross sections of concrete structures in general. The reason for this is that concrete structures are

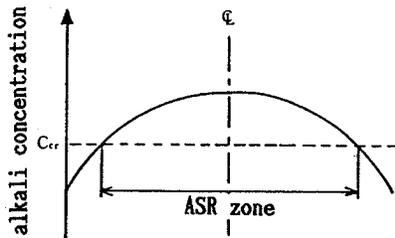
Fig. 6 Schematic alkali concentration distribution in a section of concrete member

It has been shown that alkalis in concrete involved in ASR are not distributed uniformly in the cross section of a member, but have lower concentrations at the peripheral parts of the member. This means that ASR does not occur over the entire cross section of a member, but only in an area at the center portion where concentrations of alkalis exceed certain limits (Fig. 6). This means, in effect, that excessive expansion due to ASR does not occur over the entire cross section of the member, but only in the area shown in Fig. 6. When expansion of concrete due to ASR occurs locally in the member cross section in this manner, a stress distribution such as shown in Fig. 7 occurs. That is, as ASR progresses, compressive stresses occur at the interior and tensile stresses occur sequentially at the peripheral portions, and when expansion at the interior reaches a certain extent, the concrete at the periphery reaches the limit of tensile strain, and cracking occurs. Such a limit of tensile strain is about 0.05 % in case of concrete of ordinary quality.

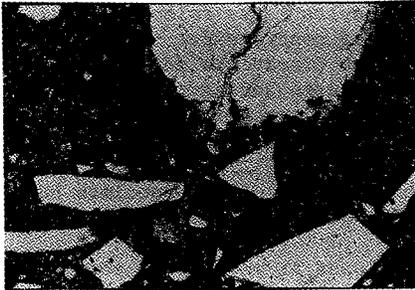
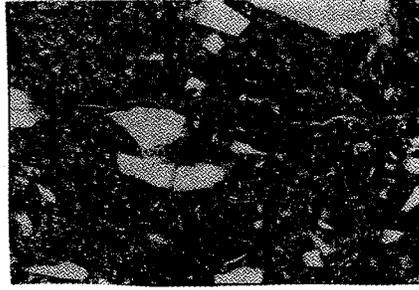
Fig.8 Microcracks in a section sampled from the central portion of a concrete cylinder, magnification $\times 200$

Fig. 8 is a micrograph of a specimen sampled from the central portion of a concrete cylinder in which chert was used as reactive aggregate, and shows an example of the numerous minute cracks formed at the interior of concrete. The cylinder had been stored for 6 months in an environment of 40°C and 100 % RH and expansion of approximately 0.3 % had occurred. As is clearly seen in this figure, cracks occurring at the interior have developed unrelated to the two phases of cement paste and aggregate particles. Such minute cracks are extremely scarce in specimens sampled from the peripheral portions of the cylinder. In this figure, one more thing that should be noted is where fine aggregate particles contact cement paste. The boundaries with the cement paste are indistinct with the appearance being that of particles dissolved in the cement paste portion. In effect, this part is where silica minerals comprising the particles are decomposed by ASR. Such parts exist in greater number the closer it is to the center with hardly any seen in the peripheral portions. Instead, there are wide cracks at the periphery extending towards the exterior as shown in Fig. 9, and most of these cracks are filled by gel which has become carbonated.

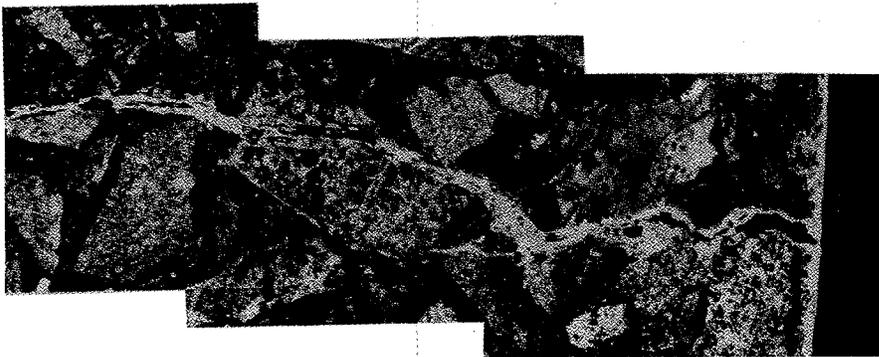
Fig.9 Macrocracks in a section sampled from the peripheral portion of a concrete cylinder, magnification $\times 40$

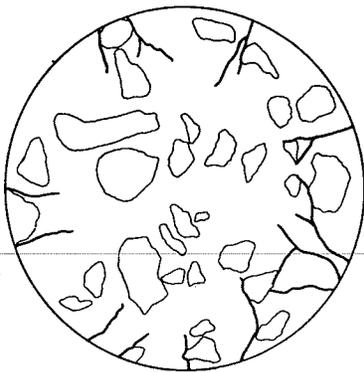
Fig.10 Macrocracks at the surface layer of a concrete cylinder
