## ASSESSMENT AND REPAIR OF DAMAGED CONCRETE STRUCTURE

Koichi Ono\*

\* Dept. of Civil Engineering, Konoike Construction Co., Ltd.  
Chuo-ku, Osaka 541, Japan

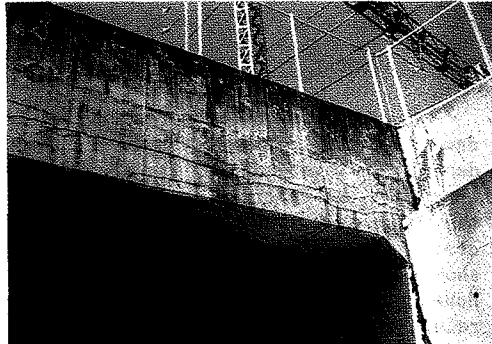
Figure 4 Cracking in a culvert box

top of a box culvert where horizontal cracks are developing. Figure 5 shows cracking in a retaining wall where horizontal cracks are dominant. Figure 6 is an example of deformed structures due to ASR. Figure 7 is an example of cracking in a building. Figure 8 shows cracking in a column of a tower where vertical cracks are dominant but map like cracks are also developing.

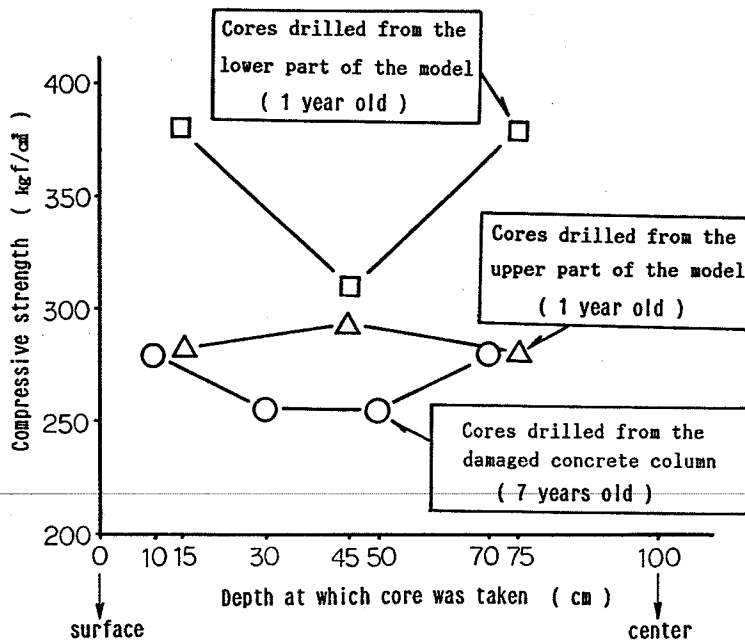
Figure 13 Reaction between compressive strength of concrete core and depth at which core was taken

Figure 13 shows the relation between the compressive strength of concrete core and the depth at which the core was taken. These cores were drilled from ASR damaged bridge column and the corresponding test model. The model was made of concrete with the same mix proportion, same reactive aggregate and same reinforcement as the actual column. The size of the model are also same as the column of which diameter is 2.0m and height is also 2.0m. The difference between the column and the model is the restraint at the top and the bottom of the column. The top of the model is free and the bottom is restrained only by the friction with the base concrete. The model was stored in the room of RH100% and 40°C. The age of the core from the actual column was 7 years when tested and that from the model was 1 year.

According to these results, the concrete strength near the surface of ASR damaged concrete structure is not always lower than that of the inside. The reason why the compressive strength of the upper part of the model is lower than that of the lower part would be due to poorer mix proportion and higher degree of the reaction.

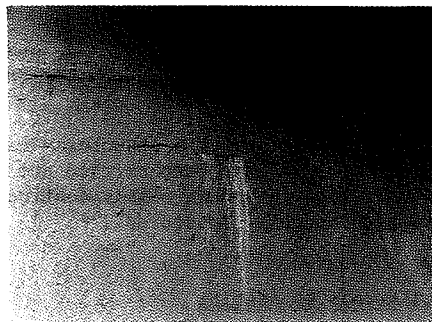
Figure 18 Column repaired by polybutadiene

The column repaired by polybutadiene cracked at 2 years after coating and gel was exuded (Figure 18).
