## ALKALI-SILICA REACTIONS BY OPAL PARTICLES IN JAPAN

Tatujiro Uno

Dept. of Industrial Raw Materials, Onoda Cement Co., Ltd.  
2nd. Tekko Bldg. 8F, No.8-2, 1 chome Marunouchi, Tokyo 100, Japan

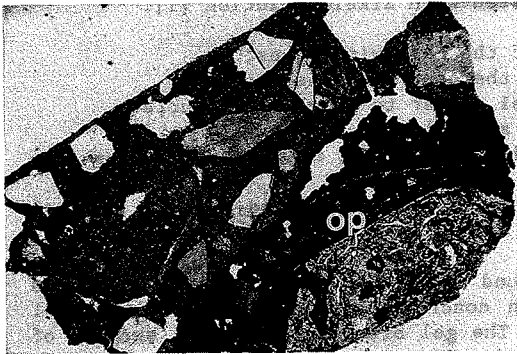
fig.3 Microscopic photograph of pop-out chip (vertical section). Op: an opalized fragment including plagioclase pseudomorph.

The photographs of a thin section on the perpendicular plane to the surface exhibited to have an opalized volcanic aggregate at its bottom. A plagioclase phenocryst became to be opalized and the pseudomorphic texture were preserved (fig.3, 4). Adding the texture, the aggregate included alunite  $[KAl_3(SO_4)_2(OH)_6]$  and sulfur which were characteristic of those hydrothermally opalized volcanic rocks.

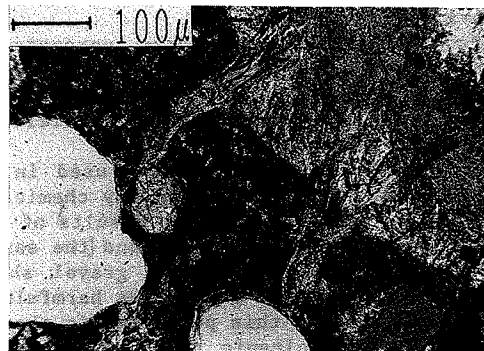
fig.7 The macro photograph of a cracked concrete block. Many globules of alkali silica gel were formed around an opal particle.

Op:opal particles, a:alkali silica gel,  
M;mortar part, B:air bubbles

On the petrographic observation of a destructed concrete the writer found that the AAR were originated from the particles of hydrothermally opalized volcanic rocks. The macrophotograph of fig.7 showed that a opal particle was surrounded with five alkali-silica gel globules on the cracked surface of concrete. Microscopically the opal particle changed to alkali-silica gel on its surface, and the gel flowed out towards the openings.
