ALKALI-AGGREGATE REACTION IN BEIJING AREA OF CHINA

Tang Mingshu, Han Sufen, Lu Yinong and Qian Chunxiang
Nanjing Institute of Chemical Technology,
Nanjing, Jiangsu, 210009, P.R. China.

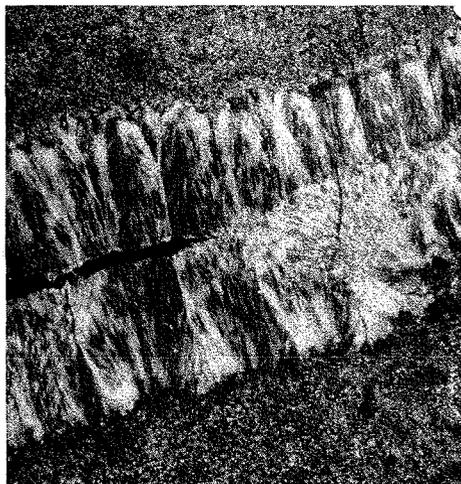
The majority of rocks, either pebble or crushed stone used in the Beijing Area is siliceous limestone and some amount of basalt, andesite etc. The siliceous deposits are of Cambrian and Ordovician periods. The dominant reactive mineral are classical chalcedony and micro- or crypto-crystalline quartz (Fig.1). From the view of texture, the crystalline quartz or chalcedony are dispersed in the matrix of calcite or dolomite, but there is also another texture displaying crystals of carbonate dispersed in a quartz

Fig. 1 A vein of chalcedony and micro- or cryptocrystalline quartz through silicate limestone

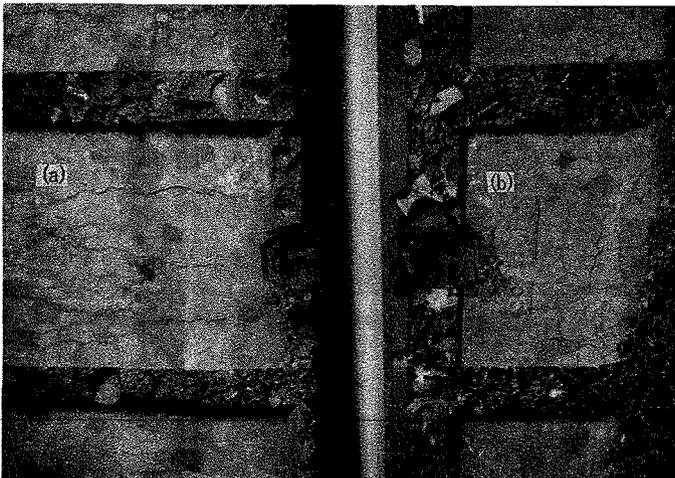
Fig. 2 shows the cracking of prestressed concrete railway ties which were produced by a precast concrete factory in Beijin in 1986 and installed in the railway station of Shanghai. It can be seen that obvious map cracks appeared on the end part of tie and cracks were aligned with the direction of major stress in the center part. The size

Fig. 2 Cracking of prestressed concrete railway tie (a) center, (b) end

of tie is $l \times b \times h = 2500 \times 450 \times 155 \text{mm}$ which was made of cement : sand : pebble : water = 1:1.249:2.772:0.298, the amount of portland cement, 470kg/m^3 ; alkali content of cement, 1.10% Na_2O equiv.; besides, 0.6% (by mass of cement) superplasticizer was added. The total amount of alkali in 1M^3 concrete reached about 5.23kg/m^3 . The pebble was taken from a quarry in a suburb of Beijing, which was confirmed to be high alkali reactivity. As described in above, the concrete mix was riched in cement, alkali and reactive component (in aggregate), and provided sufficient conditions to arouse deterioration of alkali-aggregate reaction to cause deterioration of the ties. The damaged concrete blocks were taken from the field. Crack in the blocks contained the white gel of alkali-silica which was clearly obviously visible to the naked eye. When above concrete blocks were cured in steam box at 40°C for a few months, the white gel dispersed on its whole surface. The reacted rim around the aggregate and alalki enriched on the reacted zone were confirmed.

At the beginning, the deterioration of tie was suspected to be caused by cycle of wetting and drying or freezing and thawing. Nevertheless, concrete cubes ($15 \times 15 \times 15 \text{cm}$) made from a similar concrete put in laboratory (20°C , high humidity) were also seriously deteriorated so that the reacted products were escaped and empty space was remained around the particles of aggregate (Fig.3, a). Thus it was impossible to suspect cycle of wetting and drying or freezing and thawing to be the reason causing damage. Similarly, the form of alkali-silica gel was confirmed by EDXA (Fig. 3, b). The expansion of concrete cube reached nearly 3.67% during about 8 years curing which was over 36 times the value of 0.1% limit ASTM C227. The concrete cube made in laboratory was damaged seriously and was sufficient evidence of damage caused by alkali-aggregate reaction.
