ALKALI-AGGREGATE REACTION IN NORTHERN FRANCE : A REVIEW

D. Prin and M. Brouxel
DÛNE Travaux Spéciaux, Centre d'Entreprise et d'Innovation, Campus Universitaire de la Doua,
BP 2132, 69603 Villeurbanne Cedex, France

A statistical survey was conducted on 140 bridges located in the northern part of France (Lille, Reims and Paris). This survey indicates that 5% of the studied bridges present important degradation signs likely related to AAR; 24% of the bridges show evident signs of AAR having caused up to now only minor damages; 57% of the bridges show little degradation signs; and 14% of the bridges show no degradations. This study enlighten the close relationship existing between the used aggregates (siliceous aggregates or metamorphic limestones aggregates containing pyrite) and the observed deteriorations. The chemical characteristics of the AAR gels are presented. The negative correlation existing between the concrete compressive strength and the gel alkali contents argue for a more expansive nature of the alkali enriched gels.

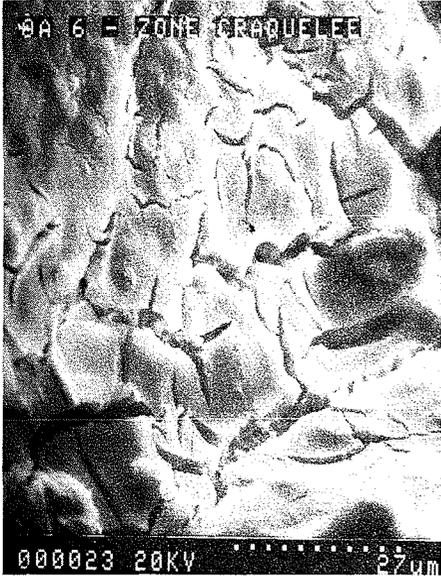
Figure 1 SEM micrograph of a massive AAR gel

AAR gel aspects. Most of the gel types described in the literature (e.g. (5)) were observed in these samples; the most common type being the massive gel (Fig. 1, 2 and 3). Lamellar and rosette-like gels are quite rare while the association with ettringite and/or thaumasite is common (Fig. 3 and 4; see also (3)).

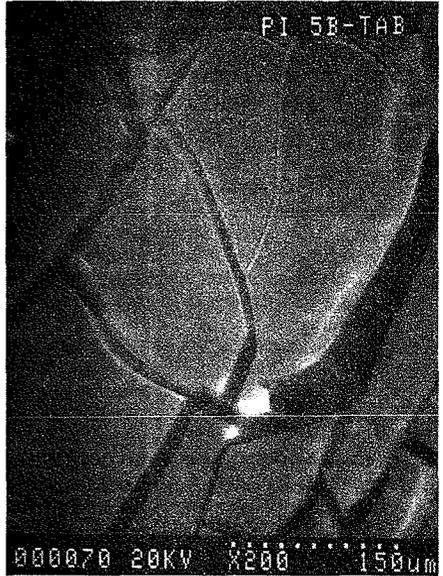
Figure 2 SEM micrograph of a massive AAR gel

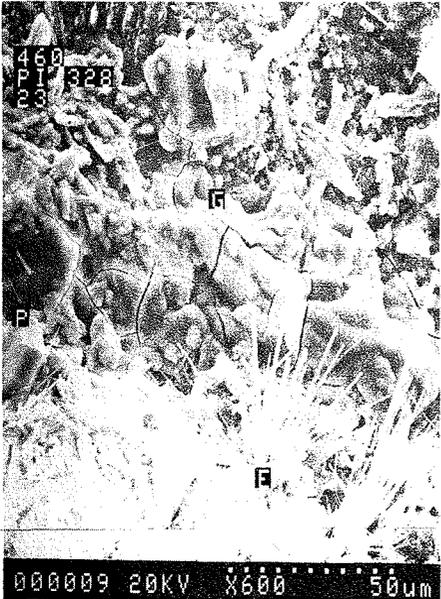
Figure 3 SEM micrograph of AAR gel associated with ettringite

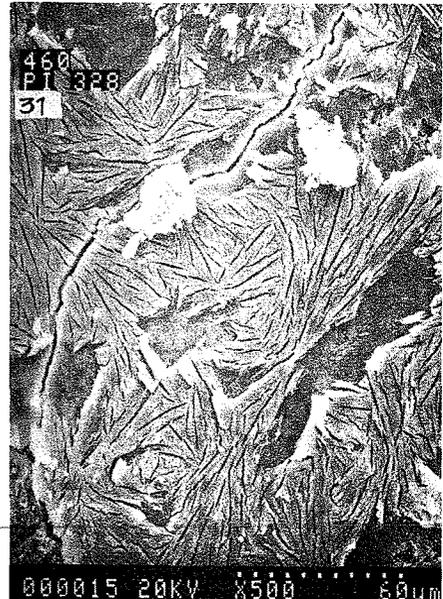
Figure 4 SEM micrograph of massive ettringite + thaumasite + calcite patch on a reactive aggregate

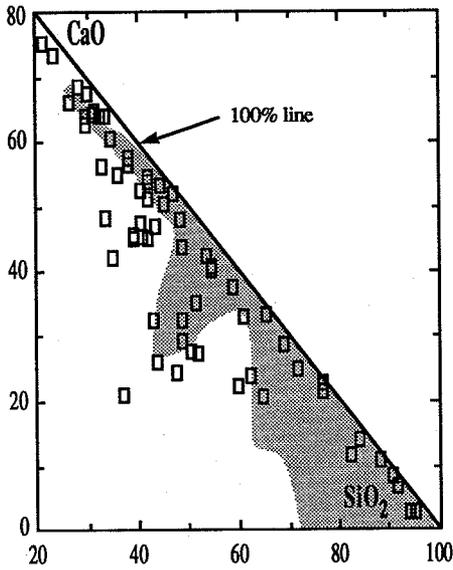
Figure 5 SiO₂ vs CaO graph of all AAR gels
The gray area represents the field of the literature data (see text for details and references).

We compared our EDAX results on the observed AAR gels with the data published in the literature since 1942 : 160 analyses of AAR gels were compiled from 20 papers (this list is of course not exhaustive and the data are available on request: (4), (8), (26), Stanton (29), McConnell et al. (30), Hester and Smith (31), Idorn (32), Buck and Mather (33), Arsberetning (34), Thaulow and Knudsen (35), Poole (36), Poole (37), French (38), Bérard and Lapierre (39), Buck and Mather (40), Cole et al (41), Bariono (42), Oberholster and Krüger (43), Bérubé and Fournier (44), Davies and Oberholster (45)). Only four elements (SiO_2 , Na_2O , K_2O and CaO) were taken into account and normalized to 100%. It can be seen in figure 5 and 6 that the distribution of the published points is clearly bimodal. Most gels present high SiO_2 contents ($\text{SiO}_2 > 70\%$) and a maximum alkali enrichment for SiO_2 contents ranging between 65 and 85 %. Some data show however an important alkali enrichment for SiO_2 contents ranging between 40 and 50 %. This second peak fits perfectly with the maximum obtained in this study. It should be pointed out that many published data come from gel analyzed in concrete enriched in alkalis or stored in alkali enriched water (17). Moreover, gel produced under natural environment conditions are shown to be richer in calcium than gels produced under accelerated conditions (4). These observations question the reliability of accelerated AAR.

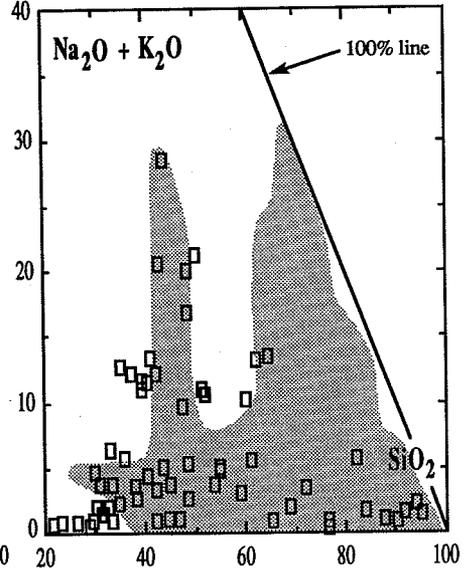
Figure 6 SiO₂ vs Na₂O + K₂O graph of all gels
(see text for details and references).

These variations may be explained by the amount of available alkalis and/or by differences in the kinetics of the reaction. When the kinetics of the reaction are normal, calcium, if present in quantities large enough, is able to reach the reaction sites : lime-alkali-silica gels are formed. When the reaction is accelerated, calcium, which has a higher hydraulic radius and therefore a lower diffusion rate, does not have time to reach the reaction sites, and alkali-silica gels instead of lime-alkali-silica gels are formed (Wang and Gillott (46)). These authors (46) stated that alkali-silica gel has a high affinity for water and will be able to sorb water and therefore show expansion. However, none of the studied gels can be considered as alkali-silica gels (the calcium content is always higher than the alkali content). It is possible nonetheless to suggest that the gels showing the highest alkali contents are the most able to produce expansion and consequently degradations (17). We have plotted the alkali contents of the AAR gel against the compressive strengths of the structural elements they belong to (Fig. 8). A rather well defined negative correlation was obtained. If we consider that the average standard concrete compressive strength is 35 MPa, it should be pointed out that three structures, affected by AAR, present higher compressive strength (45 to 50 MPa). They present gels with low alkali contents (less than 2 %). These gels are likely rather immature and present in small quantities filling all the voids and giving to the concrete a higher compressive strength. The concrete structures presenting the lowest compressive strengths (around 20 MPa) present on the contrary gels with high alkali contents ($\text{Na}_2\text{O} + \text{K}_2\text{O} = 6$ to 9 %). These observations agree with the hypothesis that gels with high alkali contents are the most able to produce expansion and therefore microstructural degradations.

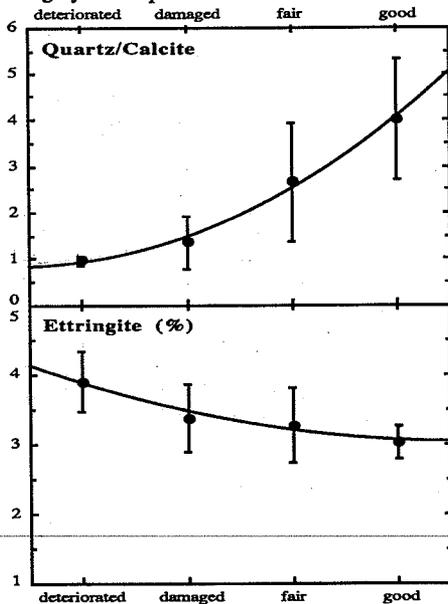
Figure 7 Quartz/Calcite ratio and ettringite % vs the deterioration conditions of the bridges

A close relationship between the quartz/calcite ratio and the degradations was observed. Indeed, on an average basis, the concretes presenting a quartz/calcite ratio close to 1 are much more often deteriorated than the concretes made mainly with quartz aggregates (Fig. 7). Two explanations can be given : first of all, the pessimum content of the reactive siliceous aggregates used in these concretes is obtained for a 50% content; second, the presence of metamorphic siliceous limestones containing pyrite grains is necessary for the reaction to develop. This second hypothesis seems more logical taking into account the fact that ettringite is commonly observed in the most deteriorated concrete structures (Fig. 7).

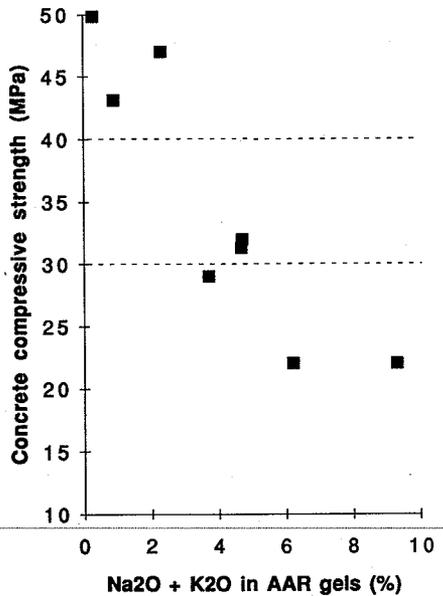
Figure 8 Variation of Na₂O+K₂O in the gels vs the concrete compressive strengths

The EDAX studies of the AAR gels confirm the important variation of their chemical composition. A negative correlation was defined between the alkali content of the gel and the concrete compressive strength: gel with low alkali contents (< 3%) were found in structures presenting high compressive strength (40 to 50 MPa) while gel with high alkali contents (> 6%) were found in structures presenting lower compressive strength (\approx 20 MPa). Immature AAR gels, characterized by low alkali contents, and filling all the existing voids improve the concrete compressive strength. On the contrary, well developed AAR gels, characterized by higher alkali contents, are most able to show expansion and therefore to produce degradations of the concrete diminishing its compressive strength.
