**DIAGNOSIS OF CONCRETE STRUCTURES AFFECTED
BY ALCALI AGGREGATE REACTION**

**Department of Materials, C.E.B.T.P. St Remy les Chevreuse
FRANCE**

Through the study of four pathological cases selected for their instructional value or for the particular way in which the disorders appeared, the different aspects of the diagnosis are explained : General method of diagnosis, typology of the disorders, quantification of microfissuration and gel morphology.

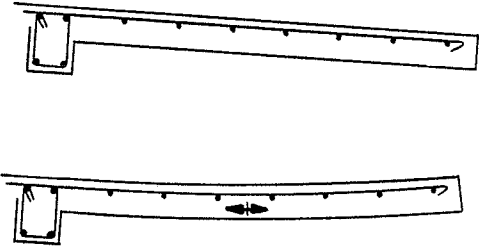
**FIGURE 1 -
EXPANSION ON THE UNDERSIDE CAUSING HOGGING TO THE BALCONIES**

This AAR phenomenon, affecting the pre-cast, unwaterproofed, balconies of this building in the Paris region is, in fact, causing hogging to the balconies which, at present, are all countersloping.

This is explained by the fact that expansion of the concrete takes place more freely on the underside of the balcony slab (unreinforced part), causing hogging to the balconies. See figure n° 1.

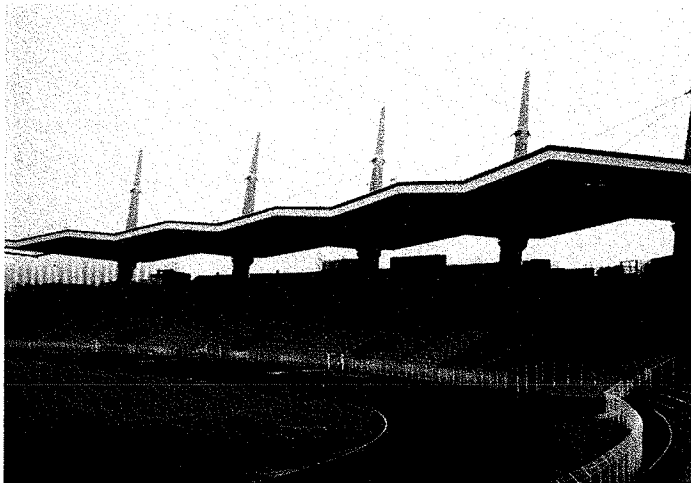
N° 1 - CASE N° 1
Stadium general view

The case studied here after is an athletism stradium qbuilt in 1975.

The disorders manifest themselves by generalised macro cracking (balustrades, terraces, pylon foundations, corbels, mast roofing supports). Oriented cracking of the masts which consist of pre-cast, pre-stressed voussoirs, has also been observed and its relationship with AAR is currently being investigated.

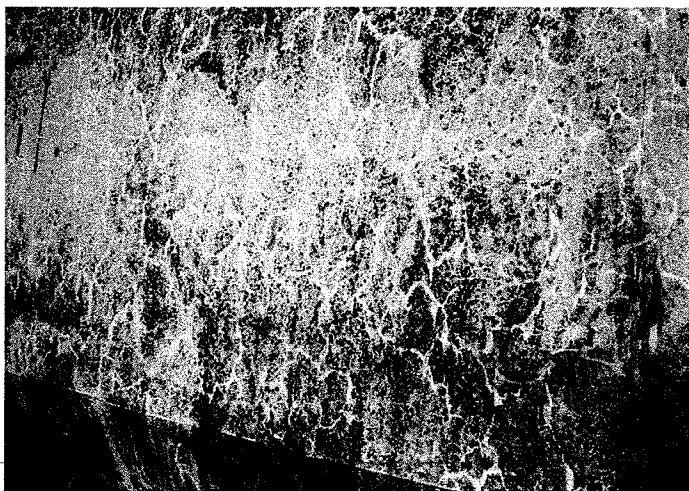
N° 2 - Macrocracking on Breast wall

The more exposed parts are the most severely affected by AAR.

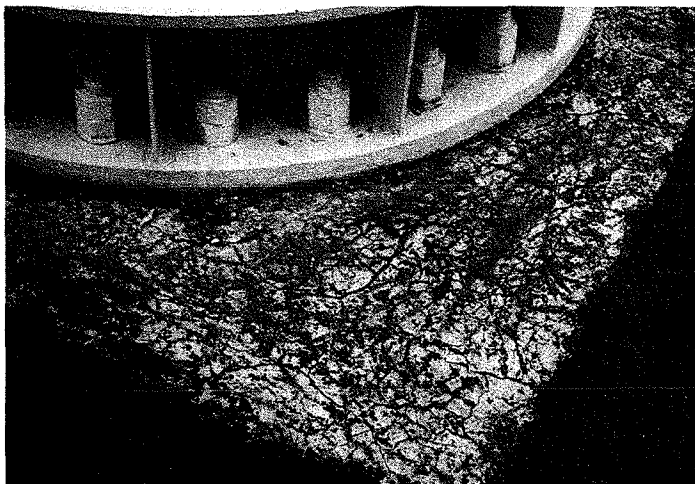
N° 3 - Pylone black foundation

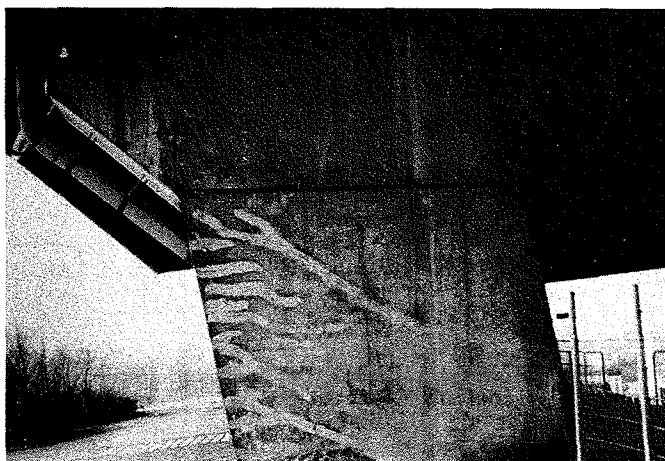
N° 4 - Prestressed columns bases
- Directionnall cracking

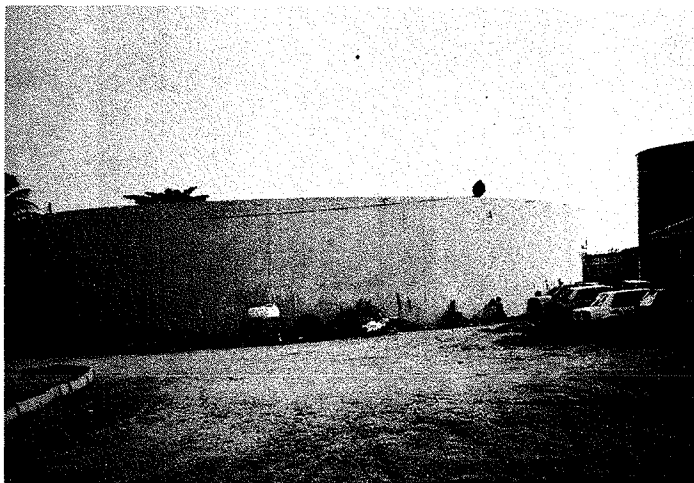
N° 5 - CASE N° 2
Tank General view

This water reservoir was built in 1986. In 1987, initial manifestations of disorder were observed in the form of spalling cone "pop-outs".

At present, the reservoir is riddled with pop-outs, and generalised macro cracking has developed. In addition, plane delamination cracking has been observed. The structure's safety no longer being assured, rebuilding is now in process some six years after construction.

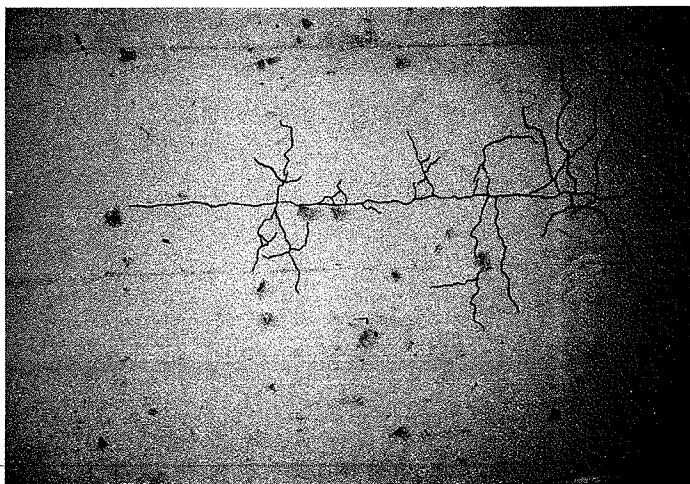
N° 6 - Water tank
- Microcracking and pop out

It should be noted, in this instance, that AAR and corrosion of the reinforcements have acted as synergic pathogenic phenomena. In fact, the concrete contains a very large proportion of chlorides (up to 1% of the weight of the cement) and corrosion to the reinforcements is currently becoming generalised. The cracks resulting from AAR form easy access routes for the water and oxygen needed for the corrosion phenomenon to develop, and vice versa.

The disorders are generalised, with greater intensity in areas where the waterproofing is breached.

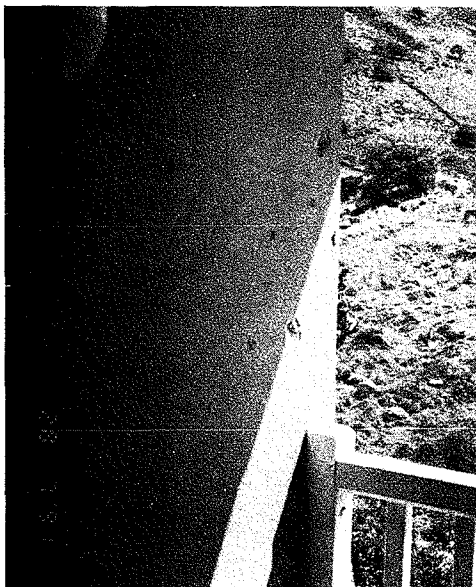
N° 7 - CASE N° 3
- Pop out on loggia walls

A further example of rapid reactivity without any synergetic effect due to chlorides is provided by a residential hotel completed in December 1988. In July 1989, a large number of pop-outs were observed, and the frequency with which they appeared was later amplified when macro cross-cracking and major structural disorders also appeared.

At the present time, approximately 70% of the rooms are affected by the phenomenon of more or less intense pop-out formation, appearing mostly in areas particularly exposed to humidity.

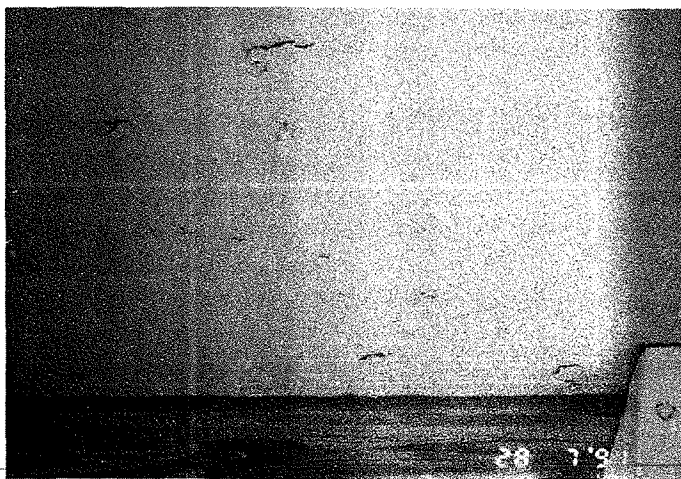
N° 8 - Pop out under concrete landing of stairs

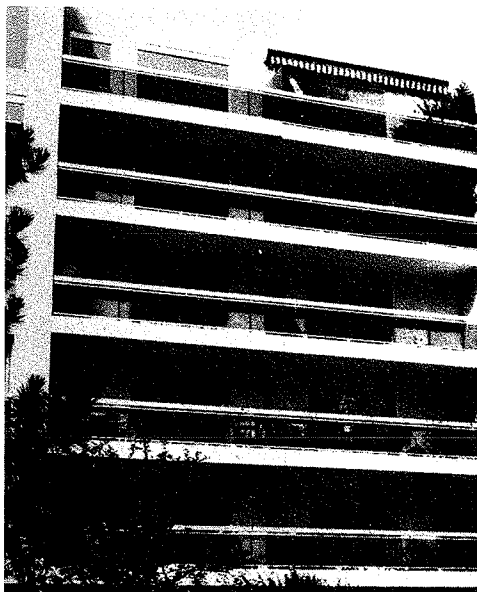
N° 9 - CASE N° 4 - Building general view with visible balcony movement at 3th level

The balconies on the higher floors, which are the most exposed, exhibit the greatest counterslope.

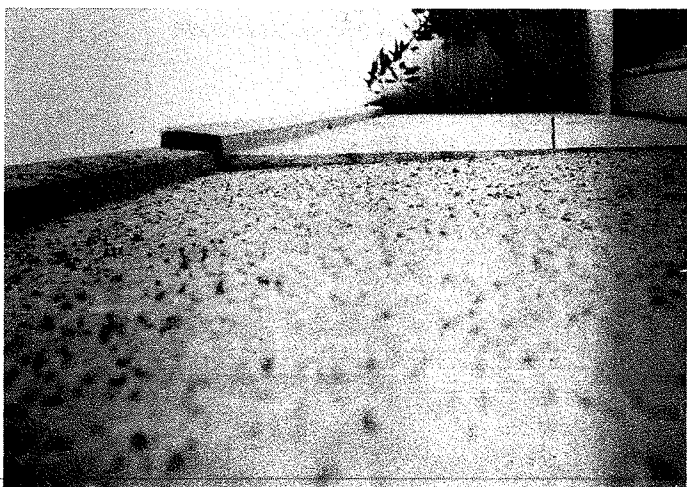
N° 10 - View from 4th level

On the fifth floor, the balcony located to the right of a gable wall which protects it from direct rainfall exhibits less hogging than its more exposed neighbour.

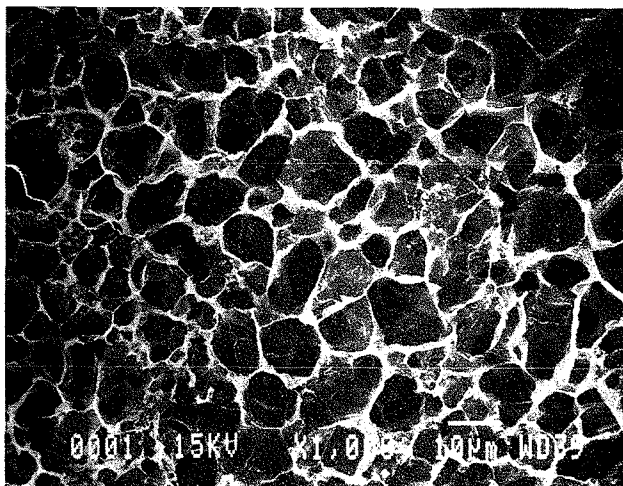
FIG N° 1 : mag. x 1000
Alveolar silica matrix detection after carbonate dissolution

This silica was revealed by a superficial acid attack (HCl 0.3 N for 1 minute) on polished sections of different samples.

Examination of these sections by scanning electron microscope revealed the extent of these lattices of silica. They consist of interconnected grids of fibrous or cryptocrystalline silica with a lot of partly disintegrated bipyramid quartzes, a lot of framboidal pyrites, pockets of clay, and metallic oxides, in the grid.

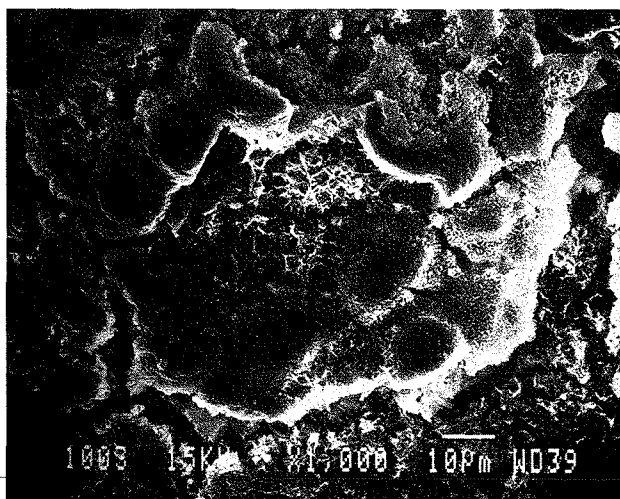
FIG N° 2 : mag. x 1000
Products of the A.S.R. after reactivity CEBTP test

A reactivity test on pre-polished aggregates, immersing them for three days in a lime-saturated alkaline solution heated to 80 degrees C, was also carried out.

The samples examined by scanning electron microscope all exhibit areas of attack, with development of reaction products.

The reactions on the limestones are more vigorous and more widespread, and are a function of the extent of the siliceous lattice. The gel facies are also very varied.

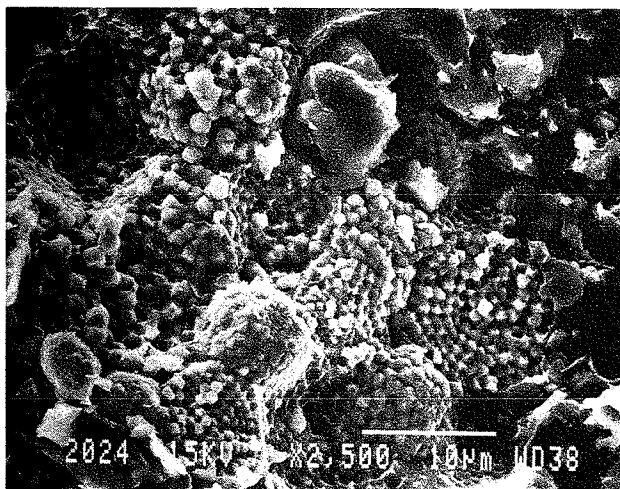
FIG N° 3 : mag. x 2500
Raspberry pyrites between microsparite crystals

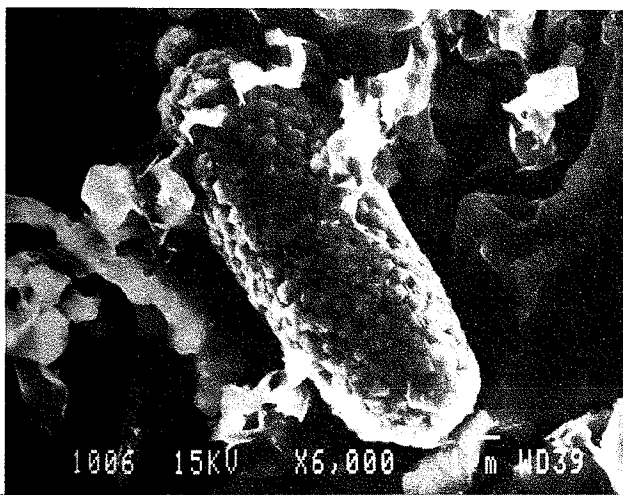
FIG N° 4 : mag. x 6000
"Ear corn" aspect of pyrite

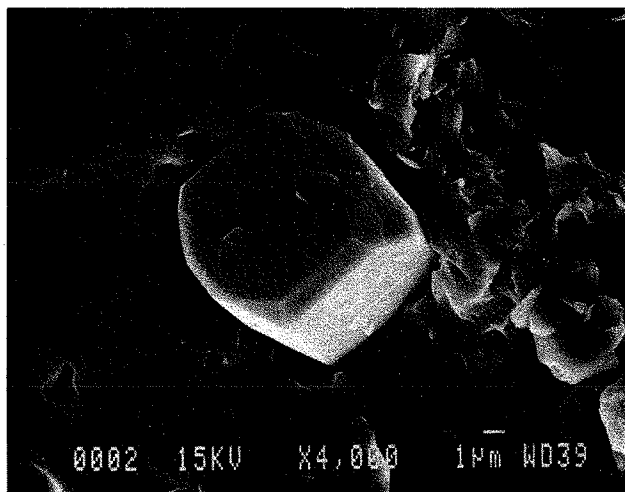
FIG. N° 5 - mag. x 4000
Automorphic crystal of pyrite

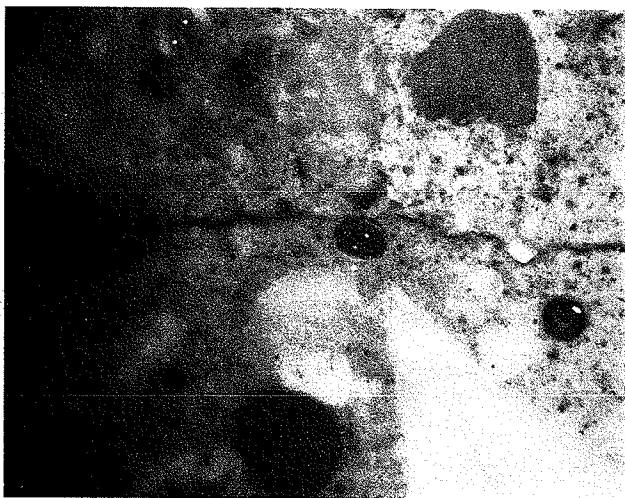
FIG N° 6 : mag. x 16
Microcrack and associated aggregate

- a direct reactive aggregate/microfissuration relationship, generally revealed by the presence of radial microfissures emanating from the reactive site.

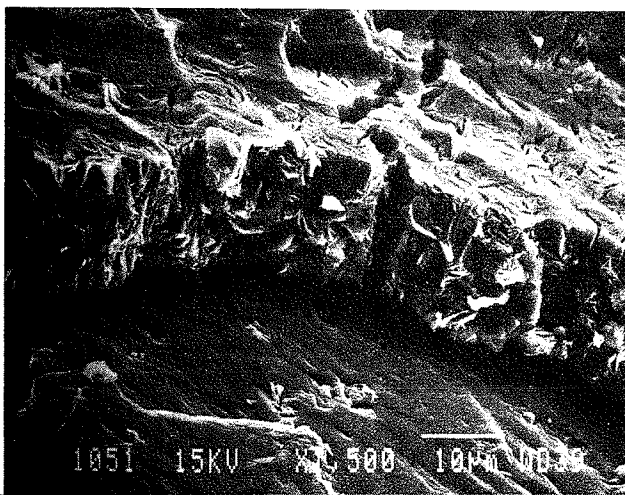
FIG N° 7 : Mag. x 1500
Massive rosette like appearance of A.S.R. product

- characteristic facies of crystallised products, agglomerated due to the initially very limited space for their expansion. These facies reveal the expansive nature of the products, resulting inevitably in microfissuration emanating from the reaction site.

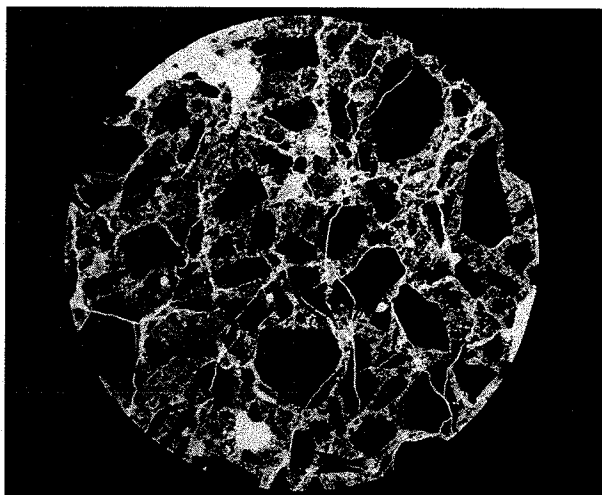
FIG N° 8 : mag. x 1
Microcracks view at the surface layer of a concrete cylinder

This method consists of revealing, on polished sections, areas of discontinuity such as cracks and cement paste/aggregate interfaces. These phenomena are revealed after impregnation with a resin loaded with an ultra-violet radiation fluorescent marker. The appraisal itself is carried out by counting under a binocular microscope using a random series method.

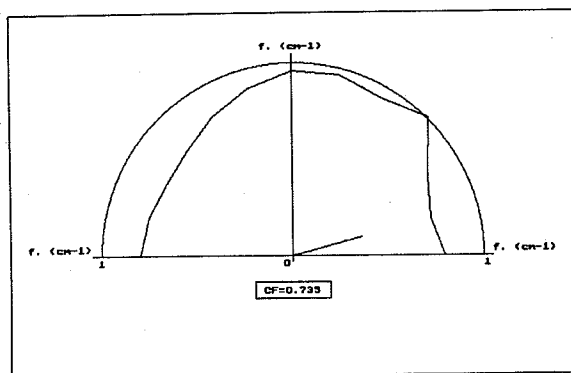
FIG N° 9
Microcracks polar curve of fig. n° 8

Each analysis is carried out in equidistant lines, successively implanted on a set of equiangular directions. The parameters obtained by the method are:

- a coefficient of cracking related to the frequency of the phenomena encountered,
 - spacial distribution allowing detection of any anisotropies in direct relation with the geometry of the structure.
- Photographs 10-11-12 - annex 2.

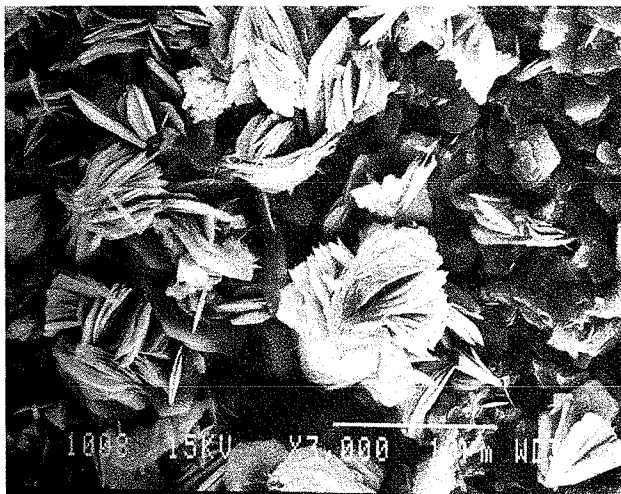
FIG N° 10 : mag. x 3000
Primary rosette - like crystals into aggregate microcrack

In the examples of structures affected by the alkali/aggregate reactions which we are describing, a remarkable diversity of observed reaction products will be noted: diversity in terms of extent, location, composition, and, above all, the micro-facies of the products. This point is a good indication of the extent of the research required for greater comprehension of these phenomena.

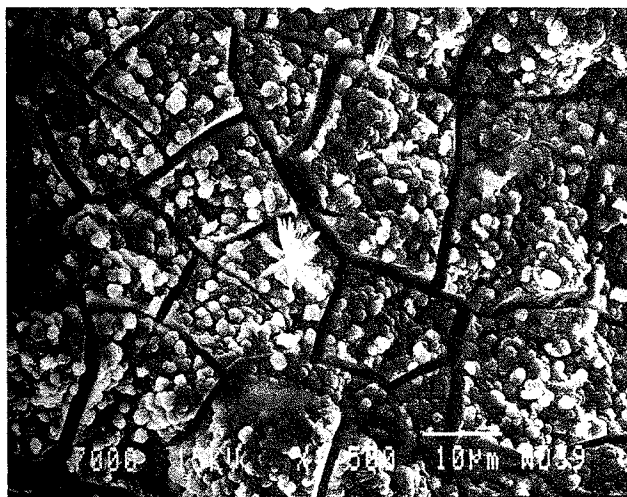
FIG N° 11 : mag. x 1500
Secondary lamellar - like crystals onto botryoidal gel

The reactive forms of fibrous and amorphous cryptocrystalline silica which these contain reacted firmly with the alkalis in the cement. Uncrystallised gels are observed on the botryoidal surface, but they are surmounted by crystallised lamellar potassic products formed during a later stage of the reactions.

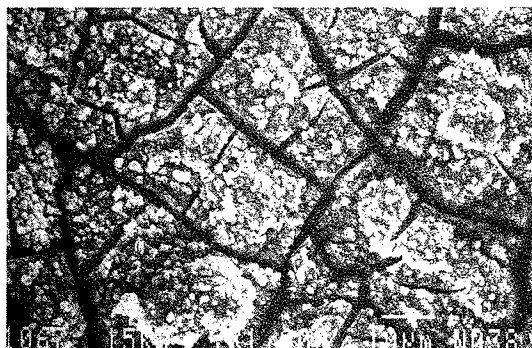
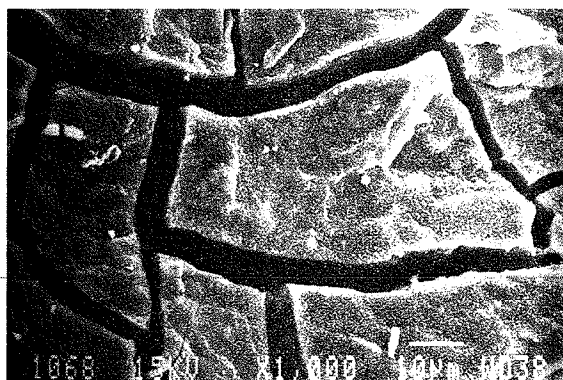
THE 9TH INTERNATIONAL CONFERENCE ON ALKALI - AGGREGATE REACTION IN CONCRETE 1992
 MICROSTRUCTURES OF A.S.R. PRODUCTS AND SEMI-QUANTITATIVE EDS ANALYSIS (Fig. n° 12)

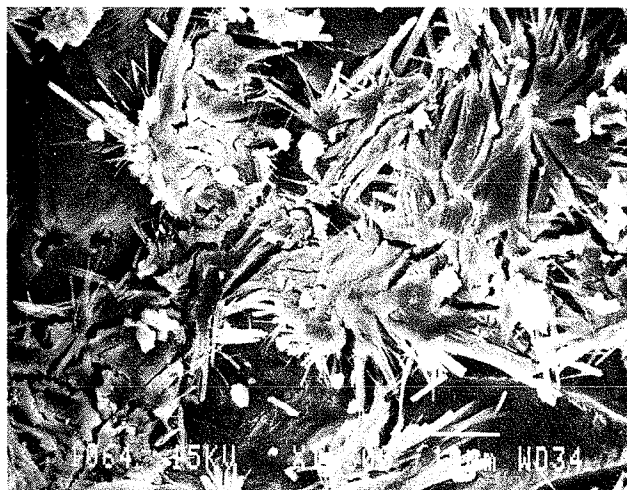
FIG N° 13 : mag. x 1300
Massive ettringite in the paste aggregate interface

A large number of structures affected by very advanced AAR have exhibited the simultaneous presence of as yet unexplained expansive secondary ettringite.

- dense superficial deposits at the hydrated cement paste/aggregate interface,
- more localised formations on the actual surface of uncrystallised gels, without any apparent microstructural discontinuity between the gel and the neoformed ettringite,
- fine needles entangled with facies of primary ettringite on gels, occasionally on the micro-crystallised surface, frequently associated with calcic pockets.

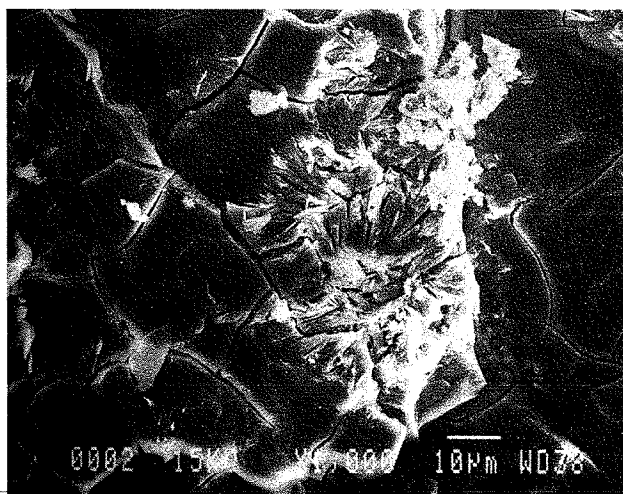
FIG N° 14 : mag. x 1000 - Continuous micro-structure between
A.S.R. products and secondary ettringite

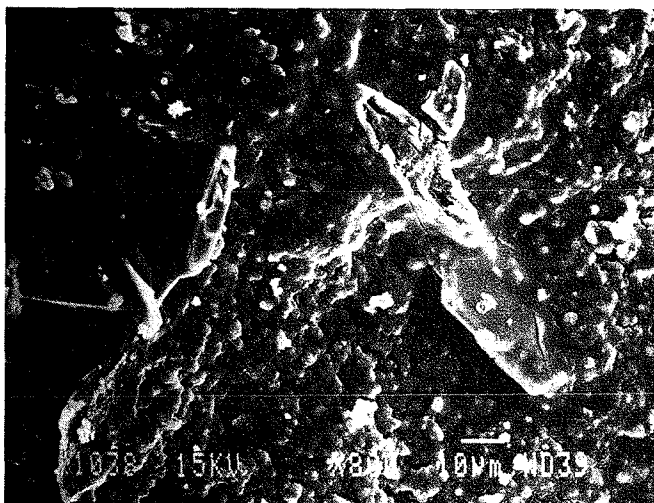
FIG N° 15 : mag. x 800 Dissolution of automorphic lime crystals and associated calcic effusions

- the characteristic facies of disintegration of the lime present in the automorphous crystals at the interface between the cement paste and the reactive aggregate,
- the thin calcic effusions emanating from these crystals in the course of disintegration. Such effusions are only slightly crackled and fill the micropores of the site, aggregate and paste.
- in certain cases, pockets of calcic formations have re-formed on the actual site of disintegration, indicating some modification of the physico-chemical attack conditions. Photographs n° 15 - 16 - annex 2.

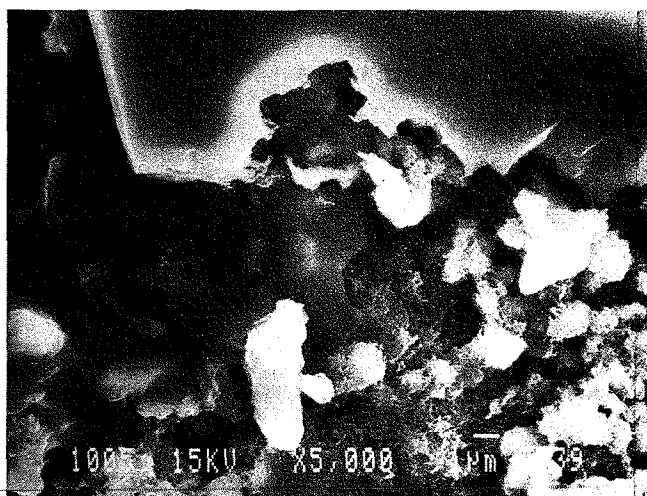
FIG N° 16 : mag. x 5000 - Characteristic lime dissolution figure
