**AN ASSESSMENT OF THE EFFECTIVENESS OF BLAST-FURNACE SLAG
IN COUNTERACTING THE EFFECTS OF ALKALI-SILICA REACTION**

This paper outlines the studies conducted and the performance of 50% slag replacement of cement at the Magpie River project in comparison to the performance of a bridge constructed at the same time, but using a conventional Portland cement mix design.

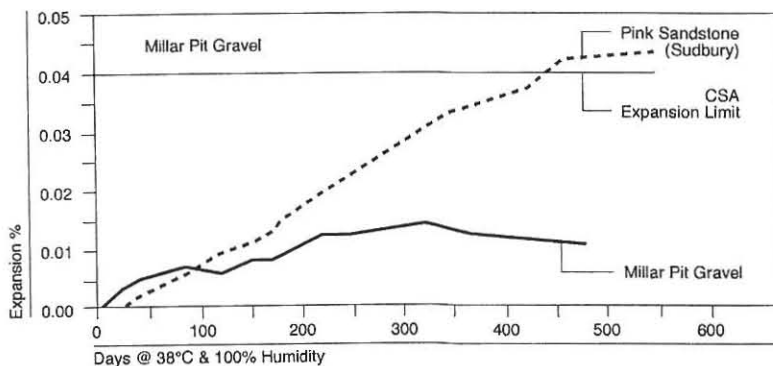
Fig. 1: Results of concrete prism testing on Millar's Pit aggregates

As shown in Fig. 1, the results of concrete prism expansion tests (CSA A23.2-14A-M77) indicated that the total expansion fell within the CSA limits. However, at the time of tender, the concrete prism testing had only been performed for a limited period (200 days). Therefore, additional testing was considered necessary to evaluate the potential for a slow, late-expanding alkali-silica form of reaction which had been known to affect numerous structures in Northern Ontario (Dolar-Mantuani 1969). It is noted that higher expansions would have been obtained with the current version of the concrete prism test that uses 420-kg/m^3 cement with the alkali loading raised to 5.25 kg/m^3 (CSA A23.2-14A-94). For example, with the current test, the Sudbury aggregate would give 0.185% to 0.201% expansion at 2 years (Thomas and Innis 1999).

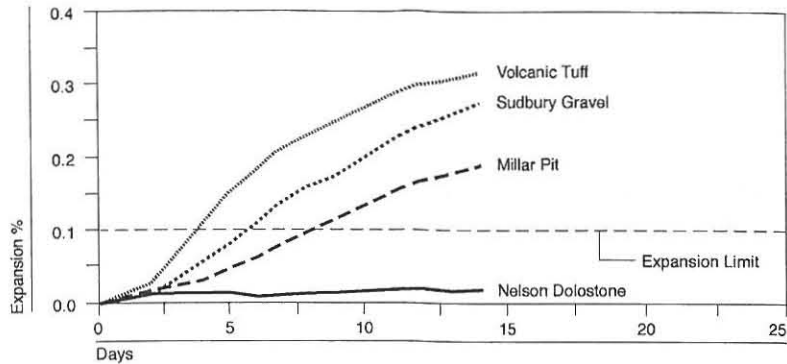
Fig. 2: Results of accelerated mortar bar testing performed on Millar's Pit Aggregates

As there was insufficient time to permit standard CSA testing to be performed prior to the award of contract, a (what was at that time) experimental accelerated mortar bar test was used to provide a rapid indication of whether or not there may be an AAR problem associated with the Millar's Pit aggregates. As shown in Fig. 2, the results of accelerated mortar bar tests (ASTM C1260) indicated that the aggregates might be at least marginally reactive (14-day expansion approximately 0.18%).

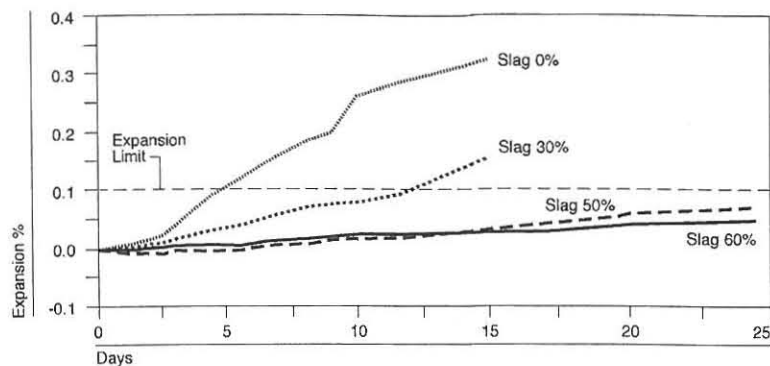
Fig. 3: Results of accelerated mortar bar tests performed on samples prepared with various slag replacement levels

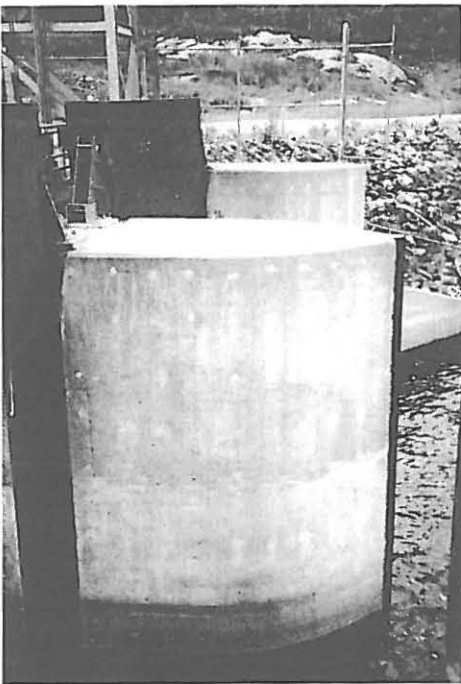
Fig. 4: Steephill Falls spillway (condition of spillway upstream pier, 10 years after construction)

Ten years after construction, all of the concrete at the Magpie River Development remains in excellent condition. Despite severe winter conditions, with temperatures often falling below -40°C , there has been no significant evidence of freeze-thaw deterioration and no evidence of AAR (Fig. 4) in any of the concrete structures.

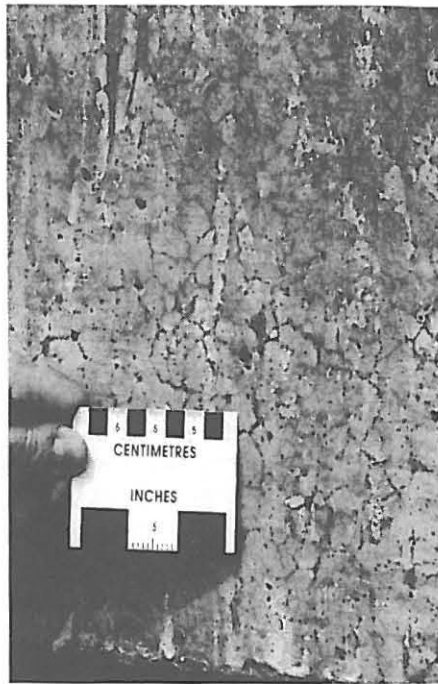
Fig. 5: Map cracking on Magpie River bridge

Although 10 years is insufficient to positively judge AAR performance, in 1998 it was observed that a bridge constructed by the MTO in the Wawa area in 1988 has cracked extensively and exhibited signs of AAR (Fig. 5). This structure was built using the same aggregates and cement as was used for the Magpie River project. In addition, as summarized in Table 3, the mix design was very similar to the Magpie River rich mix (#16 in Table 2), with the exception that no slag was used. For this reason, a program of sampling and testing of the Magpie River structures and the Wawa bridge was initiated.
