**DIAGNOSIS OF AAR IN CANNING DAM, CHARACTERISATION OF THE
AFFECTED CONCRETE AND REHABILITATION OF THE STRUCTURE**

ABSTRACT

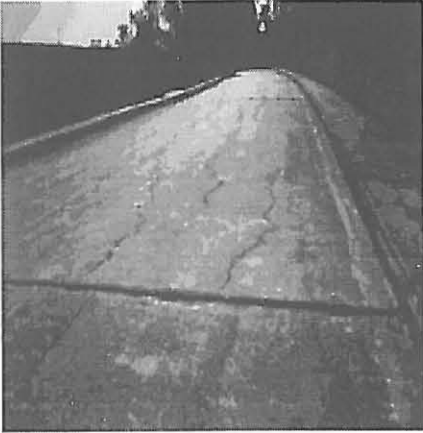
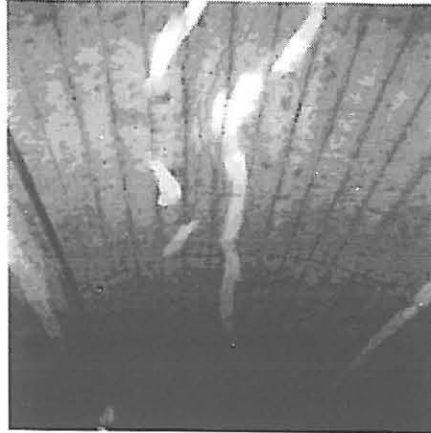
Fig. 1: Sub-parallel cracking and random cracking between the longitudinal cracks in the crest of the dam wall.

Canning Dam, constructed between 1933 to 1940, is a 66 m high concrete gravity dam with a curved crest. A 250 mm thick concrete layer placed on top of the crest forms the wearing course, which is continuous with the mass concrete. Monitoring over the past 15 years has shown that the dam wall has had an upward movement of 18.3 mm and a lateral upstream movement of 14.2 mm in this period. The movement has been associated with cracking in various parts of the dam. The top surface of the dam wall (i.e. the concrete road surface) shows extensive sub-parallel cracking with random cracking between them (Figure 1).

In view of the results obtained in these studies and severe vertical and horizontal cracking in the top section of the dam wall, above the floor of the upper gallery, the repair option chosen by the Water Corporation and the consulting engineers has been to remove the badly cracked concrete of the crest (about 4 m), and to replace it with new reinforced concrete designed to be free of AAR and other durability problems. The design involves post-tensioning of the rest of the dam wall such that the new concrete acts as the head beam for the post-tensioning anchors. This paper summarises the results from the study of the cores and those obtained on the performance of the new concrete proposed for the rehabilitation of the dam wall.

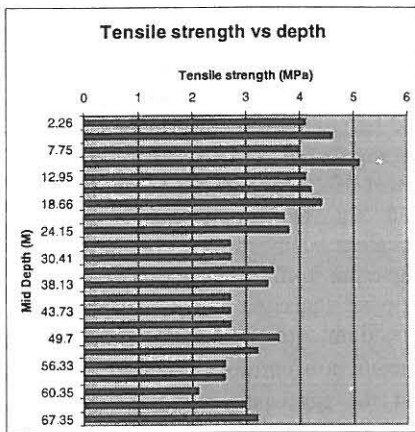
Fig. 3: Variation of splitting tensile strength of concrete with depth.

Sixty-eight core segments of 100 mm length and 100 mm diameter were tested for splitting tensile strength. Each result shown in Figure 3 is the average of 3 values for the segments from the relevant mid depth. Clayton (1989) stated that this test does not reflect the true tensile strength of the concrete, but indicates the effects of AAR on the compressive strength of the AAR-affected concrete. However, Bremner, et al. (1995) recommended the indirect tensile test (gas pressure method) for the evaluation of AAR damage to concrete. Although not exactly the same concrete segments were tested the compressive and tensile strength show similar trends. Similar comments made for compressive strength also apply to the tensile strength values. The higher strength of segments from the top of the dam wall reflects the higher quality of the original concrete rather than the effect of AAR

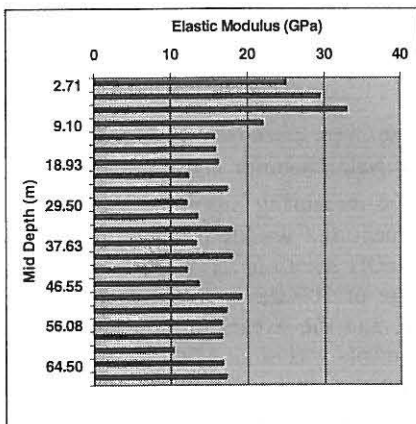
Fig. 4: Variation of Elastic modulus of concrete with depth.

Figure 4 shows the values of elastic modulus determined on 23 locations. The values of elastic modulus in a few locations in the upper part of the dam are in the range of 25-33 GPa or crack-free

portions of the core, which is the normal range for undeteriorated concrete of this type. However, in many locations, the modulus has dropped to values as low as 10, 12, 13, 15 and 16. AAR-affected concretes are sensitive to elastic modulus and can suffer losses of modulus as large as 80% (Swamy 1995). The average value of elastic modulus over the whole wall is about 17.5 GPa, although if the three values for the upper parts (depth of 7.6 m) are excluded, the average drops to 15.7 GPa. These values could be used in combination with the measured expansion strains to determine the required post-tensioning stress.

Assuming that the residual expansion potential of 0.017% (i.e. a strain of 0.00017 m/m) will be realised, and taking the average modulus of elasticity of about 16 GPa, a stress of 2.7 MPa is calculated to be needed to confine the residual expansion. However, because the rate and magnitude of expansion in the field is usually much less (around 50%) than the expansion of drilled cores kept at 100% RH 40°C, (Tomita et al. 1989) a confining stress of around 1.3 MPa is considered to be adequate for suppressing the residual expansion. However, in practice a post-tensioning stress of less than 1 MPa has been designed, which together with the structural confinement is expected to significantly reduce the cracking of the concrete.

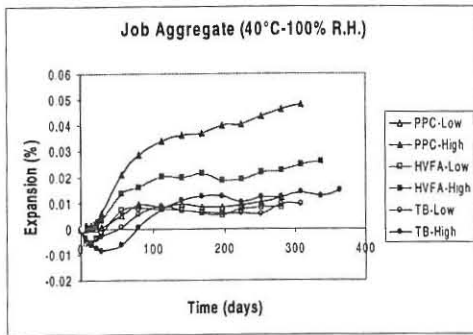
Fig. 6: Expansion curves for the various concrete mixes at low and high alkali contents

Figure 6 shows expansion curves for the concrete prisms made with the three concrete types. "Low" and "High" on Figure 6 refer to the level of alkali (Table 6). Figure 6 shows that the aggregate is potentially reactive in the presence of plain Portland cement alone, and that blended cements, particularly (TB), have successfully suppressed the AAR expansion. On this basis, the TB concrete mixture is recommended to minimise the risk of AAR in the new concrete.

A triple blend reinforced concrete (50 MPa) containing 40% fly ash and 5% silica fume has been recommended to replace the damaged parts of the dam wall, and to act as head beam for the post-tensioning anchorage zones.
