A NEW TEST TO ASSESS THE CONCRETE SUSCEPTIBILITY TO "THE DECAY" OF THE BRIDGE DECK SLABS

Keywords: concrete deck slab decay, complex pathology, alkali-silica reaction, ageing test, GCG-DUG test

Abstract

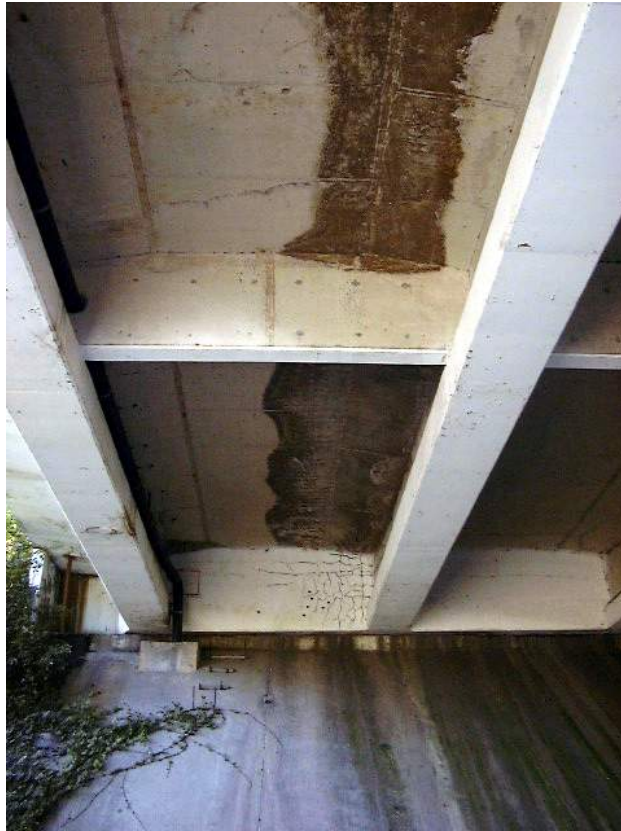
Figure 1: Dark patches on the lower deck surface.

These alterations are also underlined by the presence of typically darker patches on the lower deck surface (Figure 1) which remain visible regardless of external weather conditions, meaning that these latter are not simple humidity patches.

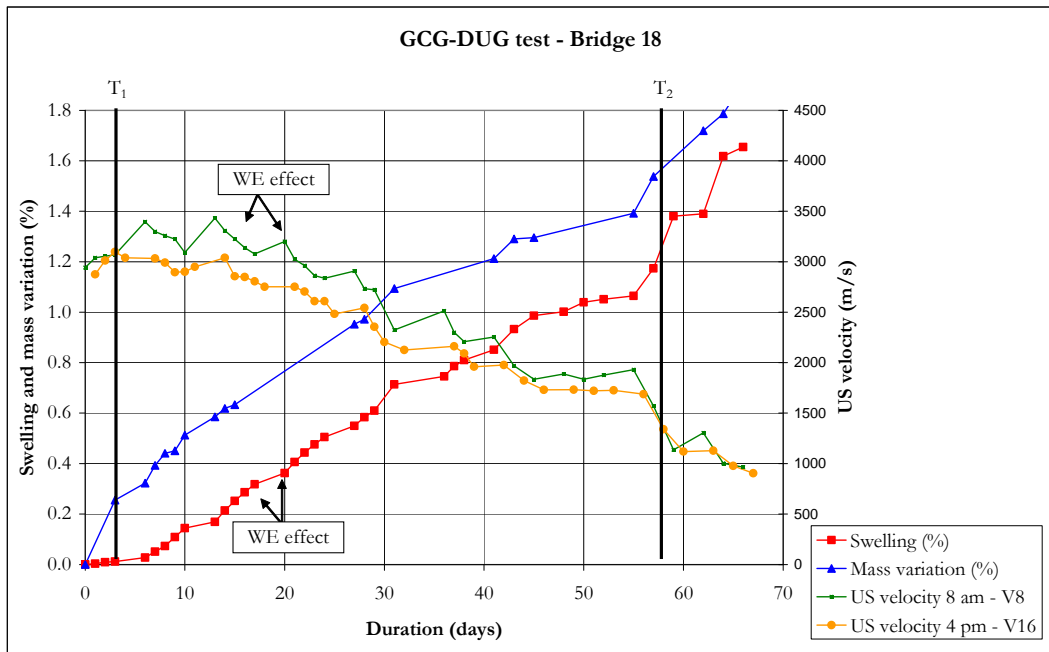
Figure 2: GCG-DUG test results – case of Bridge 18.

The analysis of all curves show three phases during the “GCG-DUG” test (Figures 2 and 3):

- phase 1 = initial phase (from 0 to T_1), without variation of sample length. V_8 is very close to V_{16} and both are growing up to the V_{16} maximum value.
- phase 2 = reaction phase (from T_1 to T_2) with uniform expansion. V_{16} decreases. V_8 increases a little bit up to a maximum and then decreases. V_8 is always higher than V_{16} .
- phase 3 = degradation phase (after T_2). Expansion and ultrasonic velocity variation increase highly. Depending on the concrete sensitivity to decay, phases 2 and/or 3 may not be observed during the test.

During the second phase (reaction development), a “week-end effect” is often observed (Figure 2). After a week-end period with only chloride and swelling exposures, the core expansion increases highly, it then decreases during the following week, when freeze-thaw exposure occurs. Moreover, V_{16} , measured after the freeze-thaw cycle, is always lower than V_8 , measured after chloride and swelling exposures. It seems, therefore, that low temperature alters ASR gel and results in a decrease of swelling. If the ASR gel, which fills in the cement past voids, is less compact due to the freezing of the water ultrasound propagation through the sample will be less easy and the velocity will decrease. This “week-end effect” is a proof of the interaction between swelling and freeze-thaw mechanisms.

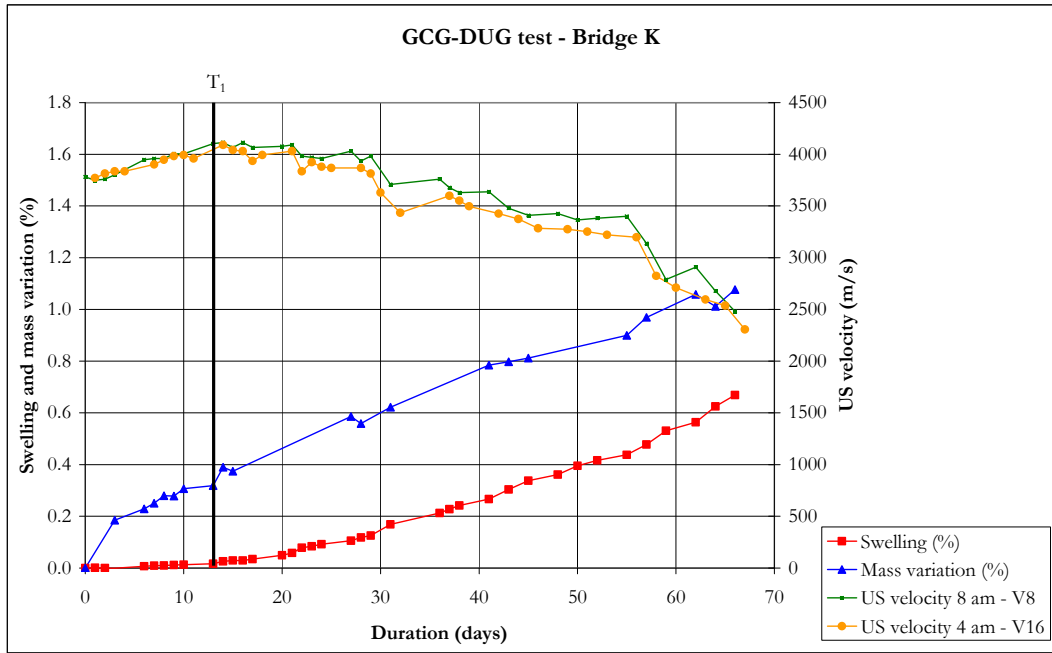
Figure 3: GCG-DUG test results – case of Bridge K.

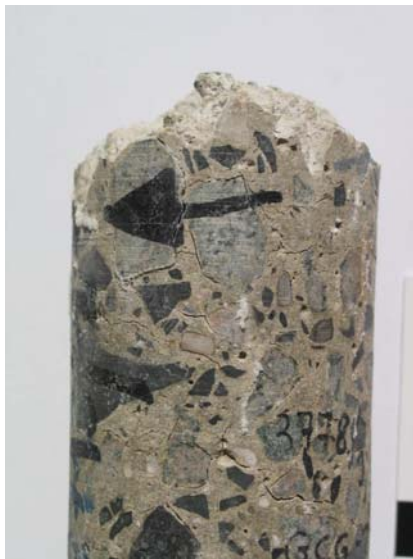
Figure 4: Bridge FH after the “GCG-DUG” test. Concrete is completely cracked (ø 50 mm).

At the end of the test, some samples are totally destroyed; the Bridge 10 sample was even destroyed after 5 days (Figure 4), while others are still in good condition (Figure 5).

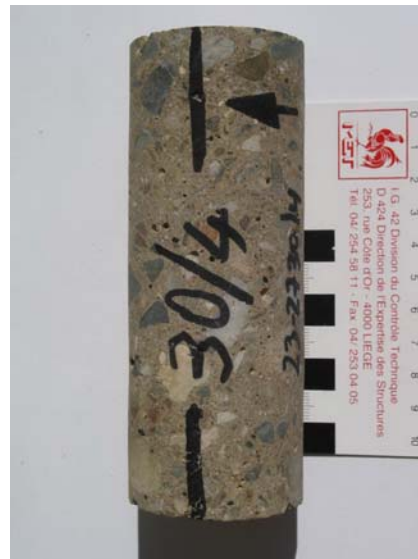
Figure 5: Bridge H after the “GCG-DUG” test. Concrete is still in good condition (ø 50 mm).
