CONDITION ASSESSMENT OF SHOTCRETE IN 10 YEAR OLD SHOTCRETE IN HVALFJORDUR TUNNEL IN WESTERN ICELAND

Gisli Gudmundsson*

Mannvit Engineering, Grensasvegur 1
IS-108, REYKJAVIK, Iceland

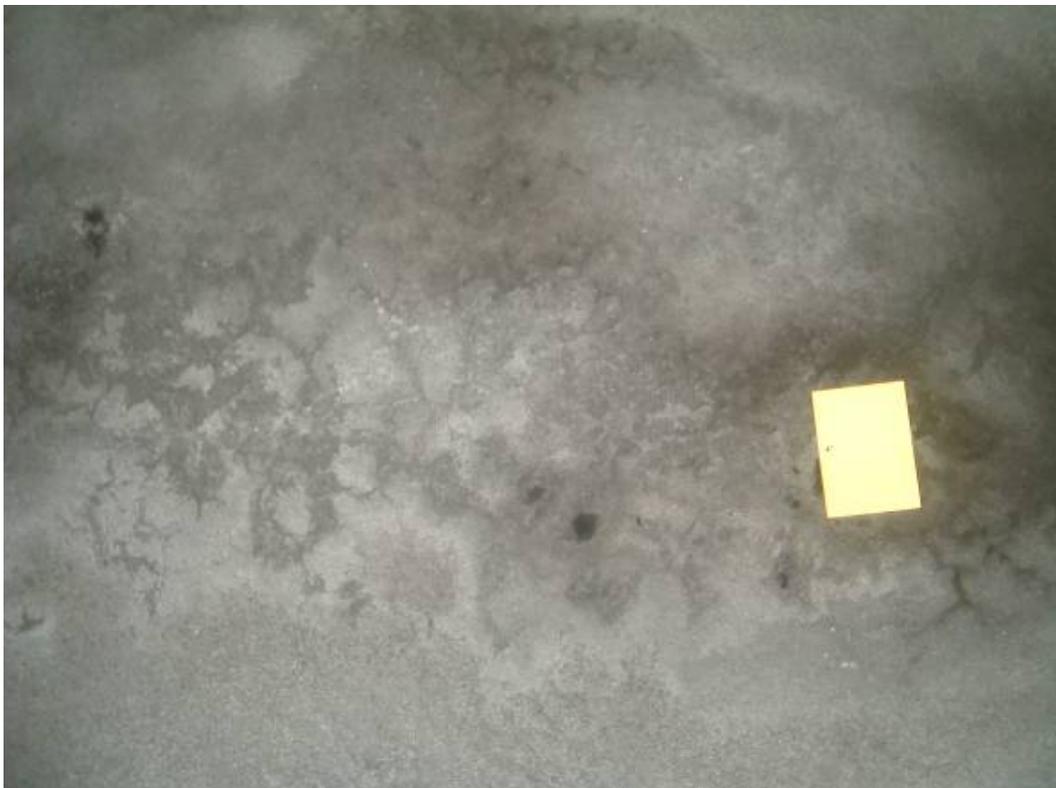
The second survey was carried out in 2005 [3]. In general the shotcrete was found to be in good condition, the shotcrete was solid and no visual evidence was found of deleterious reactions in the concrete. In this survey representative samples from major susceptible areas in the entire tunnel were examined, see Figure 1.

Samples with surface net-cracks, the cracks penetrated into the shotcrete and often through the shotcrete. These cracks were often associated with alkali silica gel and cracked aggregates were found connected to these cracks. Usually, the cracked aggregates were weak aggregates like sedimentary rocks, but solid basaltic aggregates were also found in connection with these cracks, see Figure 2.

Figure 1: AAR suspect area with surface cracks. Core was taken for further examination. The card is 75×105mm, and shows the location of the core.

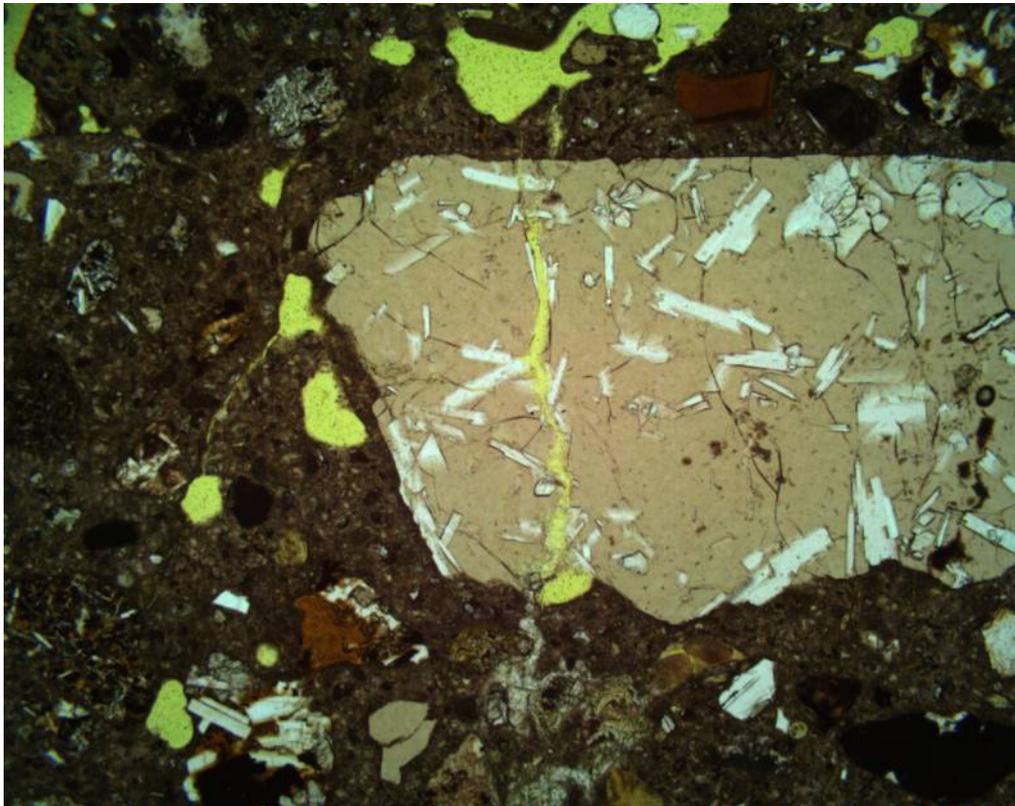
The third condition survey was carried out in 2006 [4]. This survey was carried based on the results of the 2nd survey. Shotcrete from areas with net cracks were sampled and studied under the microscope. Net cracks, similar to what is shown in Figure 1, penetrate into the concrete and can penetrate through aggregates. In Figure 3 is an example of cracked aggregates (volcanic glass). On both sides of the aggregate is alkali silica gel.

The composition of the gel which was found in the crack shown in Figure 3 was studied with SEM. The studied area is shown in Figure 4. Area 1 is close to the basaltic glass and areas 2 and 3 are further away from the basaltic glass. The chemical composition of the gel is given in Table 4.

Figure 3. Photomicrograph of shotcrete showing ASR crack carrying gel in basaltic glass aggregate. The field of view is 1.39×0.965 mm.
