# AAR IN FURNAS DAM, BRAZIL, RESIDUAL EXPANSION AND THE EFFECT OF LITHIUM

Furnas Hydraulic Power Plant is located in Brazil, and it was built in 1963. The occurrence of the AAR in the concrete of Furnas was first noticed in 1976. Once the AAR was recorded, the structure was monitored by instruments and concrete cores were studied in the laboratory through several tests and microscopy analyses.

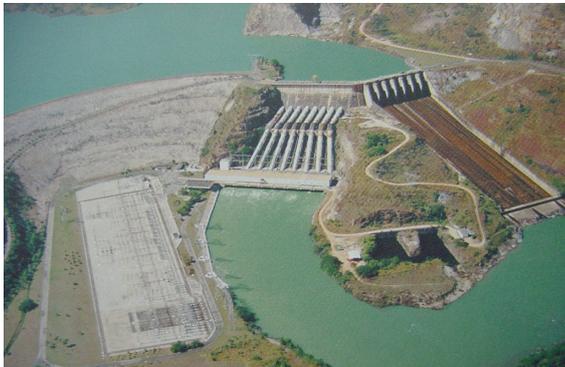
Figure 1a: General view of HPP Furnas.

Furnas Dam is a Hydroelectric Power Plant (HPP) in Brazil (Figure 1a) that manifested the symptoms of AAR. This reaction was first reported in 1976. The greatest concerns were the appearance of cracks in the top of the spillway columns, in the anchorage blocks of the water conduits, and in the powerhouse. Also an unleveling between the central wall and adjacent blocks was observed. Once AAR was reported, the concrete structures were monitored by instruments, and concrete cores (Figure 1b) were studied in the laboratory through several tests and microscopy analyses. Figure 2a shows the main occurrences of cracks due to AAR in a column of the spillway, and Figure 2b shows an exuded ASR gel in the concrete of the spillway. This paper presents part of the studies performed with aggregates and concrete cores from Furnas HPP.

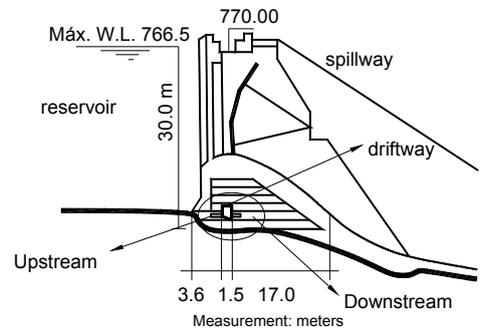
Figure 1b: Sketch showing a cross section of the spillway; detail of the drilling holes (up and downstream directions) in concrete.

the spillway of Furnas HPP in both directions, upstream and downstream. The cylindrical concrete cores were approximately 15 cm in diameter by 30 cm in length.

The driftway, built in 1961, is made up of six bands of concrete blocks, 14.5 m each (related to six spillways) and two blocks 8.75 m each (left and right abutments), adding up to a 104.5 m driftway. These blocks were built in 13 layers, about 1.5 m height each. In order to evaluate the same type of concrete, layer number 7 in the driftway was selected for this study and represents a 45 years old concrete. Its mixture proportion contained 170 kg/m<sup>3</sup> of cement, 550 kg/m<sup>3</sup> of sand (natural and artificial), 1590 kg/m<sup>3</sup> of crushed rock (maximum size of 152 mm) and 0.70 water-cement ratio. In the concrete both natural and artificial sand of quartzite from the excavations and an Ordinary Portland cement manufactured nearby Furnas dam were used, with no mineral admixture, having a total maximum alkalis of 0.60% according to the standard recommendations at that time.

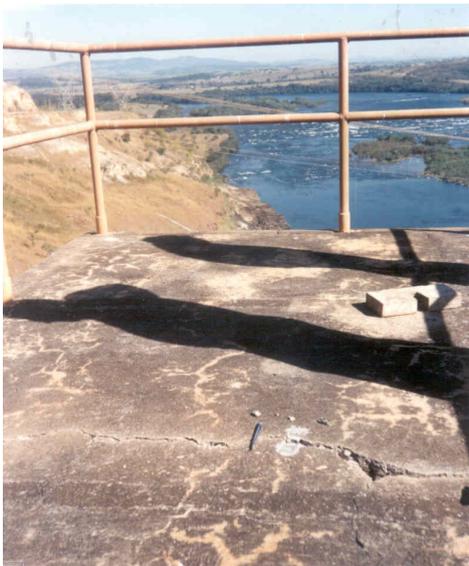
Figure 2a: Crack along transversal section of a spillway column

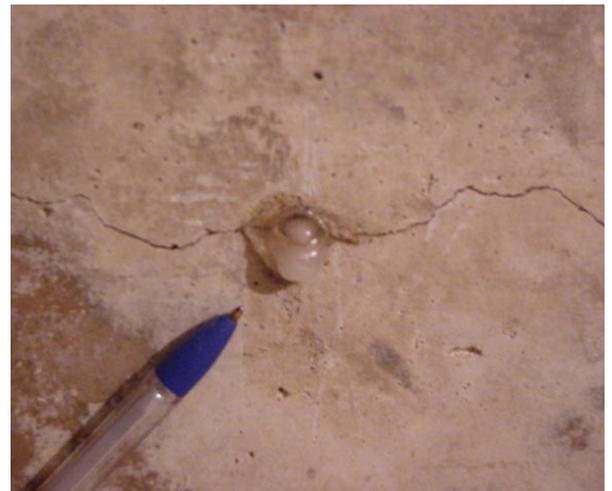
Figure 2b: ASR Gel from cracking in the concrete surface of the spillway driftway.

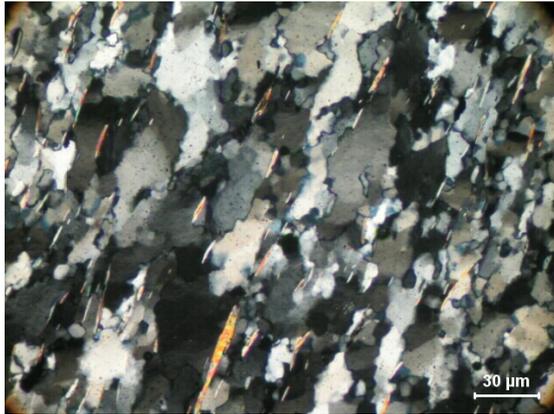
Figure 3: Detail of the quartzite aggregate showing elongated sutured grains of quartz, showing undulatory extinction and fine oriented muscovite (colored) flakes between quartz grains. Optical microscopic image with cross polarized light.

Both aggregates, from the quarry and from the concrete cores, presented similar features being classified as quartzite, containing similar mineralogical composition as determined by optical microscopy with transmitted light: quartz: 85 to 90vol%; muscovite: 5 to 10vol%; opaque minerals: < 5vol%. The samples showed fine granulation, granoblastic texture and strong metamorphic foliation, which is determined by preferred orientation of the laminar flakes of muscovite and by the elongated strained quartz with sutured boundaries between adjacent quartz grains. Quartz crystallites often show undulatory extinction due to strain, but euhedral quartz grains do not occur. Muscovite occur as small oriented flakes interspersed between quartz grains. Opaque minerals occurred disseminated throughout the rock, but preferentially around the micaceous minerals. Mineralogical composition associated with texture indicates that this rock consists of metamorphosed arenitic sediments. Figures 3 and 4 present micrographs of the main features of quartzite samples in the optical microscope at 40× magnification.

The mineralogical study of quartzite indicates that the main reactive constituent is strained quartz [6-10,12]. The presence of strained elongated quartz grains indicates that the rock was exposed mainly to shearing strain [10]. In addition, the fine size of the quartz crystallites intensifies the area for dissolution of silica from quartzite [11].

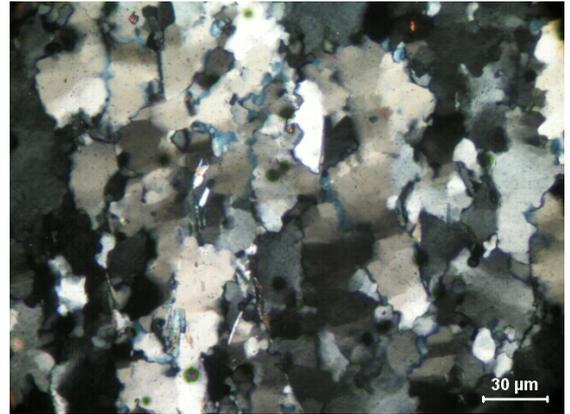
Figure 4: Detail of an area of sutured quartz grains with intense undulatory extinction. Optical microscopic image with cross polarized light.

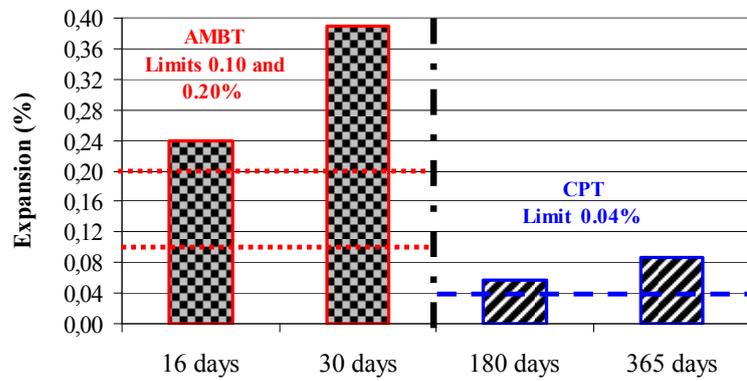
Figure 5: Expansion of mortar bars and concrete prisms

Figure 5 shows the average expansive behavior of the mortar bars (mb) and concrete prisms (cp) cast with quartzite according to ASTM C-1260 and ASTM C-1293, respectively. The average expansion in the mortar bar tests was higher than the threshold of 0.20%  $\ell/\ell$  at 16 days. The average expansion was 0.24%  $\ell/\ell$  and 0.39%  $\ell/\ell$  at 16 and 30 days, respectively. Similarly, the concrete prisms expansion tests gave values that were higher than limit of 0.04%  $\ell/\ell$  even at 155 days. At one year, average expansion was 0.09%  $\ell/\ell$ .

Accelerated mortar bar expansion tests and also concrete prism tests indicate the deleterious behavior of quartzite due to expansions higher than thresholds of both methods. Expansion tests of concrete cores immersed in water (Figure 16) showed an expressive increase in expansion at early ages and in general up to 28 days. After that, it was not noticed an increase of expansions. At 365 days, the largest expansion was 0.11%  $\ell/\ell$  for one sample from US1 class. The average expansion was about 0.08%  $\ell/\ell$ . With the purpose to verify statistically the influence of concrete class (DS, US1 and US2) on the expansions, a variance analysis was performed considering individual data at 180 and 365 days [17]. Nevertheless, the results indicate that there are not significant differences between the three classes for a significance level of 0.05% in the exposure condition tested from this analysis.

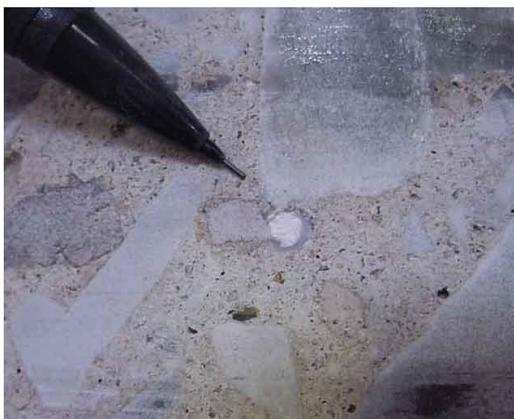
Figure 6: Void filled with white material in the interior and vitreous round the edge (Core 30A-US1).

Figures 6 to 9 present some images from the visual inspection indicating the presence of reaction products typical of AAR.

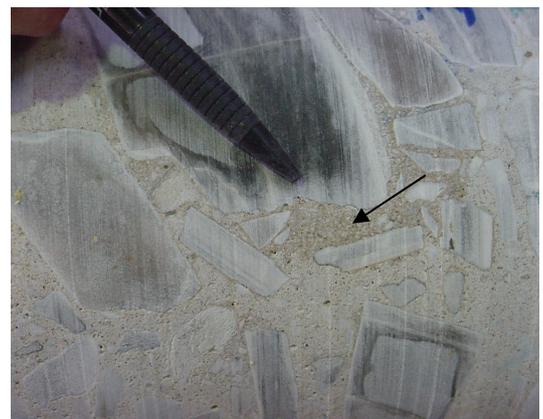
Figure 7: Dark stains in the mortar around aggregates (Core 48A-US1).

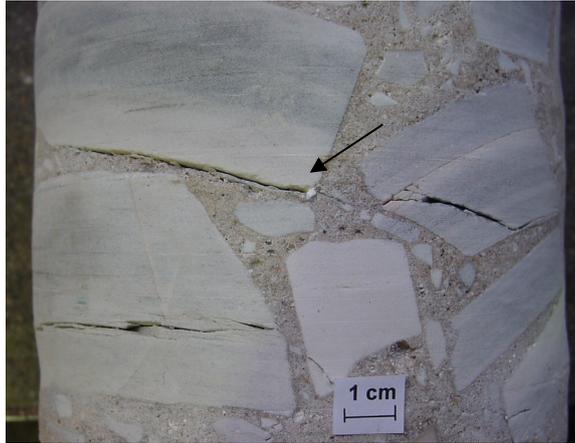
Figure 8: Cracks cutting across aggregates and white product filling in the crack (Core 12A-US2).

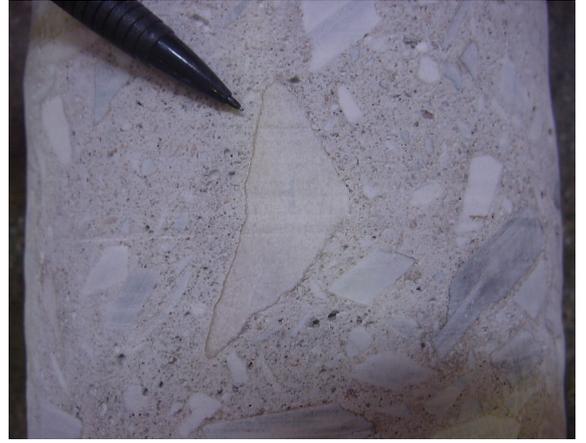
Figure 9: Dark rim around aggregate (Core 25A-US2).

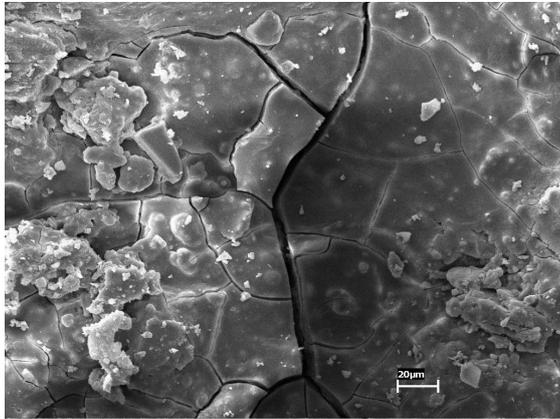
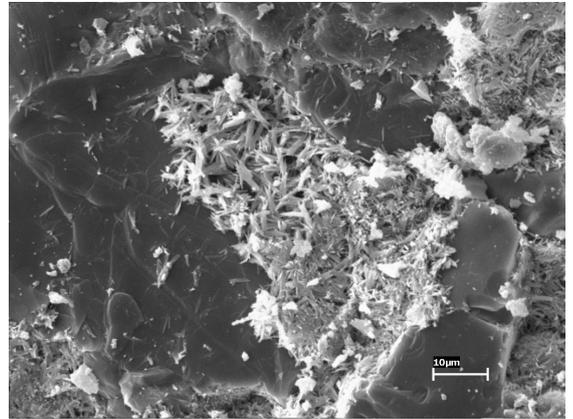
Figure 10: Micrograph of the cracked and botryoidal gel (DS-MI).

Figure 11: Micrograph of crystallized products on aggregate (DS-MI)

SEM analysis of sample LI from downstream class showed little evidence of ASR products with the exception in a zone that visually was darker than the rest of the cement paste, where a massive phase typical of gel was observed. In the sample MI, where AAR was most prevalent, the interfaces between the cement paste and the aggregates were well preserved, however cracked gel with botryoidal aspect was observed in the darker zones. Also crystallized products with silico-alkaline composition were formed on the aggregate (see Figures 10 and 11).

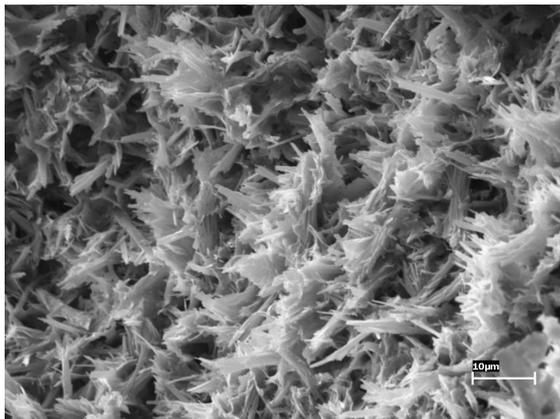
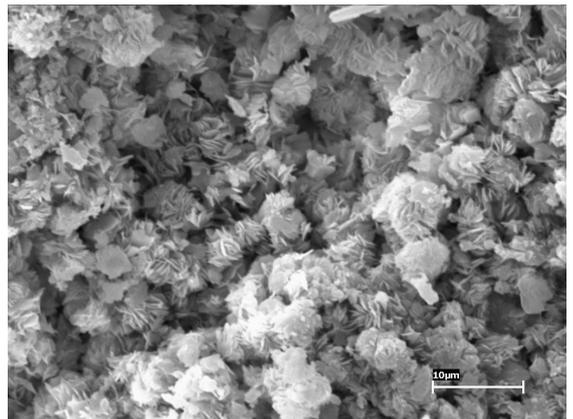
Figure 12: Micrograph of crystallized products inside an air-void (US1-LI)

Figure 13: Morphology of the rosette-like reaction products (US1-MI)

In sample LI from upstream class 1 (US1), alkaline crystallized products were observed inside the voids whereas massive and cracked gel were found in the dark zones of the mortar and fine crystals around the aggregate interface. In sample DS-MI, the investigation identified cracked gel around the voids (associated to the vitreous rims in the voids by visual observation), crystallized products of AAR in voids (white material visually) and some ettringite in the matrix. Figures 12 and 13 show the products from US1 class.

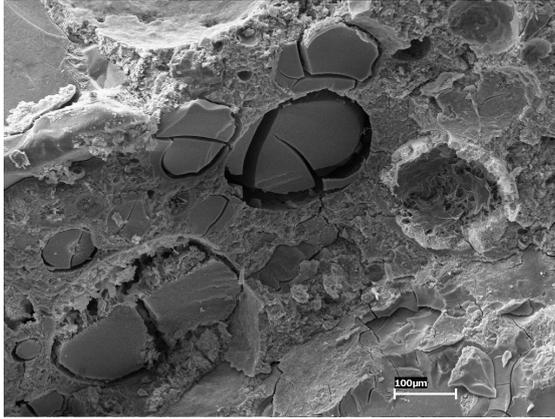
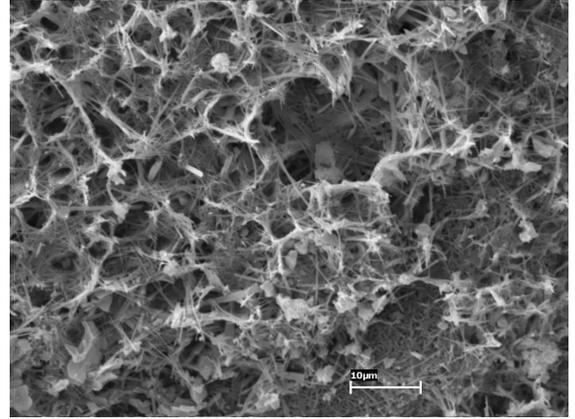
Figure 14: Micrograph showing several voids filled with gel (US2-MI)

Figure 15: Micrograph indicating laced crystals in the mortar (US2-MI).

In the sample LI (belonging to class US2), SEM observations showed voids filled with crystallized products with silico-alkaline composition, massive and cracked gel and fine crystals, some of them ettringite, in the mortar. The sample had the following DS-MI characteristics: fine crystals in the interfacial transition zone (the rims observed in the visual inspection) and in the aggregate, several products such as massive gel and crystallized phases in laced crystals in the voids, alkali-calcium-silica crystals in mortar and ettringite. Micrographs 14 and 15 shows some of the phases of AAR observed in class US2.

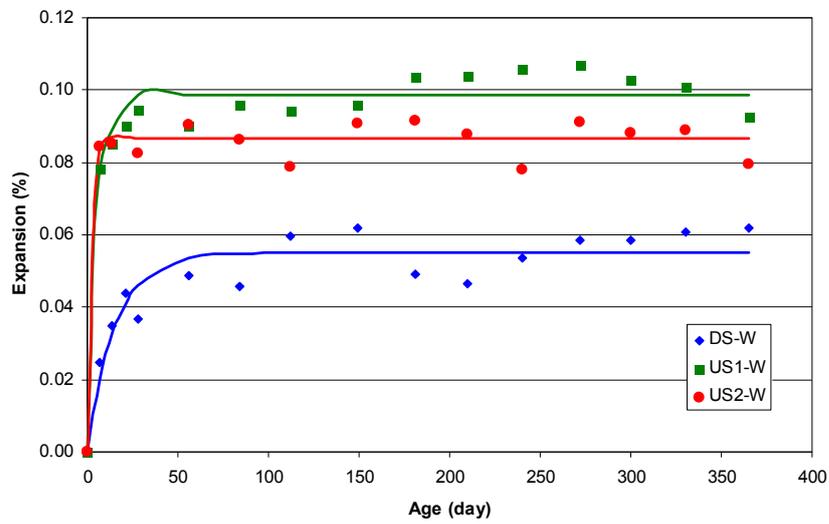
Figure 16: Expansion over time for samples of each class (DS, US1 and US2) immersed in water at 38°C.

The average residual expansion over time for the four core samples of each class (DS, US1 and US2) immersed in water at 38°C are shown in Figure 16. The experimental results of the concrete

cores tested in this condition were best fit according to the following equation  $y = a(1 - \exp^{-b \cdot x})$ . The average residual expansion over time for the four core samples of each class (DS, US1 and US2) submerged in NaOH (1N) at 38°C and the results for the cores from US1 class tested in a lithium nitrate:sodium hydroxide solution at a molar concentration of 0.74 are given in Figure 17. In those exposure conditions, the experimental results of concrete cores tested were best fit according to the equation  $y = 1 / (a + b \cdot x^c)$ .

Hasparyk et al. [18] reported expansions from 0.02%  $\ell/\ell$  to 0.06%  $\ell/\ell$  at one year in concrete cores exposed to 100% RH at 38°C from different structures of hydraulic power plants. It is known that water plays an important role in chemical reactions. According to Poole [19], water has two functions, the first allows migration and movement of alkaline cations and hydroxyl ions, and the second function is related to gel adsorption leading to expansions. When a concrete is deteriorated by AAR, it contains gel in its interior in a non saturated form. Any additional water can produce expansion due to gel adsorption [19,20]. This behavior can explain the high values of expansion detected at first ages in the present study. Thus, the occurrence of high expansions at first ages cannot be linked only to the saturation of concrete by water absorption but also to the adsorption of pre-existent gel followed by its expansion. On the other hand, expansions that are detected at more advanced ages can be related to new formed gel and its water adsorption.

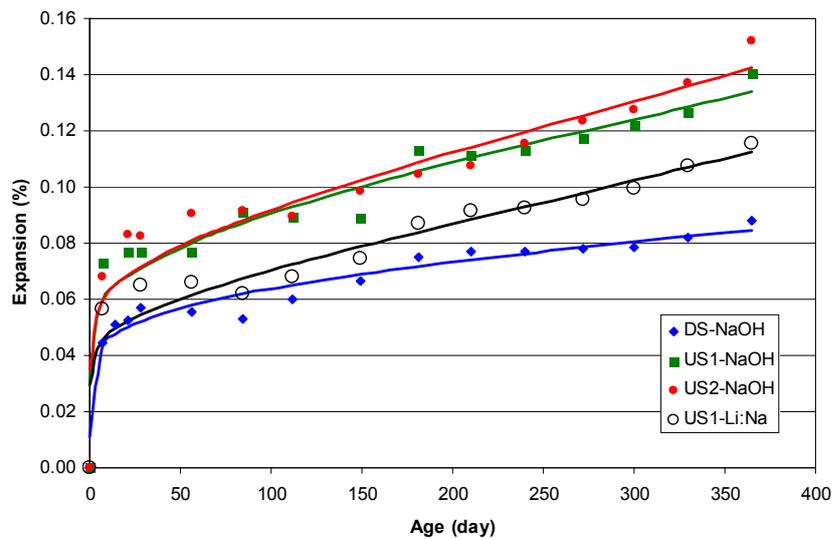
Figure 17: Expansion over time for samples of each class (DS, US1 and US2) immersed in NaOH and LiNO<sub>3</sub>:NaOH solution at 38°C.

Figure 17 shows an expressive increase in expansion up to 28 days followed by a constant period at around 90 days for concrete samples in DS class and 112 days for US1 and US2 classes that were immersed in NaOH. After that, expansions do not stop and it is verified a gradual but expressive increase of expansion over time for US1 and US2 classes, and less intensive for DS class up to one year. The largest expansion value measured was 0.18% at one year for US2 class. The average expansions at this age were 0.09%, 0.14% and 0.15% for DS, US1 and US2, respectively. The smaller expansion observed in class DS suggests a reduced pre-existing gel when compared to other classes. On the other hand, reactive aggregate tends to be higher and can lead to higher expansions in a high

alkaline environment. However, micro-cracking due to AAR observed in the DS cores is smaller than in the US1 and US2 classes, thus a smaller level of cracking can difficult the entrance of alkaline hydroxides from solution to interior of concrete resulting in smaller expansion.

With the purpose of verifying statistically the influence of the concrete class (DS, US1 and US2) on the expansion at exposure condition of immersion in NaOH at 38°C, a variance analysis was also performed at 180 and 365 days individually [17]. Results indicate that there are significant differences between the three classes for a significance level of 0.05% for this the exposure condition. In addition, the Duncan's multiple range test of homogeneity of groups [22] was performed for each age mentioned above. This method was used to determine a range statistic for each comparison by ordering the group means from smallest to largest and the number of steps that two means are apart in the ranking. The results indicate that US1 and US2 class are statistically similar while DS class formed a different group.

By immersing the samples in NaOH, the reaction products have water to expand and the alkaline hydroxides can generate new reaction products further increasing the expansion as compared to the immersion in water. The high values of expansion (in the range of 0.09% to 0.15% from cores from three classes) indicate the presence of reactive minerals in aggregates. However, DS class showed a distinct behavior from the others that can be explained by the minor incidence of gel and micro-cracking observed by visual and microscopic analyses.

The tests with cores immersed in Li:Na solution (Figure 17) also showed an increase of expansions at early ages up to 28 days. After that, it was observed a slower increase in expansion, different from the behavior occurred during NaOH immersion. Nevertheless, the reduction of the expansion was not so high. The work done by Folliard et al. [23] on the optimum concentration of lithium indicates that it can depend on aggregate type, minerals and exposure conditions. Thus, despite reducing expansion in the presence of lithium, the employed dosage may not have been the optimum. It is necessary additional studies with materials employed, and also from the geochemical and mineralogical point of view in order to understand the real reasons for this behavior and to verify the optimum concentration. Work by Kaneyoshi et al. [24] using accelerated tests in concrete cores drilled from a column of a bridge showed a reduction in expansions of more than 50%, if an adequate lithium concentration is applied.
