EXPERIMENTAL STUDY ON THE LONG-TERM PROPERTIES OF PRESTRESSED CONCRETE MEMBERS AFFECTED BY ALKALI-SILICA REACTION (ASR)

This paper provides a general plan of the long-term experimental study, an interim report of the outdoor exposure over the past two years and results of a loading test using cracking load.

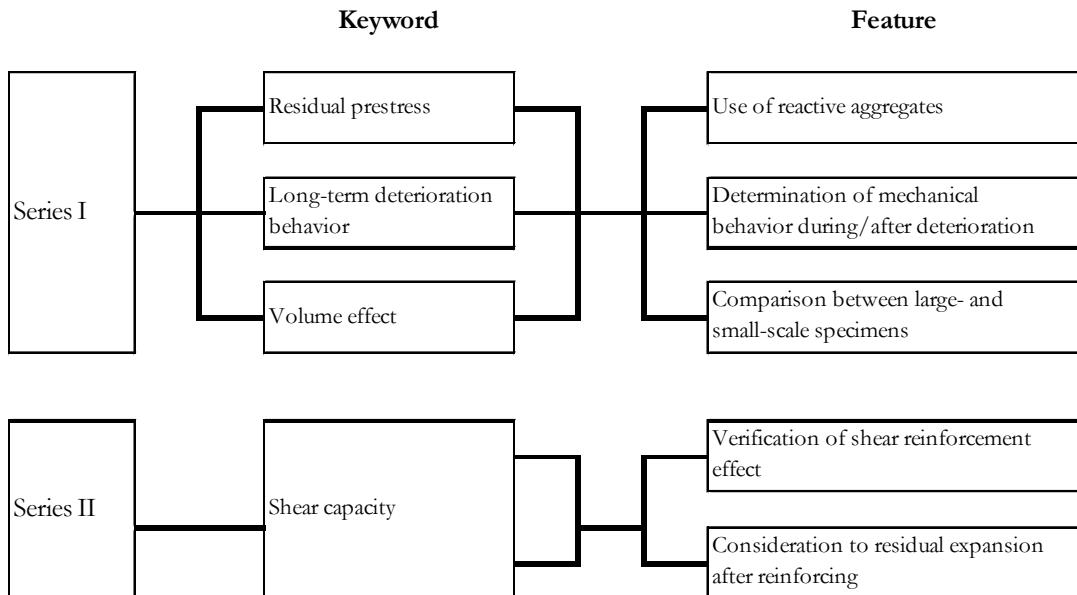
Figure 1: Schematic view of the experiment

The following specimens (Table 1) were prepared for experiment series I to determine the deterioration behavior of PC members in actual bridges. This study was also designed to include comparative examination with control specimens containing non-reactive aggregates or with small-scale specimens for assessment. Figure 2 shows the dimensions of the specimens, and Figure 3 shows the concept of evaluations of the specimens.

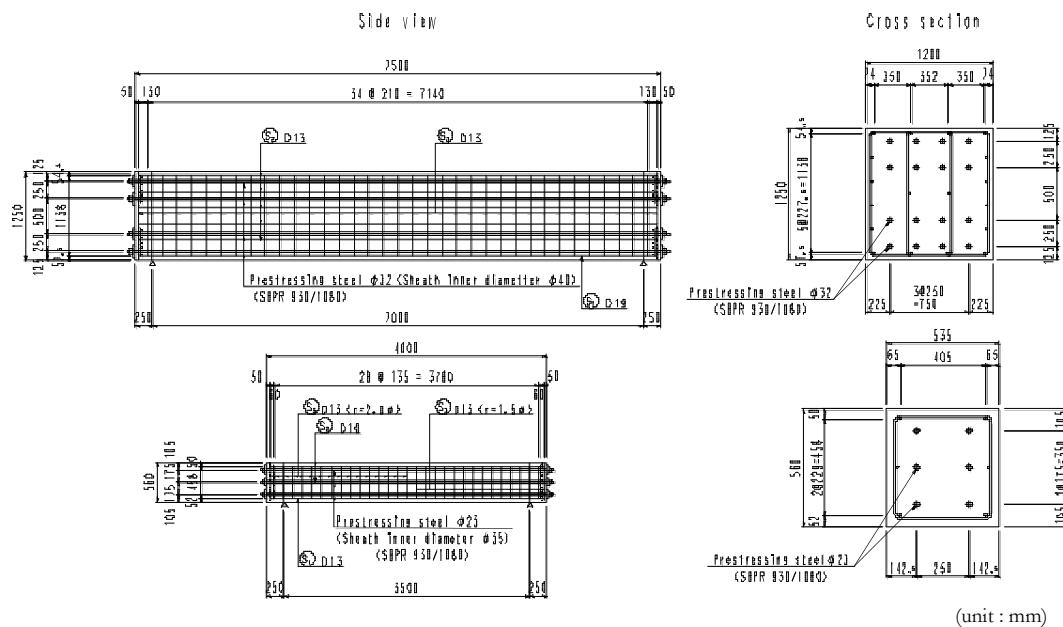
Figure 2: Large- and small-scale specimen dimensions

Specimen No.	Specimen size (mm)	Aggregate type	Specimen name
I-1-a	Large-scale (1200 x 1250 x 7500)	Reactive	Large-scale ASR reactive specimen
I-1-b		Non-reactive	Large-scale control specimen
I-2-a	Small-scale (535 x 560 x 4000)	Reactive	Small-scale ASR reactive specimen
I-2-b		Non-reactive	Small-scale control specimen

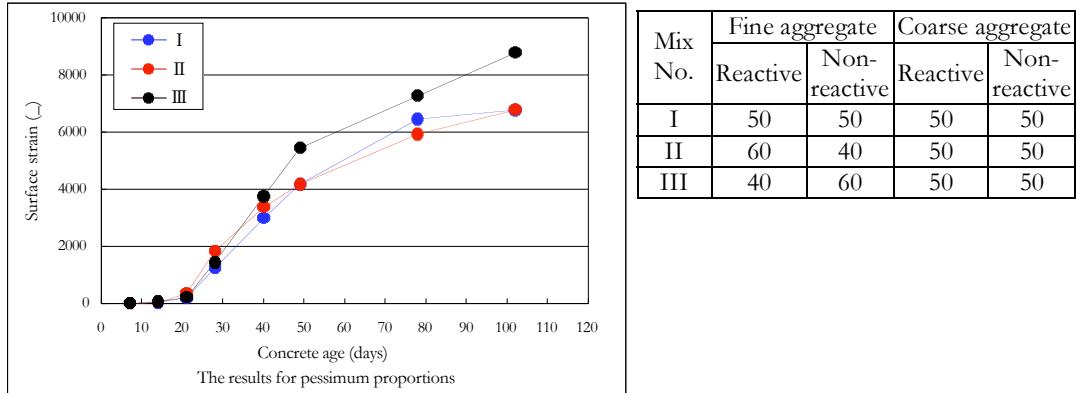
Figure 4: Test results for pessimum proportions

The mix proportion for the ASR reactive specimens (containing reactive aggregates) was determined based on mix proportions of the actual structure which exhibited ASR deterioration in a PC beam of a pier. In terms of reactivity, ratios of reactive and non-reactive aggregates were determined by a preparatory test for pessimum proportions (Figure 4). Table 2 shows planned mix proportions for the ASR reactive specimens.

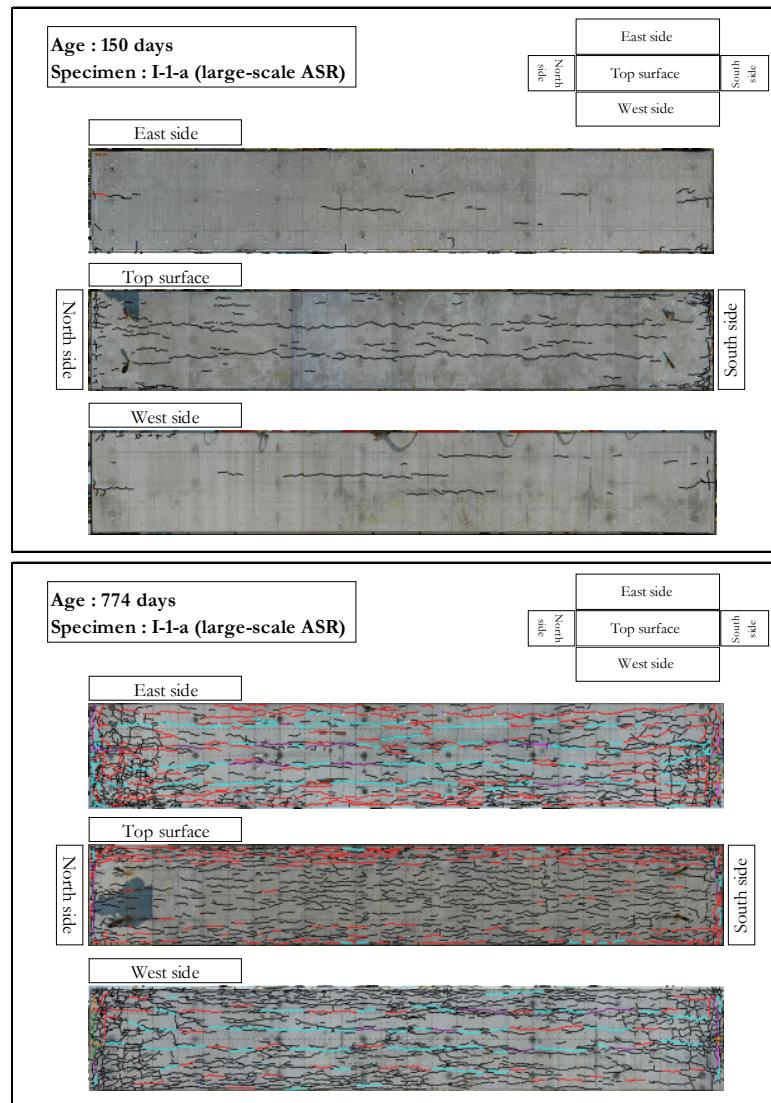
Figure 5: Cracking on the large-scale ASR reactive specimen

Cracking was observed visually, and image data was recorded using digital cameras. Figure 5 shows cracking observations on the large-scale ASR reactive specimen at the ages of 150 days and 774 days. No remarkable cracks were found on the control specimen (containing non-reactive aggregates), and the ASR reactive specimen exhibited cracks (width: 0.05 to 1.2 mm) along the direction of the prestress or the axis of the member. It is already known that ASR cracking in PC members occurs in the direction of the prestress. Such ASR cracking characteristic to PC members was confirmed in the current experiment.

Horizontal cracking which was characteristic to PC structures occurred in the ASR reactive specimens (Figure 5), generating a concern whether originally plane sections in the structure properly remained plane in the vertical direction. For verification of this issue, strain was measured using strain gauges installed on the concrete surface and on the reinforcing bars in concrete placed in the direction of the bridge axis. Figures 18 and 19 show the results at the maximum load applied. As seen in the vertical displacement measurements, the ASR reactive specimen, as compared to the control specimen, exhibited a significant decrease of about 20% in its rigidity. However, no major differences were found in general performance, with no behavior like a "built-up beam" with multiple neutral axes. This proved that plane sections behaved as a whole and remained plane properly in either specimen.

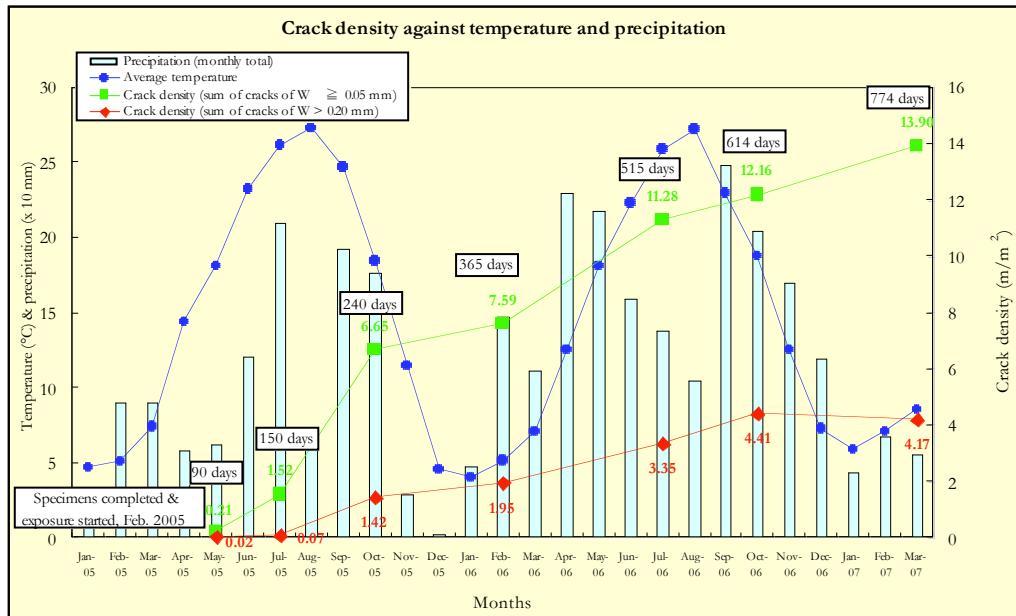
Figure 6: Crack density against temperature and precipitation

Figure 6 shows changes in crack density in the large-scale ASR reactive specimen against temperature and precipitation. In general ASR is said to progress more significantly during summertime when temperatures and precipitation are high. This trend was obvious in the current study, with the crack density rapidly increasing during the period from 150 days (July, 2005) to 240 days (October 2005). The increase in crack density then slowed down until 365 days. As the gradients of the curves indicate, the rate of increase again picked up at 614 days with the increases in temperature and precipitation. Density of cracks wider than 0.2 mm was larger in the large-scale specimen than in the small-scale specimen.

Consequently, it was confirmed that the rate of ASR deterioration depended on temperature, precipitation and other ambient conditions, and it also varied depending on the volume of the member.

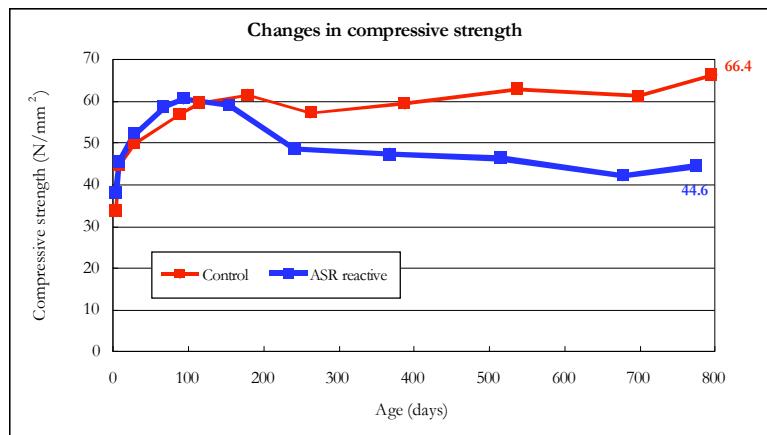
Figure 7: Changes in compressive strength

Figures 7 and 8 show compressive strength and modulus of elasticity measured on the cylindrical test pieces which were taken during concrete placement of the specimens. Values of the ASR reactive specimen started to drop clearly at 150 days when cracking became remarkable and showed a drastic drop in modulus of elasticity at 240 days after the first summer. At 774 days, values of the ASR reactive specimen were significantly lower than those of the control specimen: 70% for compressive strength and 20% for modulus of elasticity. However, these values were from the test pieces in which expansion by ASR was not restrained. Expansion in actual structures is restrained by reinforcing bars and others. Therefore, these measurement values may be used as indices only for deterioration in simple concrete but not for deterioration in an actual structure containing reinforcing bars.

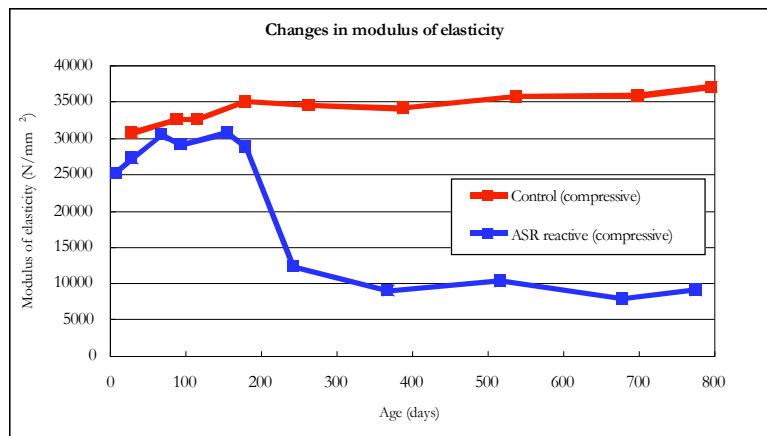
Figure 8: Changes in modulus of elasticity

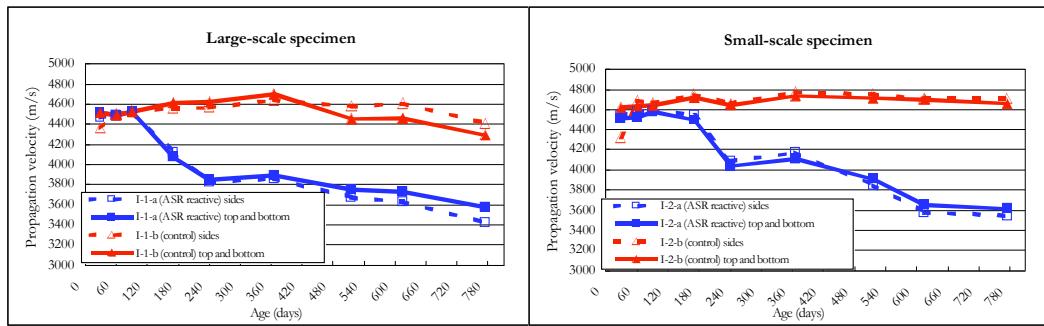
Figure 9: Changes in ultrasonic propagation velocity -- large- and small-scale specimens

Figure 9 shows changes in ultrasonic propagation velocity. No remarkable change was found until 90 days in the large- and small-scale specimens. Propagation velocity in the large-scale ASR reactive specimen started to significantly decrease at 150 days, down to about 80% of that of control specimen at 240 days, and continued to decrease then slowly until 774 days. In the small-scale specimen, propagation velocity significantly decreased after 240 days, slowed down as seen in the large-scale specimen, and then reached the same level as the large-scale specimen at 774 days. The difference in how propagation velocity decreased in the large- and small-scale specimens was considered to be due to the volume effect on the rate of ASR deterioration.

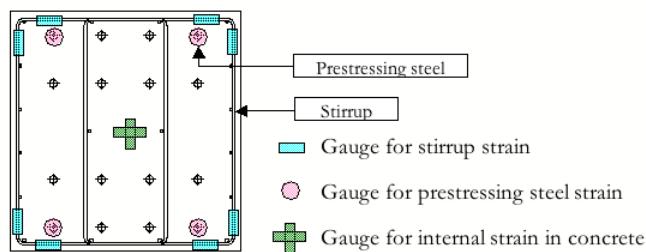
Figure 10: Locations of the measurement devices

Measurement gauges were installed on the specimens in order to determine long-term strain properties during ASR deterioration (Figure 10). In addition, contact strain gauges were placed at mark intervals of 300 mm on concrete surfaces.

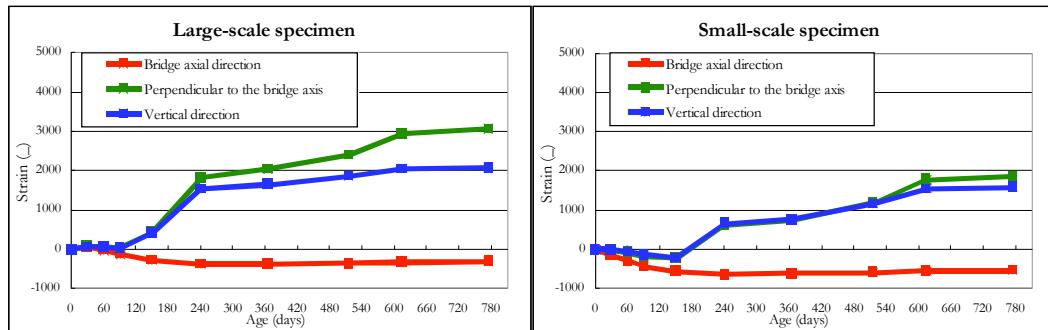
Figure 11: Changes in internal strain in concrete

Figure 11 shows changes in internal strain in concrete at the midsupport of each specimen. Neither specimen showed significant change until measurement on 90 days, suggesting drying shrinkage. In the ASR reactive specimens, a sign of expansion strain was found at 150 days in the large-scale specimen and at 240 days in the small-scale specimen, in the vertical direction and in the direction perpendicular to the bridge axis but not in the prestress direction. The slow expansion continued until 774 days in both specimens. The discrepancy between the large- and small-scale specimens got smaller with age. This tendency is very close to the one seen in the ultrasonic propagation velocity mentioned above.

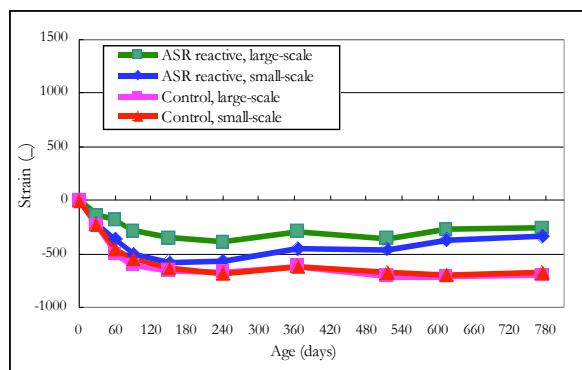
Figure 12: Changes in prestressing steel strain

Figure 12 shows changes in prestressing steel strain measured at the midsupport of the large-scale specimen using weld gauges. Figure 13 shows changes in tension force measured using load cells. Although both strain and tension force showed decreases presumably attributable to drying shrinkage and creep, no significant differences were found until 774 days between the ASR and control specimens or between the large- and small-scale specimens. Changes in length in the axial direction of the member measured on concrete surfaces using contact strain gauges were only slight. These measurement results suggest that residual prestress in the ASR reactive specimens is at a similar level to the control specimens at the present time.

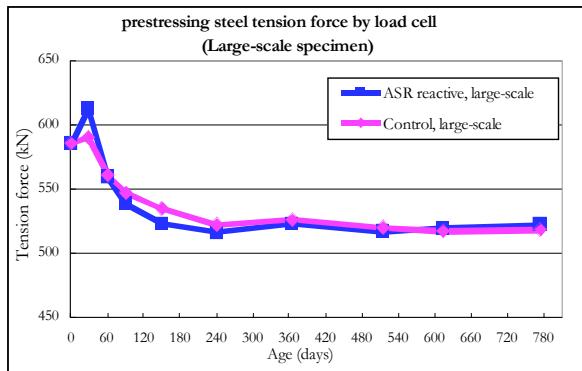
Figure 13: Changes in prestressing steel tension force

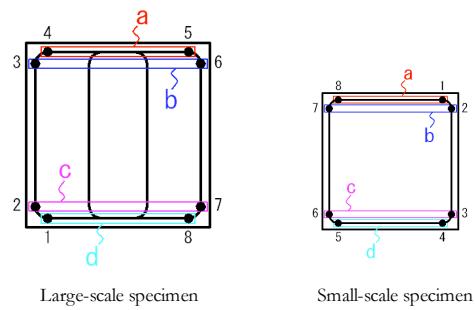
Figure 14: Stirrup measurement locations

Figure 14 shows locations of stirrup strain measurement at the midsupport on the large- and small-scale specimens, and Figure 15 shows the measurement results. Stirrup strain showed a sign of expansion after 90 days, and its tendency continued until 774 days. Across the cross section, expansion increase at the top fiber was more significant than at the bottom fiber, suggesting more advanced ASR deterioration on the top side which has been directly exposed to sunlight and rainfall for months.

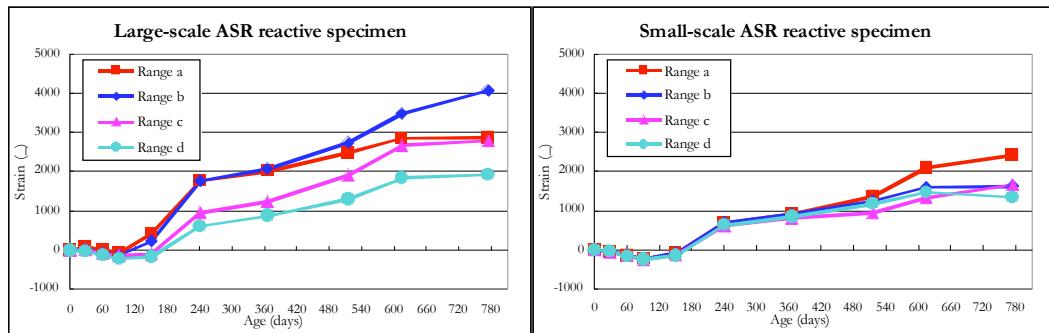
Figure 15: Changes in stirrup strain

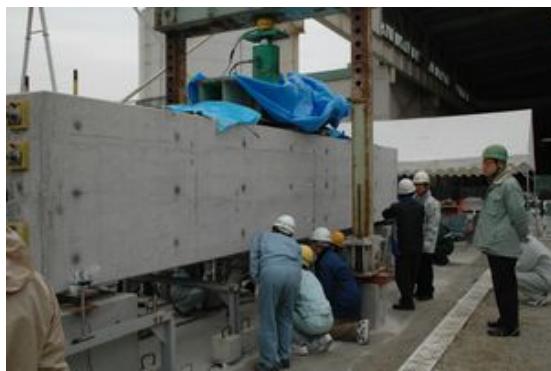
Figure 16: Loading test

The loading experiment used the large-scale ASR and control specimens (I-1-a and I-1-b) for measurement. The test load of 1500 kN was determined to achieve a target stress level in concrete at the midsupport equivalent to bending tensile stress in concrete (-1.99 N/mm^2), without affecting the continued long-term measurement. A hydraulic jack was used for applying the load. Figure 16 shows a view of the loading test.

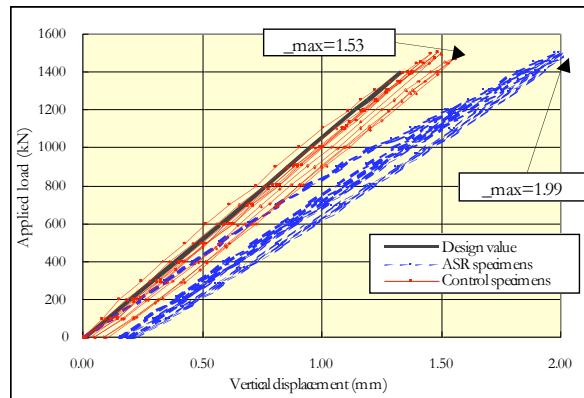
Figure 17: Load-displacement relationship

As a means to evaluate rigidity of the specimens, vertical displacement was measured using high sensitivity displacement sensors installed at the midsupport and supports. Figure 17 shows the measurement results.

The load-displacement curves suggested that the control and ASR reactive specimens almost retained the linearity. In contrast to the design displacement of 1.42 mm, vertical displacement at the maximum load applied reached 1.53 mm in the control specimens and 1.99 mm in the ASR reactive specimens at maximum, exhibiting a rigidity decrease of about 23% in the ASR reactive specimens. The design values in Figure 17 were calculated from modulus of elasticity of the test pieces containing normal aggregates.

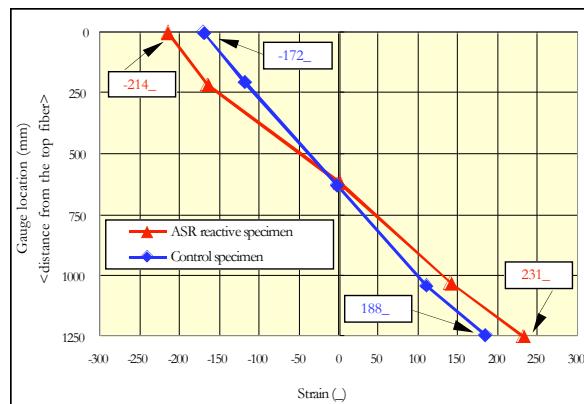
Figure 18: Concrete surface strain

Strain on the concrete surface and that in reinforcing bars in concrete showed similar tendencies, suggesting that the plane sections in the ASR reactive specimen remain plane properly.

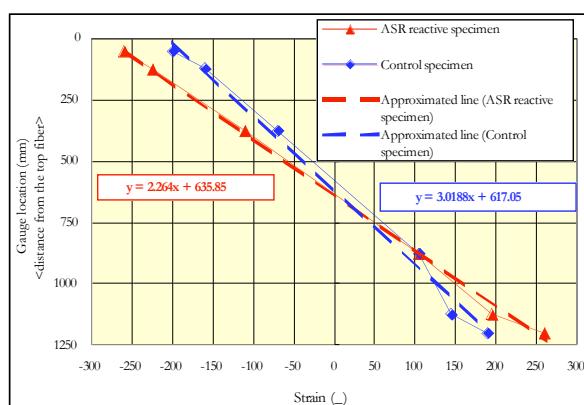
Figure 19: Approximate equation of internal strain
