# **STUDY ON MMA-BASED REPAIR MATERIAL FOR REPAIRING THE CRACKING CAUSED BY AAR IN CONCRETE**

## **Abstract**

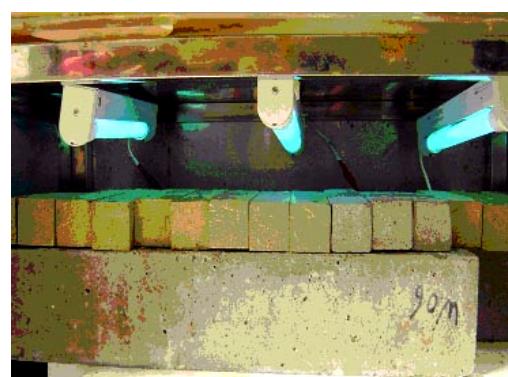
Figure 8: Experiment with ultraviolet radiation.

The ultraviolet radiation durability of RMPMA has been notable because it is a kind of organic material. The deleterious wave for RMPMA is  $290 \sim 315\text{nm}$  of which the fluorescence violet lamps (three lamps) with 10W were chosen in simulation test as shown in Fig 8. The results show that the tension strength and bending strength of RMPMA after radiating 250d can keep up 85%. If referring to the radiation data from a northwest of China, RMPMA can stand about 45 years in ambient site.

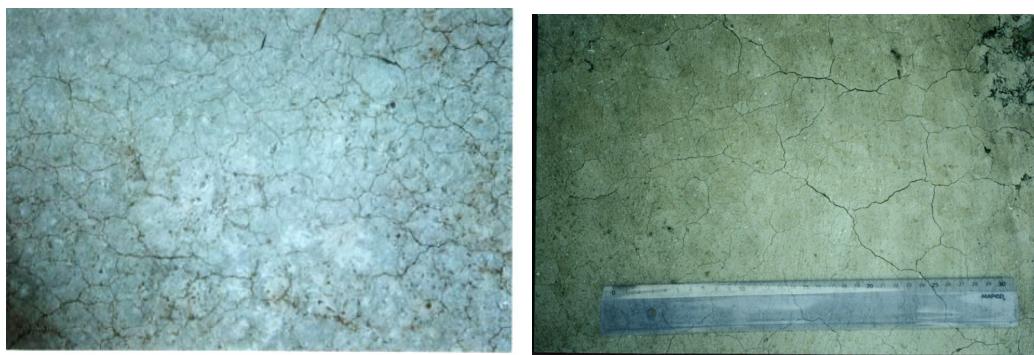
Figure 9: Cracking concrete prepared outside the lab.

Fig 9 shows concrete prepared outside has many cracks with width of  $0.10 \sim 0.60\text{mm}$ . The

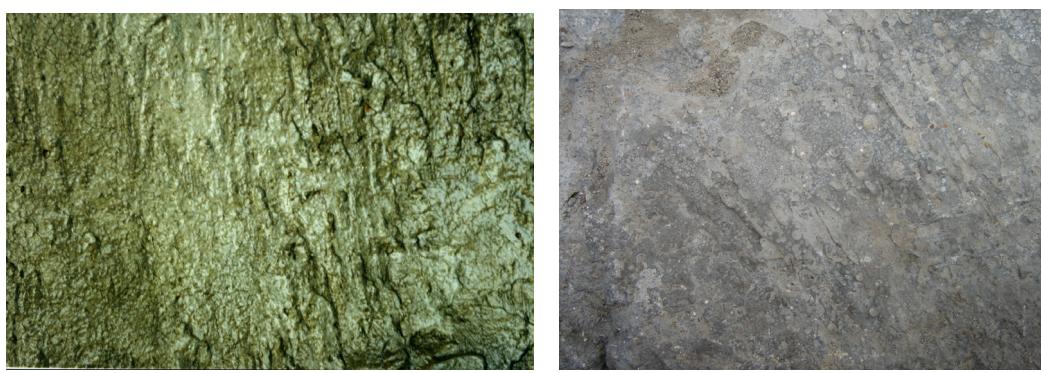
(a) just finished

(b) after 4 years

Figure 10: The cove concrete with RMPMA.

concrete were covered by RMPMA and the appearance was as shown in Fig 10 where no cracks were observed (see Fig 10(a)), even after 4 years (see Fig 10(b)).
