STRENGTHENING AND MONITORING TECHNIQUES FOR ASR-AFFECTED FOOTING OF BRIDGE PIER

Keywords: Bridge pier footing, Strengthening method with prestressing steel (PC confined method), Expansion-controlling effect, Monitoring

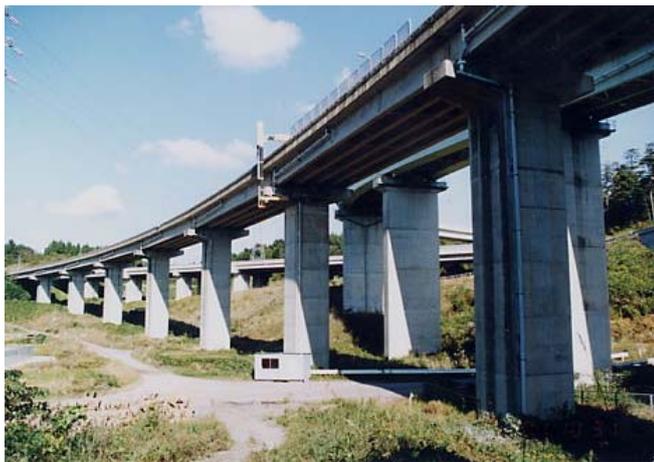
Figure 1: Overall view of the bridge.

Table 1 is an outline of the bridge with the ASR-damaged pier footing repaired and reinforced in this work. Figure 1 is an overall view of the bridge and Figure 2 is a bridge pier before strengthening. Figure 3 is a general drawing of the bridge pier.

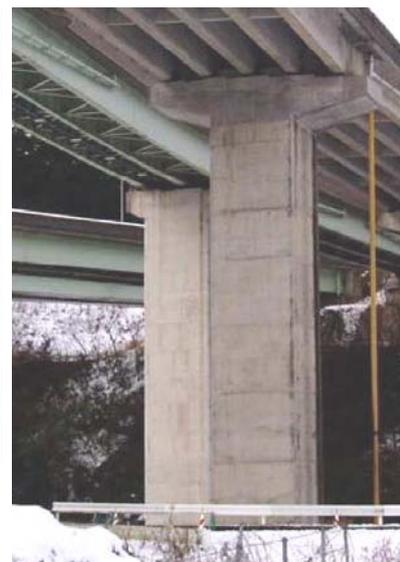
Figure 2: Bridge pier before strengthening.

Excavation was carried out as deep as the top surface of the leveling concrete surrounding the base of the footing, as shown in Figure 2. Cracks were present over the whole top surface of the footing. The cracks measured about 5 mm in width. The cracking was particularly prominent at edges where the top face and sides of the footing met, and the concrete was weakened in places. Some concrete had peeled off at the edges and some steel bars were exposed as a result of this edge weakening and due to the effects of excavation.

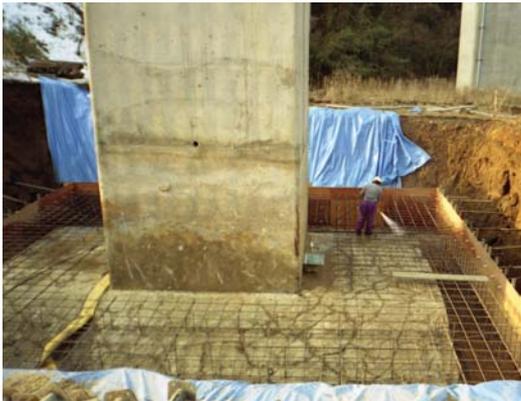
Figure 4: Deteriorated concrete at the footing top.

After removing the cover concrete around the upper region of the footing periphery, most of the exposed bends of the steel bars were found to be fractured. Figure 4 shows the deteriorated concrete on the top of the footing. Figure 5 shows the deteriorated concrete around the top edges and on the sides of the footing.

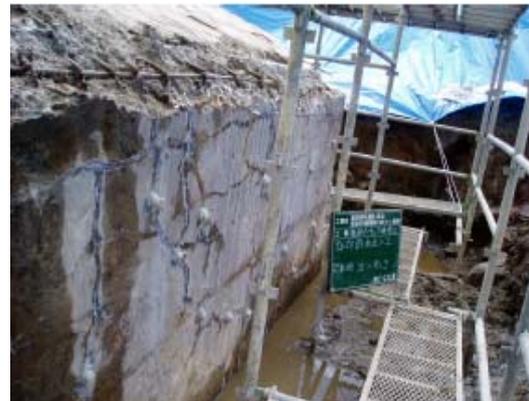
Toward the top of the footing sides, cracks had developed with the same density as on the top of the footing. Edge cracks that had developed in the horizontal direction were especially prominent, measuring 20 mm in maximum width. These cracks appeared to be the result of fracturing of most of the reinforcing bars in this region. Toward the bottom of the footing, these side cracks tended to decrease in number and width.

Figure 5: Enlarged view of deteriorated concrete at the edge and sides of the footing top.

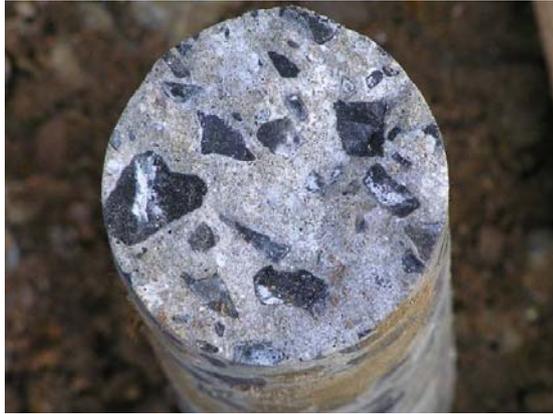
Further, white deposits were observed not only around coarse aggregate particles but also inside the aggregate particles in the cores. These deposits seemed to be gels formed through reaction with alkalis that permeated the aggregates after they cracked due to the ASR. Figure 7 shows a cross section of one core.

Figure 7: Cross-sectional view of a core sample (ø100 mm).

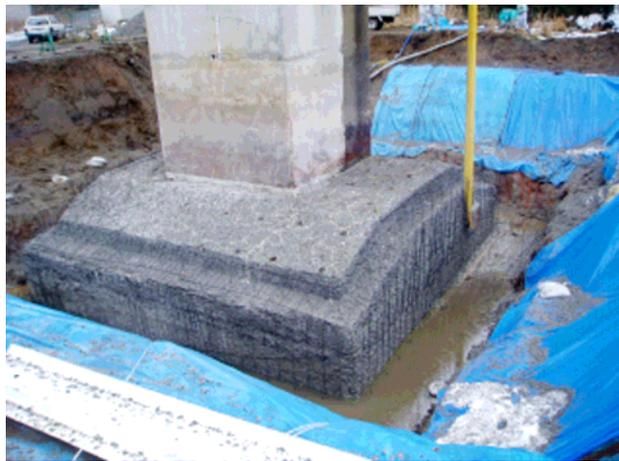
Figure 11: Footing after chipping away concrete.

The concrete at the top and sides of the footing within 1 m of each top end was chipped away to a depth of about 200 mm by using breaker and water jet to expose the steel bars. Because the visual inspection had identified fractured steel bars at these bends, an anticorrosion product was applied to the steel bars and new bars were spliced as splints to the fractured bars. Figure 11 shows the footing after the concrete had been chipped away.

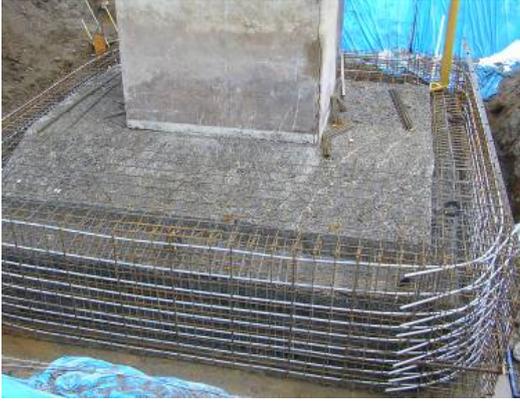
Figure 13: Layout of prestressing steel strand around periphery of footing.

The peripheral reinforcement was with prestressing steel strand (1S21.8 mm). To ensure pressure at the edges of the footing, these prestressing steel strands were wound with a minimum radius of 3.8 m. The level of the stress introduced was not less than 0.2 N/mm² as in the case of the vertical prestressing. Taking into account the possible rise in prestressing steel stress as ASR-induced expansion of concrete proceeds and in earthquakes, the effective tensioning force was set at 30-40% of the yield load of the steel. Figure 6 shows the layout of prestressing steel. Figures 12, 13 and 14 show the prestressing steel strand around the periphery of the footing and the vertical prestressing steel bar, respectively. Figure 15 shows bridge pier after the strengthening.

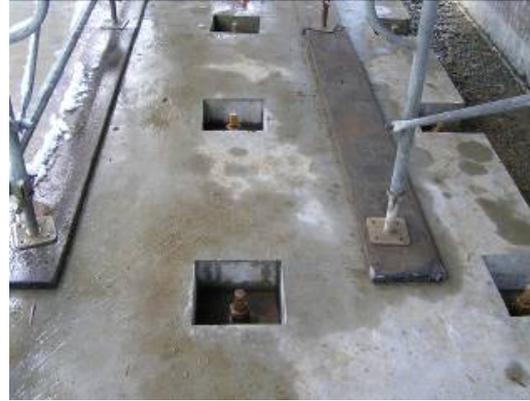
Figure 14: Layout of vertical prestressing steel bar.

To control the ASR-induced expansion of the concrete, prestressing steel was wound around the periphery of the footing and also laid in the vertical direction. The steel was then tensioned. Prestressing steel bars (D32 mm) were used for the vertical prestressing to ensure the bonding between steel and concrete. At the bottom end of these prestressing steel bars, a 500 mm deep anchorage zone was provided and a nut was turned onto the end of the bar to enhance bonding. In addition, to distribute the prestressing force over a wide area, a 250 mm square anchorage plate was attached to the top end of the bar. It is known from a previous test on column members that confining at 30% of the yield of the prestressing steel generates a restraining pressure of 0.2 N/mm² which can confine concrete expansion [2]. The amount of prestress for the current test was determined as the number of prestressing steel bars capable of introducing a confining force of 0.2 N/mm².

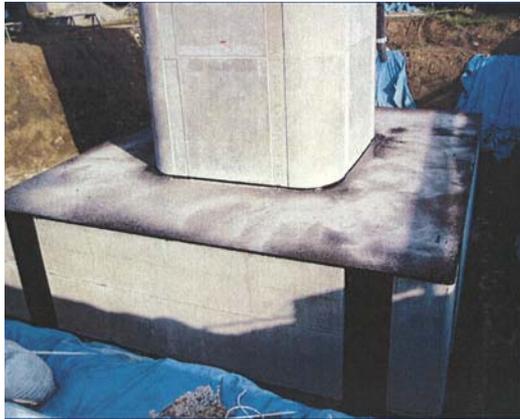
Figure 15: Bridge pier after the strengthening.

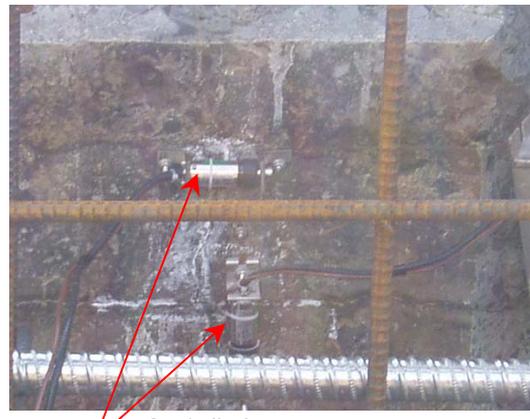
Crack displacement gauge
Figure 16: Crack displacement gauge.

Expansion of the footing concrete was measured by attaching crack displacement gauges to a selected crack on one of the sides of the footing. A relatively large crack was selected for this purpose and gauges were attached in both vertical and horizontal directions. Figure 16 shows crack displacement gauges, Figure 17 shows the change over time in crack width. The results revealed that
