DIAGNOSIS AND PROGNOSIS OF PORTUGUESE CONCRETE RAILWAY SLEEPERS DEGRADATION – A COMBINATION OF ASR AND DEF

During the winter of 2003 visible map cracking was detected in prestressed monobloc concrete sleepers in service in Portugal. Three types of sleepers were identified according to different degrees of visual deterioration in order to diagnose the causes and also to prognose the long-term behaviour of the deteriorated concrete sleepers.

This paper presents the results of the diagnostic analysis performed, that concluded the cracking was due to the occurrence of alkali-silica reaction (ASR) and delayed ettringite formation (DEF) in the concrete. The ASR was caused by the use of alkali reactive aggregates and the DEF by the employed steam heat-curing regime in combination with the high cement content used in the concrete mix design.

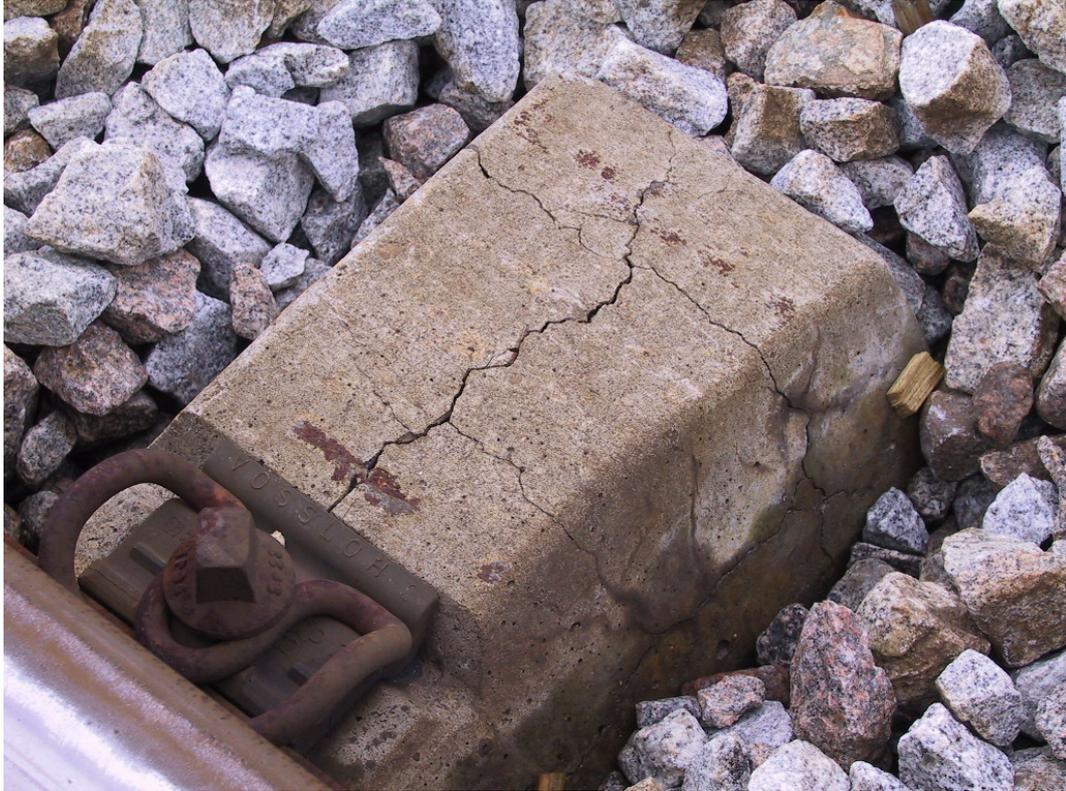
Figure 1 – End view of a cracked concrete railway sleeper.

During a routine inspection in the winter of 2003, the maintenance staff of a railway track in Portugal observed the occurrence of cracks running parallel to the prestressing wires in monobloc concrete railway sleepers and which were much more pronounced in the zone of the fastening inserts at both ends of the sleepers (Figure 1). After an initial visual inspection for the sampling of the sleepers, an important experimental program was conducted by Laboratório Nacional de Engenharia Civil (LNEC), a public institution of the Portuguese Ministry for Public Works, Transports and Housing.

Type A - produced in July 1996, highly cracked, the maximum opening of the cracks being 4 mm in width and at the two end faces;

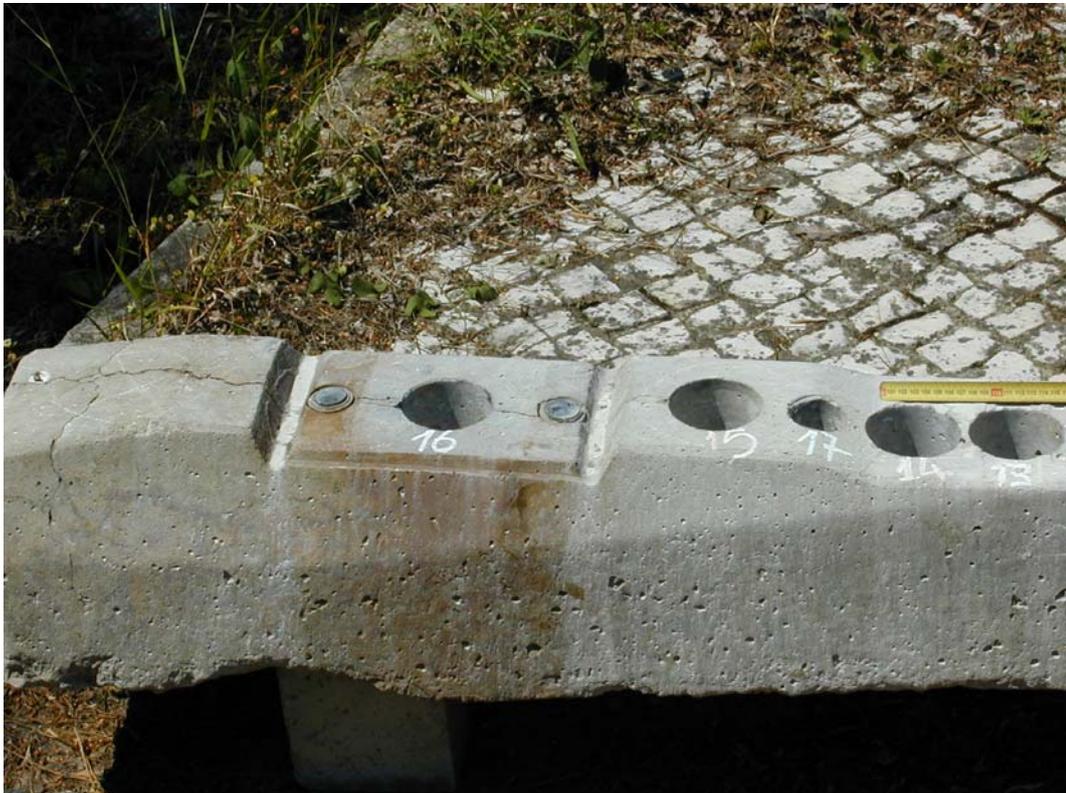
Figure 2 – View of the concrete sleeper A type after core drilling.

From each sleeper type a total of 17 core samples (73 mm in diameter and varying in length, depending of their location) were drilled for different tests (Figure 2). The samples were examined visually and by stereo-optical microscopy for signs of deposits [1]. Wet zones around the aggregates and white deposits in the air voids (Figure 3) were observed in the concrete cores of A and B sleepers types. The white deposits were scraped for further analysis by x-ray diffractometry (XRD).
