FACTORS AFFECTING THE EXPANSION AND CRACKING OF MODEL BRIDGE PILES IN SEAWATER, AND THE EFFECTS OF MECHANICAL CONFINEMENT

Ahmad Shayan*, Aimin Xu and Roger Olasiman

ARRB Group Ltd, 500 Burwood Highway, VERMONT SOUTH, VIC 3133, Australia

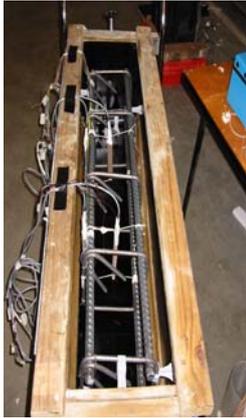
Figure 3: Steel cage.

After demoulding, all the piles were wrapped in moist cloth and, after one week, surface strain gauges were installed in appropriate locations. Subsequently, the piles were wrapped in moist cloth again and then half-immersed in their containers, either in tap water or salt solution. In the case of salt solution, the moist wrapping was present only in the top part of the pile, so that salt does not migrate up the pile. The whole assembly was then wrapped in plastic sheeting and placed at 38°C for expansion measurement. Figures 3 to 5 show the various stages of preparation of the model piles.

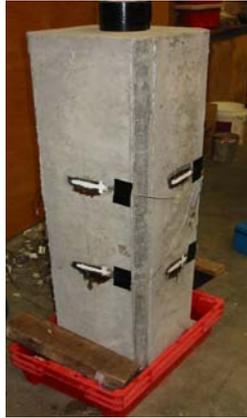
Figure 4: Finished pile.

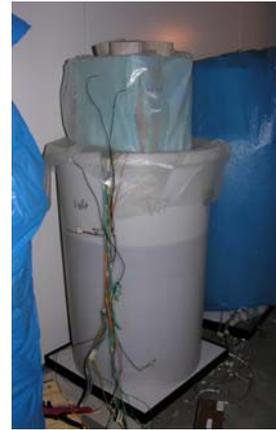
Figure 5: Storage of pile.

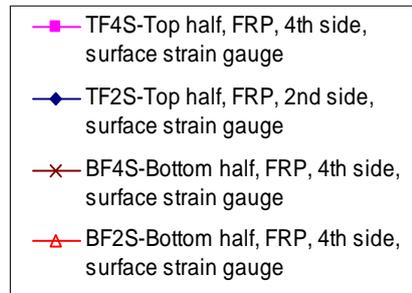
Steam curing, half-immersed in salt solution

Steam curing, half-immersed in water.

Highly reactive concrete, steam curing, half-immersed in water.
Highly reactive aggregate, high sulphate

Highly reactive concrete, steam curing, half-immersed in salt solution. Highly reactive aggregate, high sulphate.

Figure 12: Strain developments in jackets of columns with highly reactive aggregate (Columns 10-11, and 13-14).

The strains measured in the RC jacket and on the CFRP layer are shown in Figure 12, which indicates continuing expansion and reflects the ongoing internal expansion of the piles, as the jacket material itself is non-reactive. Neither of the methods eliminated or reduced the deleterious expansion to safe levels.

In fact, recent monitoring revealed cracking in the concrete jackets due to internal AAR expansion of the original concrete. The fact that the CFRP wrapping did not completely contain the lateral expansion could partly be attributed to the non-circular cross section of the piles. The AAR expansion induces non-uniform stresses on the side faces of the wrapped piles, which are not effectively contained by CFRP at mid-face, due to the square shape. Therefore, the side faces are free to expand. However, CRFP-wrapped cylindrical specimens used by Wigum and Thorenfeldt (2004) [8] appeared to provide more effective confinement of the AAR expansion, although still incomplete. So, the shape effect may explain the observed lack of full confinement. Based on the maximum strain measured on the CFRP (2500 μ strain) and its modulus of 240GPa, the stress generated by AAR in the CFRP is about 600MPa which is far below its tensile strength of 3800 MPa.
