# ALKALI-AGGREGATE REACTION IN WESTERN CANADA: REVIEW OF CURRENT TRENDS

Fred Shrimmer\*, Anett Briggs, Benjamin Hudson

<sup>1</sup>Golder Associates Ltd., VANCOUVER, British Columbia, Canada

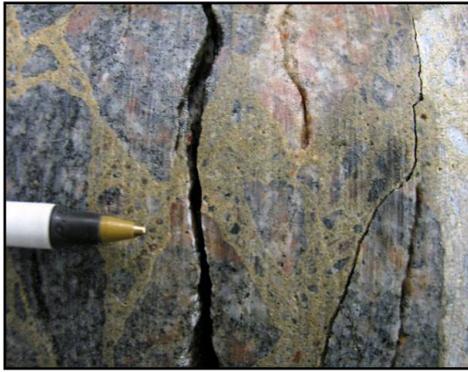
Figure 2: Concrete core, Pointe du Bois GS, showing ASR gel deposits associated with granite aggregate

Cases of AAR in concrete in Manitoba are few. A well-documented case of deleterious AAR is the Pointe du Bois Generating Station east of Winnipeg (Figure 2). The facilities were constructed over a number of years, with the earliest phase of construction being 1909-1911, using cements that were imported, likely from Ontario or Quebec (Robinson, pers. comm., 2008). Later construction phases were accomplished using local cement, produced in Manitoba. These cements had different characteristics, and none of the concrete at Pointe du Bois made using these later cements have exhibited significant deterioration due to ASR. The aggregates used at the project were locally-sourced granitic deposits.

Langdon & McPhail (1994) provide a detailed discussion of AAR at the Pointe du Bois GS.

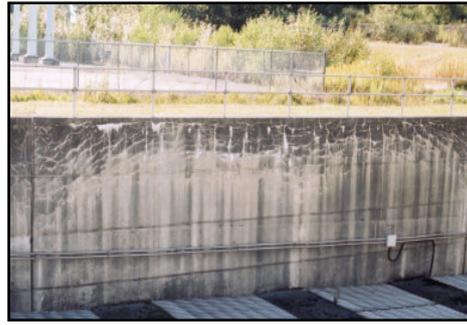
Figure 3: Massey Tunnel walls, Hwy 99, Delta-Richmond BC

Figures 3 to 5 illustrate some examples of AAR in British Columbia. Examples of DRI evaluation samples are shown in Figures 6 to 7. Reaction rims on reacted aggregate particles, ASR gel in cracks, air voids and on fracture surfaces, and cracks in aggregate and through paste are observed in these photos.

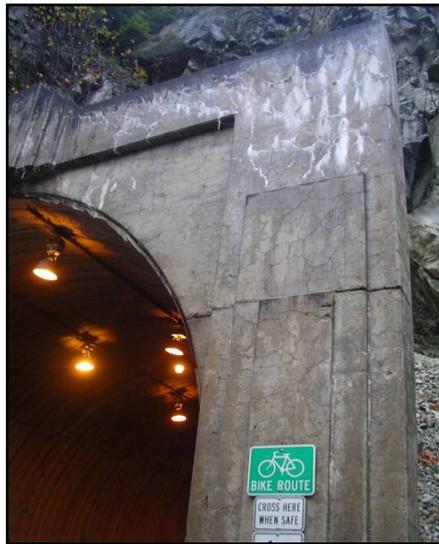
Figure 4: Saddle Rock tunnel, Hwy 1 north of Yale BC

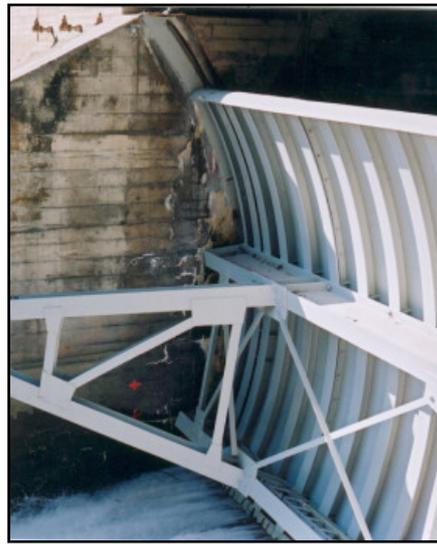
Figure 5: Radial gate wall of a dam in southern BC exhibiting ASR distress

In the second instance, suspected ASR was confirmed in a dam suffering from jamming of the radial gate, but only after foundation/geotechnical assessments were carried out to verify that settlement had not affected the operation of the radial gates. Progressive/cumulative expansion of concrete elements in the dam had not been noticed until the structure was some 30 years old, at which time, modification of the radial gate to operating condition had to be undertaken roughly every five years, thereby providing an indication of the rate of expansion.

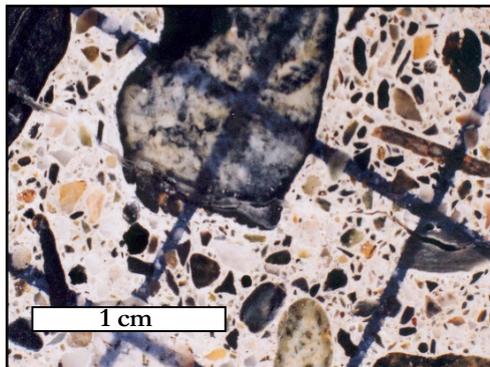
Figure 6: Damage Rating Index sample of polished concrete, showing ASR-gel-filled crack and reaction rims on aggregate.

In many cases, the effects of AAR are observed to be ‘masked’ in the structure by distress caused by freeze-thaw activity and/or reinforcing steel corrosion. Use of Petrographic-based methods such as the Damage Rating Index (DRI) have been found to be useful in distinguishing between the effects of AAR and those caused by corrosion or freeze-thaw cycles.

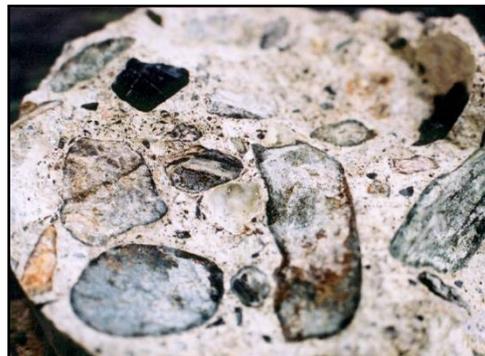
Figure 7: ASR gel, reaction rims on aggregates on sample of concrete from dam, Southern BC.

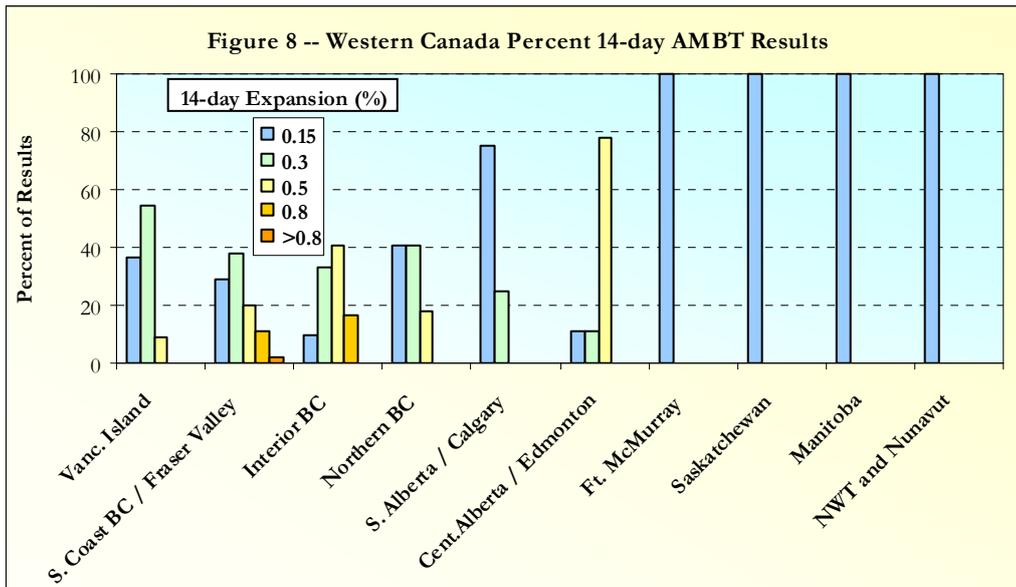
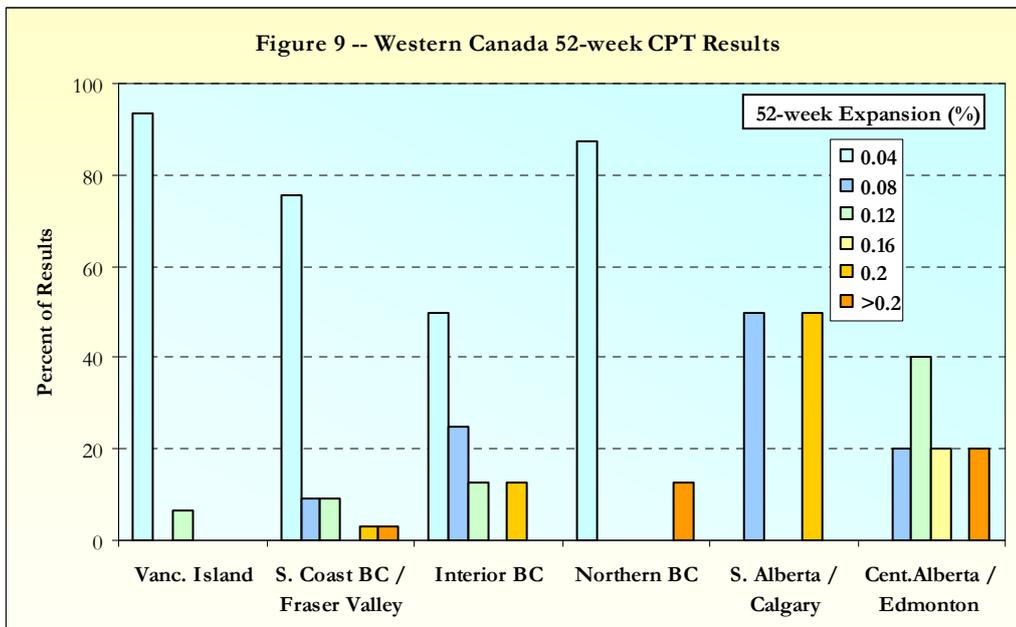
AAR data for Calgary and southern Alberta are illustrated in Figures 8 and 9. Reactive rocks in this region include volcanic rock, sandstone, chert and quartzite.

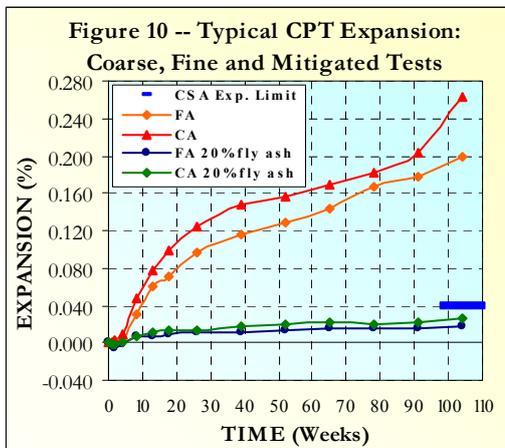
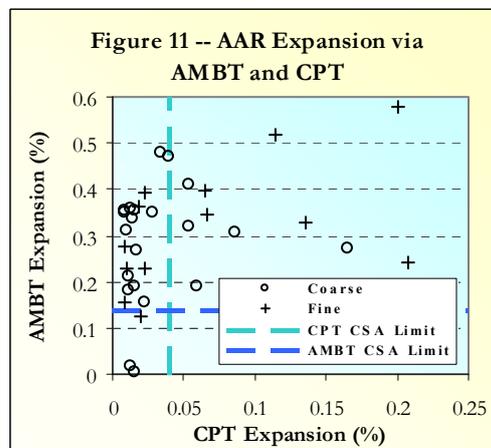
On the basis of numerous testing programs, it is apparent that many western Canadian aggregate sources exhibit differential expansions for fine and coarse aggregates, wherein the fine aggregates exhibit expansion levels that are usually higher than those of the accompanying coarse aggregate fractions. This is depicted in Figure 10.
