A REVIEW OF ALKALI-SILICA REACTIVITY IN TURKEY: A CASE STUDY FROM IZMIR, WEST ANATOLIA

Abstract

A review of the alkali silica reaction (ASR) history in Turkey is presented in this paper including case studies from the vicinity of Izmir. The first case of ASR in Turkey has been detected in the bridges that were built from mid-eighties to mid-nineties in this region. This paper includes some recent findings from detailed petrographic examination of ASR gel found in the concrete cores taken from these bridges and concrete alkali budgets estimation. It was no surprise that the map cracks in the concrete pavements of Izmir Adnan Menderes Airport was also due to ASR since they contain reactive sand and built in a similar period with the deteriorated bridges. ASR in the apron concrete was analysed by microstructural methods and concrete mix design was estimated. Today, non-reactive crushed limestone aggregate is used in concrete production in Izmir and no evidence of ASR is observed in the structures that were built after mid-nineties.

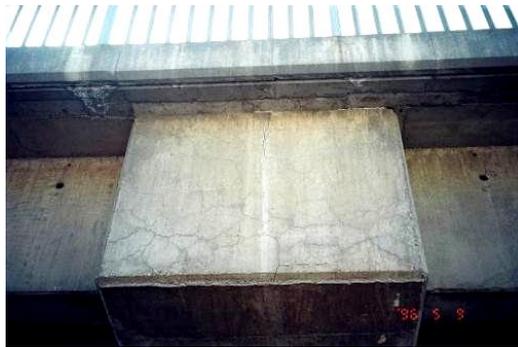
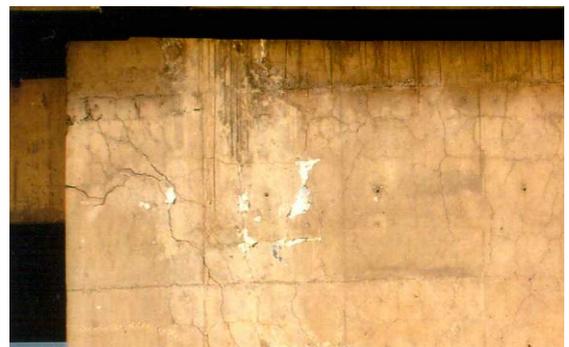
Figure 1: ASR map cracking on the bridges in the vicinity of Izmir

First AAR damage in Turkey was observed during a routine inspection of highway engineers in 1995. Extensive cracks were discovered on the decks, piers and abutments of six highway bridges (Naldöken, Turgutlu, Buca, Hilal2, Halkapınar and Turan) along with other structures which were all built in a period from mid-80s to mid-90s in the vicinity of Izmir (see Figure 1). The deteriorated bridges were investigated as a part of the study on the maintenance and rehabilitation of highway bridges in the republic of Turkey in which Oriental Consultants Co. Ltd. and Japan Overseas Consultants Co. Ltd. and Turkish General Directorate of Highways (KGM), funded by the Japan International Cooperation Agency (JICA). The findings of this study were reported by Tetsuya Katayama, who was chartered by JICA, for KGM engineers in Ankara, Istanbul and Antalya in May, 1996 [2], and were later published as the first international documentation on the occurrence of AAR in Turkey [3]. It was stated that the local sand-gravel particles from Gediz and Nif river systems containing more than 3% reactive glassy rhyolite were the cause of deleterious ASR expansions of several concrete bridges in the Izmir area.

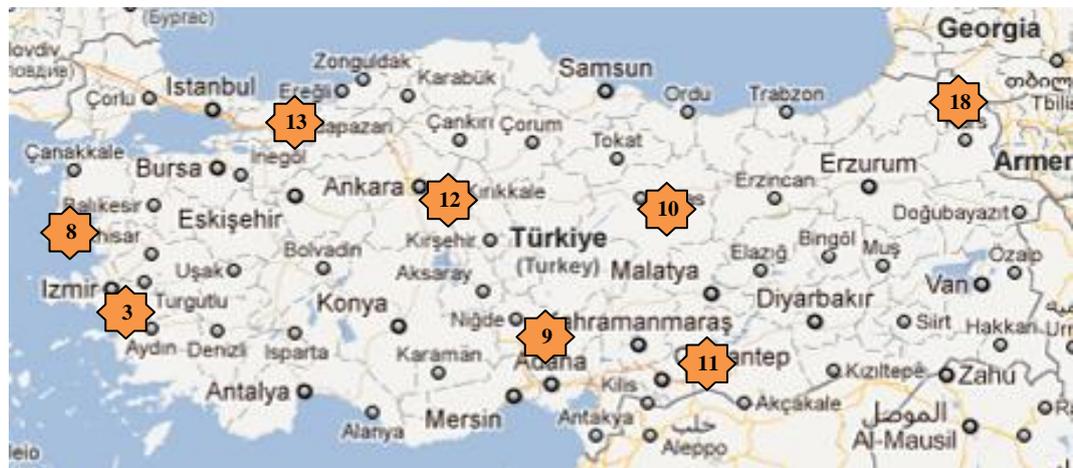
Figure 2: Representation of reactive aggregate sources on the map of Turkey [14]

In the beginning of 2000s, utilization of local mineral admixtures in concrete mixtures containing local reactive aggregates was studied by many researchers [4-6] and the documentation of deterioration has been continued [7]. Many other aggregate sources in the country were also found to be reactive; including Bozdivlit basaltoids from Aliaga [8], basalts from Nigde [9], sand and gravel from Koc River [10], sand from Firat (Euphrates) River [11], cherts from Ankara [12] and sand/gravel from Sakarya [13] as represented in Figure 2 [14],

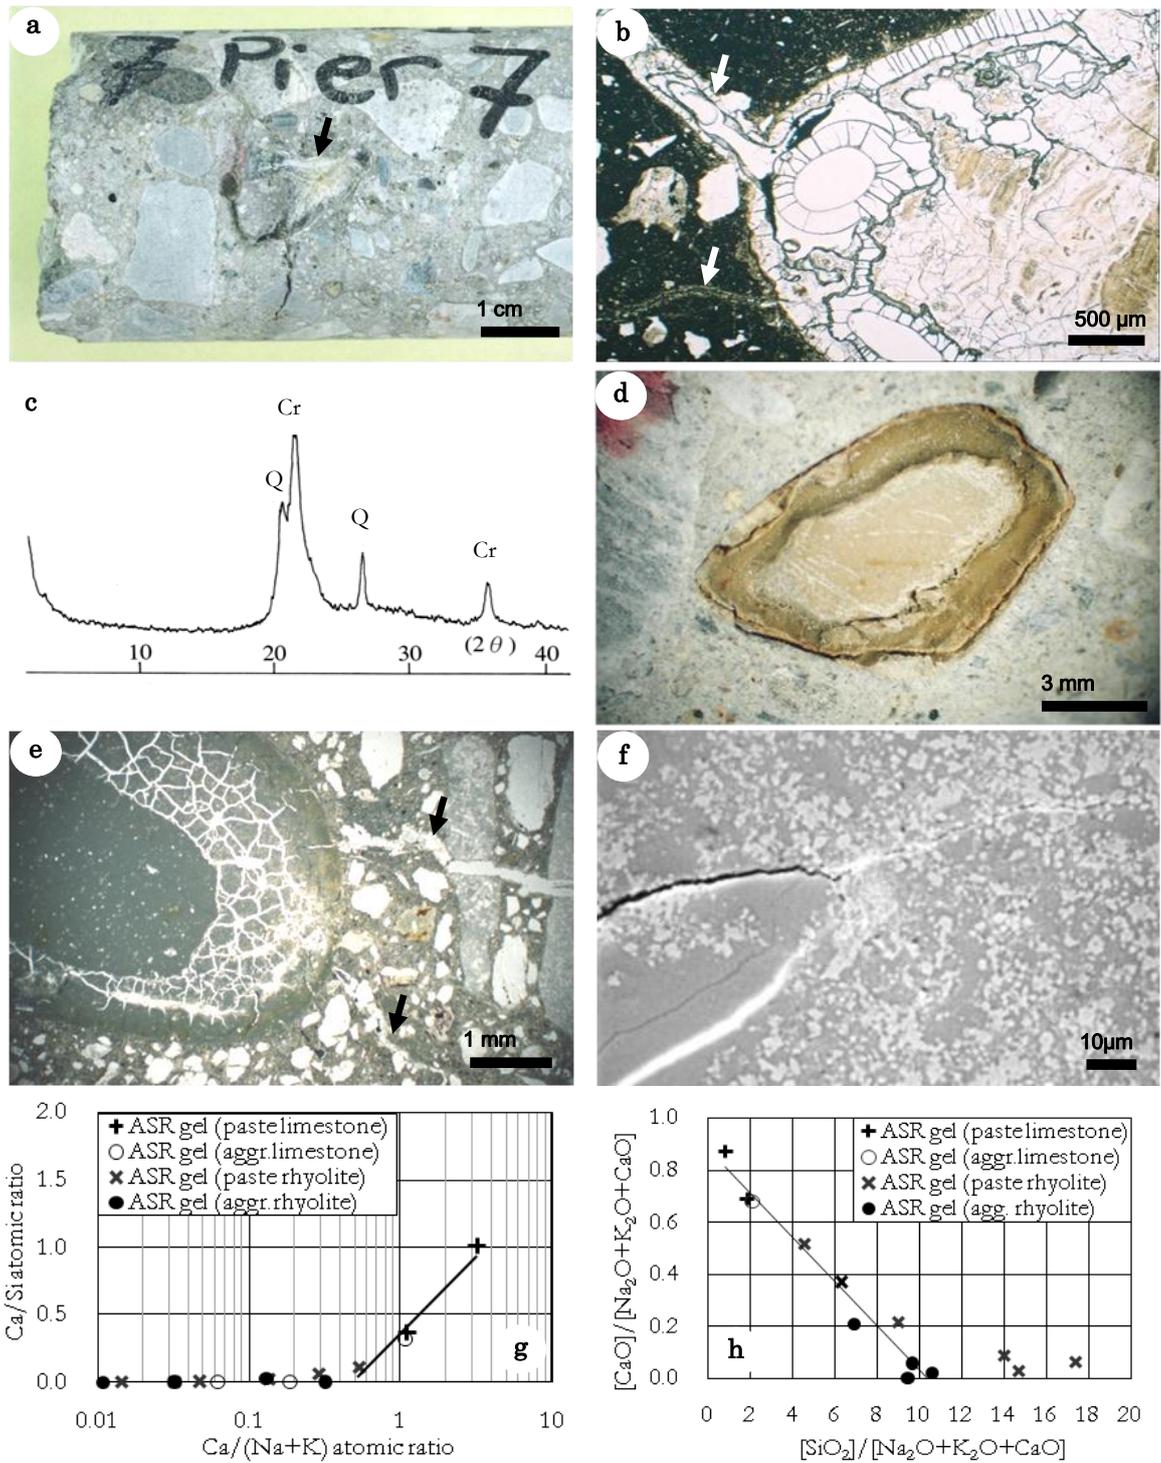
Figure 3: ASR gel in Hilal-2 bridge, Izmir: a) pop-out 1 week after coring, b) on glassy rhyolite particle c) rich in cristobalite. d) Rimmed limestone particle with e) radiating expansion cracks, originated from siliceous fossils now being replaced by ASR gel. g),h) compositions of residual ASR gel after separating alkali-rich sol during storage.

A glassy rhyolite particle with a milky white tint, rich in cristobalite due to incipient devitrification as indicated by XRD analysis, popped out 1 week after coring (Figures.3 a,b,c). This resembles in appearance and mineralogy Whakamaru rhyolite in New Zealand with a marked pessimum proportion of 10%. A siliceous limestone developed conspicuous reaction rim and radial expansion cracks (Figures.3 d,e) coming from siliceous fossils now being replaced by ASR gel (Figure.3f). Active ASR gel separates alkali-rich ASR sol during storage, leaving siliceous ASR gel [19]. Recently, ASR gel in the polished thin sections from the deteriorated concrete (Hilal-2), stored for 11 years (30mm by 20mm, thickness 15 μ m), were analysed by EDS in Japan (JEOL JED2140, 15kV, 0.12nA, data acquisition time 100s, dead time 35%). Compositional trends of such residual ASR gel in the reacted rhyolite and limestone particles are shown in Table 1 and Figures.3g,h.

Typical ASR gel formation was observed in the deteriorated bridge and apron concretes. With the concrete from the affected bridges, active ASR gel separated alkali-rich ASR sol, leaving siliceous ASR gel during long-term storage, even on the thin section. Such residual ASR gel in the reacted rhyolite and siliceous limestone (Hilal-2) presented an increase in the CaO content with decreasing alkali content.

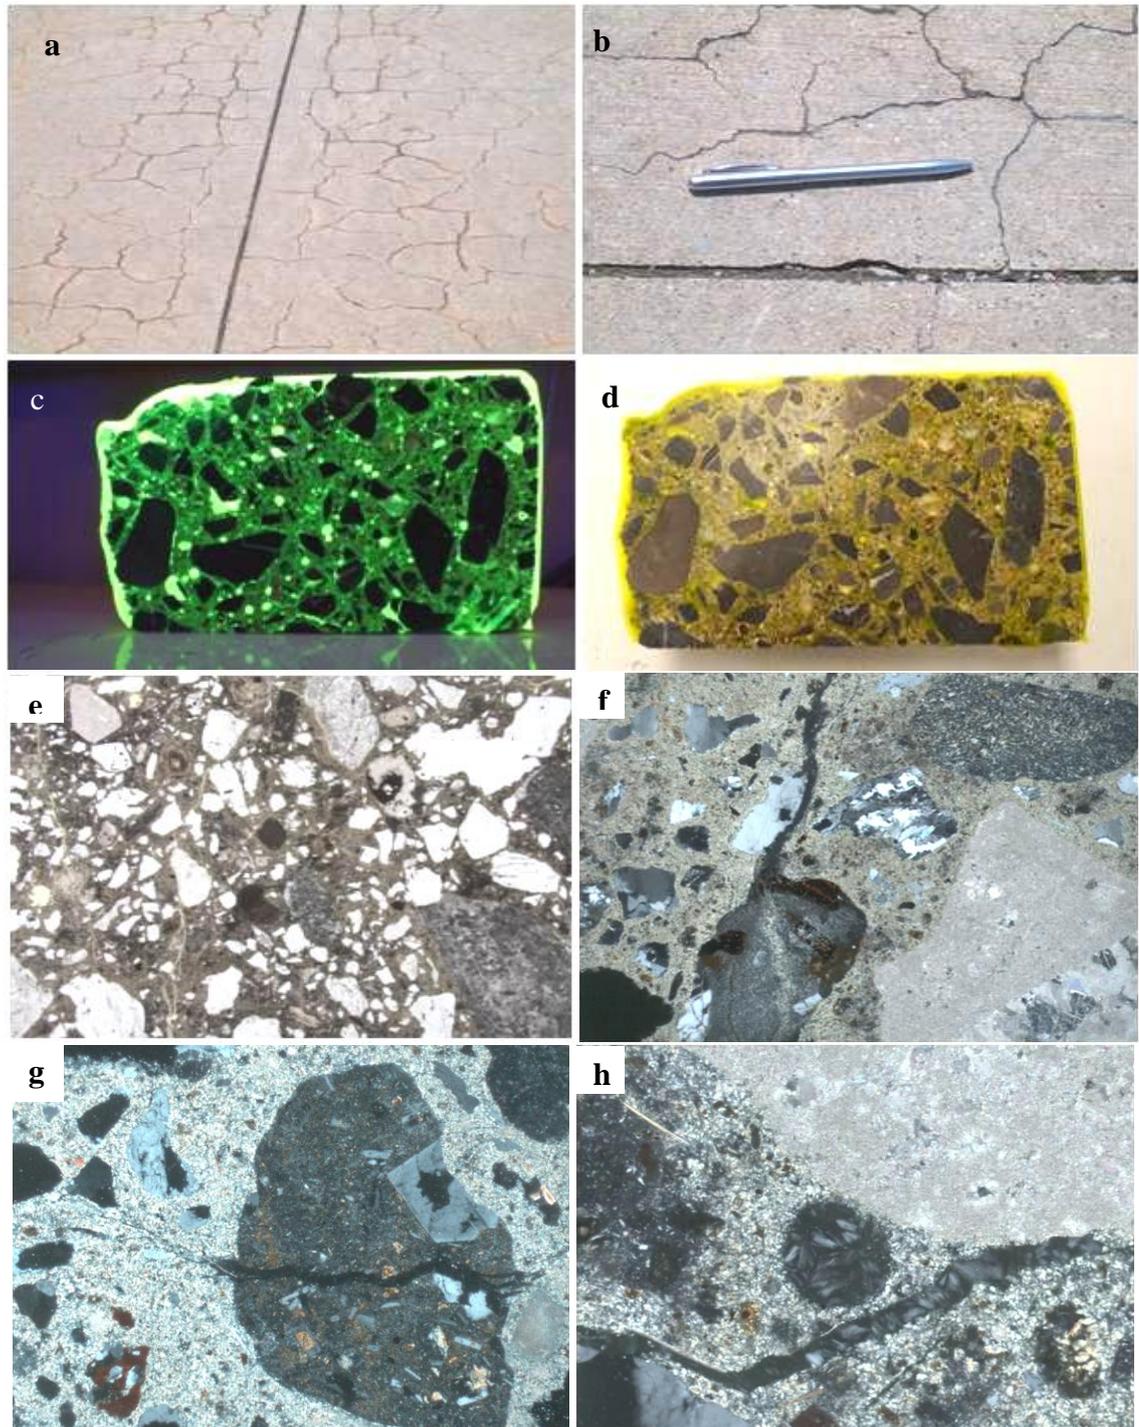
Figure 4: a,b) ASR map cracking observed at ADB apron and taxiways, c),d) Epoxy impregnated polished sections from ADB apron concrete, e)-h) Optical photomicrographs of the ADB concrete. e) Very wide field of view [\leftrightarrow 11.5mm]. PPL image, f) A typical ASR crack formed by a glassy rhyolite sand particle. XPL image, Field of view [\leftrightarrow 2.87mm], g) ASR gel exuding along the crack from glassy rhyolite sand particle. XPL image, [\leftrightarrow 2.1mm]. h) Ettringite precipitation within the air voids and cracks that connect and skirt the particles of both coarse and fine aggregates. XPL image, Field of view [\leftrightarrow 0.71mm].

The deteriorated apron and taxiway concrete pavements of Adnan Menderes Airport (ADB) (38°17'21"N 27°09'18"E) located in Izmir, Turkey were investigated. The deteriorated apron and taxiways were built in 1985 as an addition to other existing airport structures. During this construction, it was stated by the authorities that the concrete was produced by using the same aggregate sources as that were used in the deteriorated highway bridges. Approximately five years after the construction of above-mentioned parts, the operation engineers observed a closing of construction joints and cracking. Until 2004, the signs of deterioration have increased while concrete continued expanding, thus, a renovation has become a necessity. Site observations revealed extensive map-cracking and moving joints while the old apron and other airport buildings showed no sign of deterioration. The photographs shown in Figures 4. a,b were taken during the main author's site visit just before the renovation in 2004.

From the ADB apron, a 100mm dia. core was extracted for characterization. The core was sawn into two pieces: one was used for thin and polished section preparations, while the other was completely epoxy impregnated and polished for general examination. During the preparation of thin sections, all the cutting, grinding and polishing processes were applied by using laboratory-grade ethanol as the coolant/lubricant liquid, although non-polar solvent is generally desirable to avoid the leaching of alkalis Na and K from ASR gel and deterioration of epoxy bonding. Before thin sectioning, small cuts of concrete specimens were impregnated with low-viscosity epoxy mixed with 1 wt% Hudson-yellow pigment (Figures 4.c,d).

Microstructure of thin and polished concrete sections was studied by polarizing microscopy, scanning electron microscopy and EDS microanalysis of ASR gel. Optical photomicrographs of the ADB concrete are given in Figures 4.e-h and SEM photomicrographs are given in Figures 5.a-c. Coarse aggregate was mainly composed of crushed limestone. Fine aggregate contained dominantly (>50%) quartzite and its fragments some of which may be potentially late-expansive. The remaining sand grains were essentially composed of

chert, alkali feldspar/plagioclase fragments, glassy rhyolite and weathered rock fragments. Photomicrographs illustrate reaction of sand particles, i.e. ASR gel exuded along cracks from the glassy rhyolite into cement paste (Figures 4f,g). Cracks in concrete presented a random network, originating from the reacted particles to pass by the surface of inert limestone (Figure 4h) and quartzite particles (Figure 5b), being filled with ASR gel. A typical qualitative EDS analysis of the ASR gel in the air void indicates that the gel was mainly composed of Si and Ca with minor amounts of alkalis Na and K, as shown by the spectrum of ASR gel in Figure 5.d.

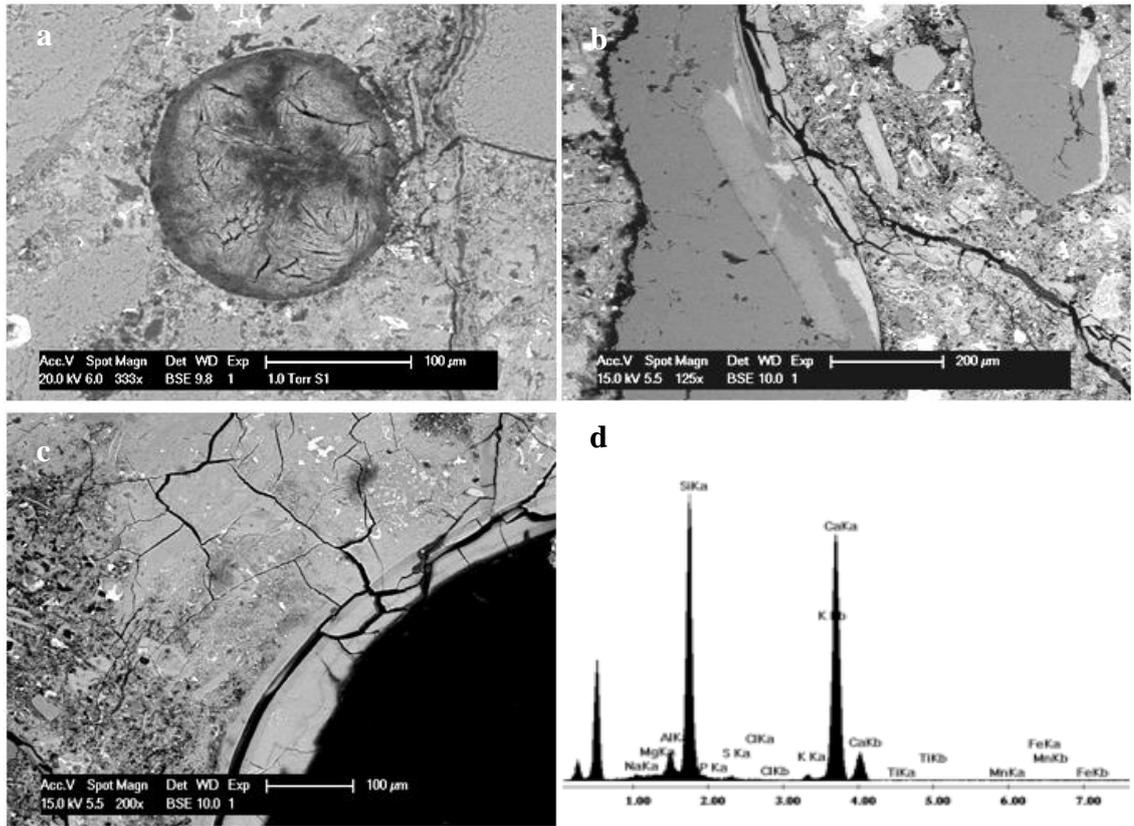
Figure 5: a) Secondary ettringite formation inside air void. b) Crack-filling ASR gel, partly skirting the sand particle of quartzite and extending from other reacted portion in concrete. Note the absence of ASR gel in the grain boundaries of quartz crystals within the inner periphery of this quartzite particle. c) ASR gel migrating into the wall of an air void. d) EDS spectrum of highly Ca-rich ASR gel in the air void.

The examined parts of the concrete did not seem to show any entrained air characteristics, although measured air content amounted more than 5% (Table 3). Available air voids and some cracks at the interfacial transition zones (ITZ) around the aggregate were significantly filled or lined with ettringite and portlandite (Figure 5.a). Since there is no information related back to the mix design of the airfield concrete structures built in 1985, it was decided to estimate concrete mix design based on the code of practice for the petrographic examination of concrete proposed by the Applied Petrography Group [20] and the references therein. As a result of the petrographic examination of thin and polished sections of the concrete, characteristic information on the concrete mix was obtained as shown in Table 3. The estimated W/C ratio of the concrete was between 0.48 and 0.50, while the cement content was found to be 250 kg/m³.

Regarding the environmental conditions of the region, the possibility of an external sulphate attack and freeze-thaw attack (related de-icing salt attack) was minimal. During the microstructural examination of ADB apron concrete, ettringite was observed inside the air voids and the cracks around the aggregate presumably created by ASR. Secondary ettringite formation is most probably related to ASR which is similar to cases previously reported in the literature [21, 22], but DEF in the cast-in-place concrete is likely related to the
