# STUDY OF THE EFFECTIVENESS OF LITHIUM AND SILANE TREATMENTS ON FIELD STRUCTURES AFFECTED BY ASR

Thano Drimalas<sup>1</sup>, Kevin J. Folliard<sup>1</sup>, Michael D.A. Thomas<sup>2</sup>, Benoit Fournier<sup>3</sup>, and Anthony Bentivegna<sup>1</sup>

This paper presents information two of the different demonstration projects undertaken under FHWA's *Alkali-Silica Reactivity (ASR) Development and Deployment Program*, with an aim at implementing in the field a number of techniques for mitigating the deleterious effects of ASR in highway structures. This paper presents data of highway bridge columns in Houston, TX and jersey barriers in Leominster, MA that were treated different types of products in order to minimize expansion. Novel techniques including electrochemical lithium impregnation and other forms of applications are presented herein. These long-term demonstration projects provide accurate field evaluations of concrete deteriorating from ASR. A number of techniques are used to monitor these sites with the results to date are shown in this paper.

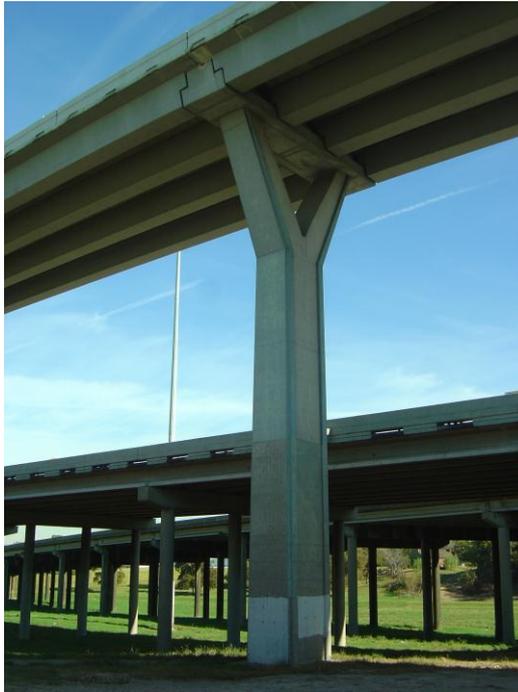
FIGURE 1: Photo of a typical bridge column treated in Houston, Texas

A stretch of columns in Houston, TX which were constructed in the late 1990's and is used to carry a high occupancy vehicle lane into downtown Houston, began showing signs of distress within a few years of service. An initial site visit was conducted in 2005, to evaluate the distress mechanism. Under the ASR deployment project, it was determined that ASR was occurring in the columns which led to the selection of 10 columns to determine the efficacy of various post treatments to slowdown or mitigate the ASR expansion. The ten columns were divided into groups with moderate to severe damage and low to moderate damage. Columns 31-36 are considered to be moderately to severely damaged, while columns 41-46 are considered to be slightly to moderately damaged. The treatments selected for each of the above columns are listed below:

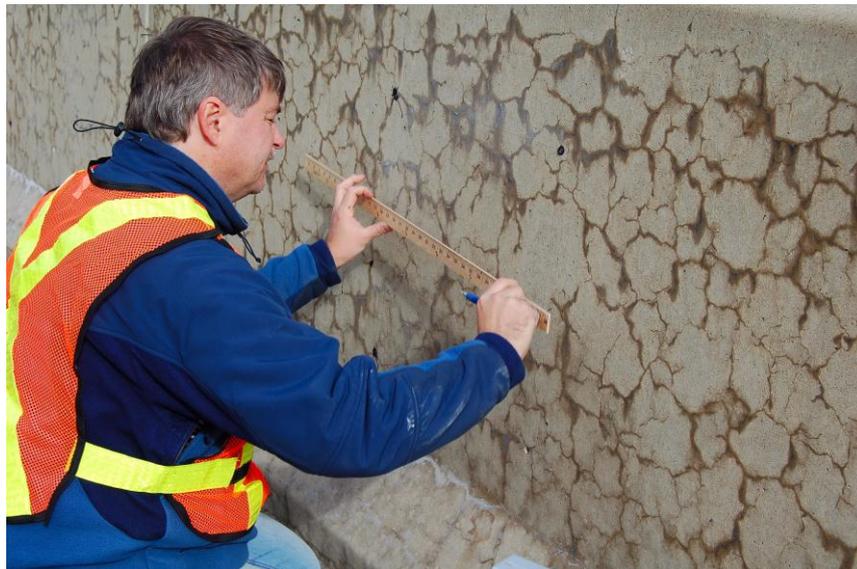
FIGURE 2: Photo of a typical Jersey barrier treated in Leominster, Massachusetts. A grid is being drawn on the surface of the barrier for the determination of the Crack Index [6].

Instrumentation and monitoring began in 2006 for these jersey barriers which included expansion measurements, relative humidity monitoring, and crack mapping. These measurements have continued since 2006 with measurements occurring once or twice a year. The majority of the testing segments have 2 monitoring sites per side. In addition, crack indices are recorded from each of the expansion measurement locations [6] (Figure 2).

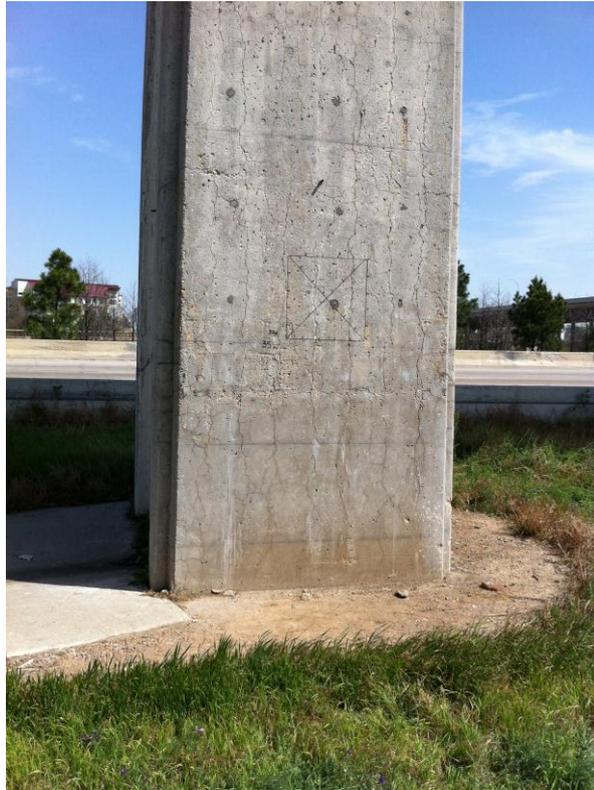
FIGURE 5: Etched surface from the electrochemical lithium migration column 46

difficult to compare treatments. The columns that are expanding include blasted surface treated with silane, electrochemical impregnation of lithium, and lithium impregnation by vacuum. The electrochemical treated column shows similar etching to the surface of that found on column 35. The electrochemical treated column by lithium provided the least prevention from both sets of columns. The blasted surface with topical lithium also expanded in both sets; however, the application of this silane over paint has provided successful results.
