# EVALUATION OF DAMAGE IN THE CONCRETE ELEMENTS OF THE VIADUCT “ROBERT-BOURASSA-CHAREST” AFTER NEARLY 50 YEARS IN SERVICE

The Robert-Bourassa-Charest viaduct (Quebec, Canada) has developed over the years clear symptoms of AAR-related damage. Several inspection surveys and analyses have confirmed that the coarse aggregate used in the construction (local siliceous limestone) was potentially alkali-reactive and for many years monitoring and laboratory tests were carried out on different elements of the structure. The demolition and replacement of the viaduct in 2010-2011 gave the opportunity for extracting and testing cores from different elements (concrete foundation blocks, columns and deck slab) of the structure, some of which had been repaired about 10 years ago using different approaches (sealers, polymer-based surface treatments and fiber-reinforced encapsulation). This paper presents the overall evaluation of the damaged elements of the viaduct through mechanical and microscopic tests, as well as in the visual inspections carried out prior to the demolition.

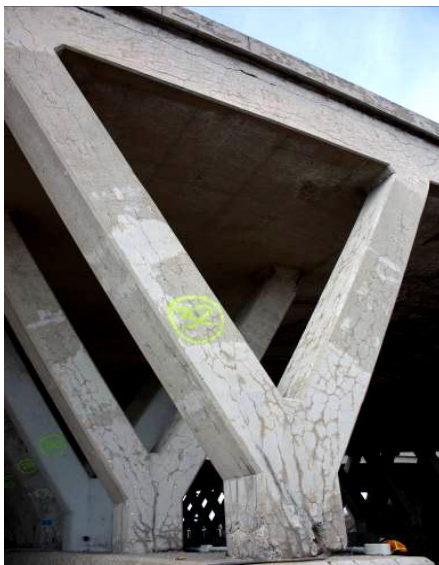
A

Table 2 gives a summary of the visual rating of the two columns examined. The column 32 (exposed) suffered a very high degree of damage with generalized oriented and pattern cracking, and concrete disaggregation (Figure 1 A). Moderate-to-high degree of cracking is also observed on the column 43 (not exposed) despite being protected from direct moisture by the bridge deck (Figure 1 B). For the foundations block, the extent of damage ranged from very severe (extensive cracking, concrete corrosion and spalling, disaggregation, pop-outs) in the exposed portions to fair in the protected (under the deck) areas (Figure 1 C and 1D).

Figure 1. Robert-Bourassa-Charest concrete elements: A. Concrete column 32 (exposed). B. Concrete column 43 (not-exposed). C, D. foundation blocks.

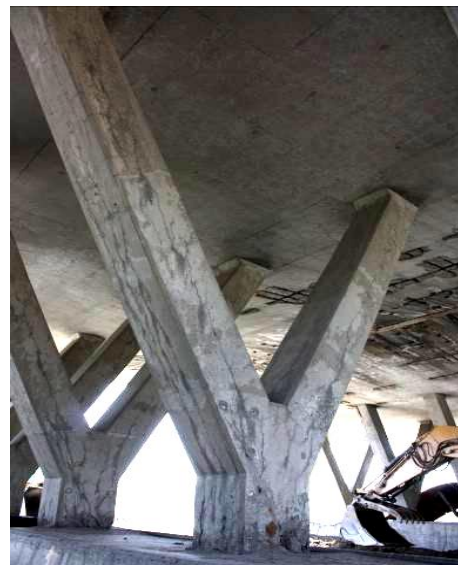
B

The responses of the test regarding the plastic deformation over the five cycles were almost the same as the hysteresis area, although the result obtained at the 20% loading for the column 32 was unexpected. It thus seem that for this parameter, as for the hysteresis, the use of 40% of the concrete mix-design strength as the loading test condition gives a better indication of the degree of damage of a concrete core. As for the cores from the foundation block, the values of plastic deformation when the average of the last four cycles is used, do not seem to be useful as they were quite arbitrary. The values of modulus of elasticity, as the average value of the cycles II and III or the average value of the last four cycles provided similar outputs for both loadings. Based on the outputs of the SDT, the internal damage in the non exposed (or protected) column 43 seems more important than that of the column 32. This may be surprising at first sight; however, the visual survey of the columns revealed significant cracking in the column 43 (Figure 1 D).

The samples presented a lower degree of damage (DRIs of 270 to 350) in comparison with those from the foundation blocks (DRIs of  $\geq 800$ ) (Figure 4). The cores from the non exposed column 43 presented a greater degree of damage than the ones from the exposed column 32. These results would seem surprising at first sight; however, they go in the same direction as those obtained in the SDT (section 5.2) and from the visual survey of the element, which show significant cracking in the column 43.

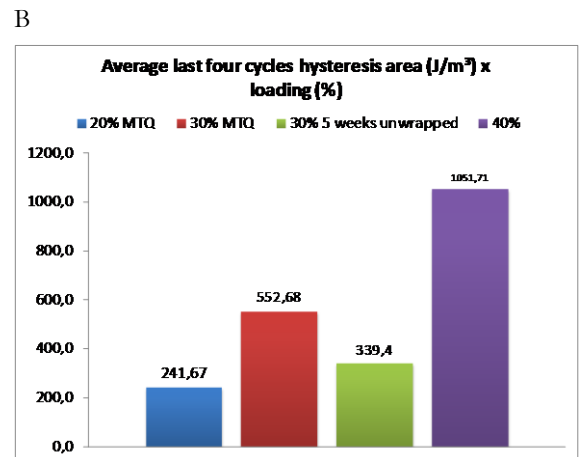
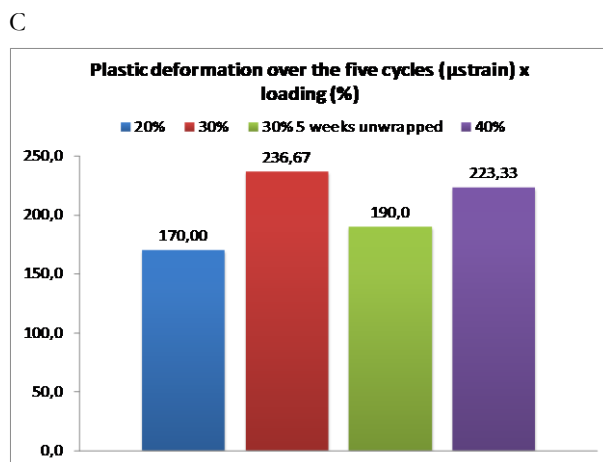
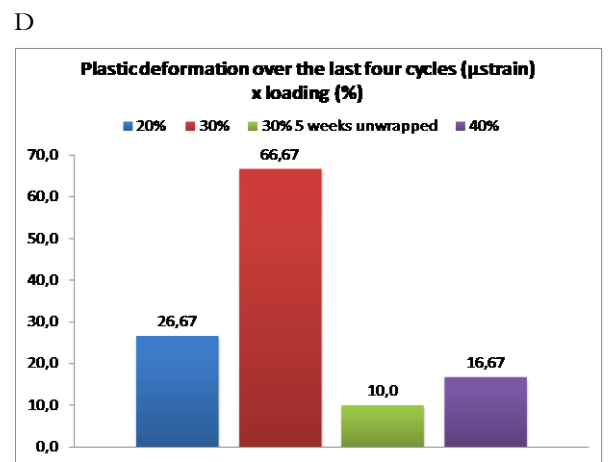
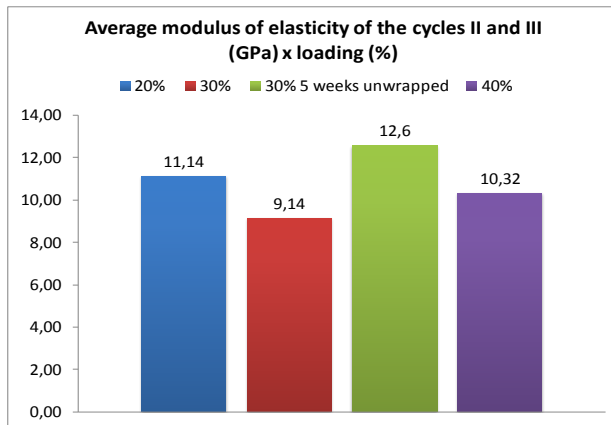
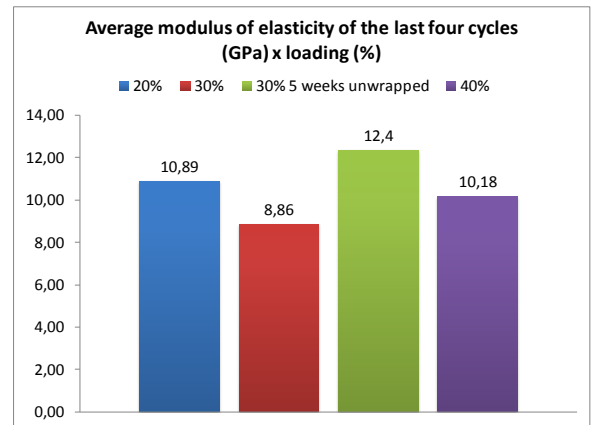
Figure 2. Responses of some SDT output parameters versus the loading applied (% of the concrete strength) for the cores from the foundation blocks.

Figure 2 presents the responses of some SDT output parameters when the test is carried out with the three different loadings mentioned before. It is possible to see that the greater is the loading applied, the larger is the hysteresis area either for the first or the last four cycles. However, the values obtained in the first cycle were about three times larger than those corresponding to the average value of the last four cycles. A somewhat similar response was observed regarding the plastic deformation, although the differences observed in the results of the hysteresis area for the first cycle at 30% and 40% of the design load are quite similar (likely due to high variability between test specimens). The results of the modulus of elasticity as the average of the cycles II and III were the opposite of the plastic deformation (as expected). In the same way, the results of 30% and 40% were switched, and the damage variability of a heterogeneous material could likely explain this fact. The values of plastic deformation and modulus of elasticity for the last four cycles do not seem to be useful as the values were quite arbitrary (mainly for the plastic deformation).

Figure 2 also illustrates the effect of drying on the output responses in the SDT (for a loading applied of 30% of the concrete mix- design strength). The moisture “history” of the test specimen is a critical parameter as specimens subjected to an extended drying period prior to testing show a significant increase in stiffness (and modulus of elasticity) and therefore decreased hysteresis area and plastic deformation throughout the test (for the first and last cycles).

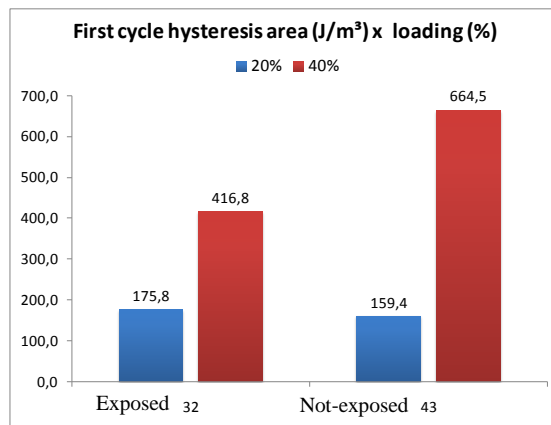
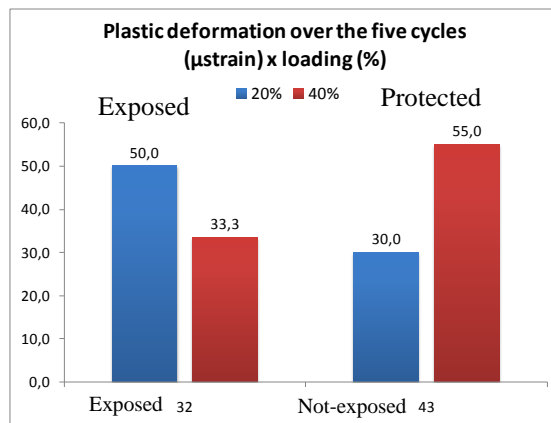
Figure 3. Responses of some SDT output parameters over the different loadings applied (20% and 40% of the concrete mix-design strength) for the two columns studied.

Figure 3 presents the responses of some SDT output parameters when the test is carried out with two different loadings (20% and 40%) on the cores extracted from the columns 32 (exposed to excessive moisture) and 43 (exposed to environment but protected from direct moisture). Once again, the greater is the loading applied, the larger is the hysteresis area, either for the first or the last four cycles. The values obtained

in the first cycle were about two times larger than those corresponding to the average value of the last four cycles. These differences are however lower for the columns than for the foundation blocks. As the level of damage in the foundation blocks is greater than for the columns, it seems that using data from the first cycle hysteresis in the SDT test method becomes more critical as the degree of damage increases in the concrete.
