# COMPARISON BETWEEN IN-SITU EXPANSION MEASUREMENTS ON AAR-AFFECTED BEAMS, DRILLED CORES AND LARGE SAWN SECTIONS

Ahmad Shayan and Aimin Xu

ARRB Group, 500 Burwood HWY, Vermont South, VIC 3133, Australia  
[Ahmad.shayan@arrb.com.au](mailto:Ahmad.shayan@arrb.com.au)

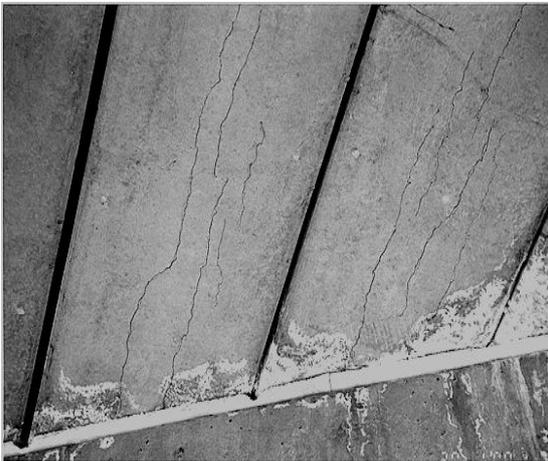
Figure 2- Longitudinal parallel cracking in the soffit of deck planks

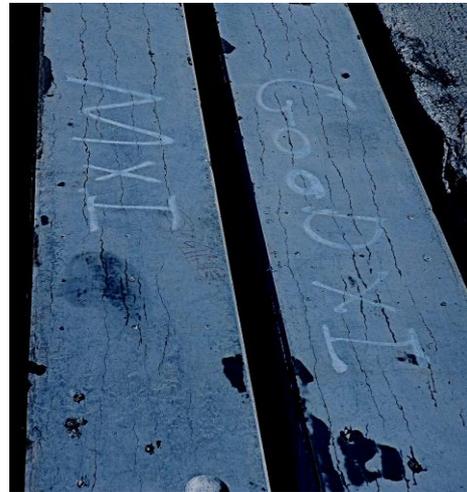
Figure 3- cracking in the soffit of planks M67 (left) and M12 (right) highlighted by wetting

Three planks of varying degrees of cracking were selected by the bridge owners for investigation, and labelled least cracked, intermediate and worst, based on their interpretation of the extent of cracking (Table 1). Figure 3 shows cracking in two of the planks. Eleven cores of 95 mm diameter were taken through the thickness of the whole plank (380 mm) from each of the three planks for various tests, including petrographic examination, scanning electron microscopy (SEM) and energy-dispersive X-ray (EDX) analysis, residual alkali content and cement

The soffit of all the planks showed distinct parallel longitudinal cracking as shown in Figure 3. More cracking existed on the side faces of planks M 26 and M 67 than in M 12. Core holes drilled from each plank showed that the longitudinal cracks penetrated to the depth of the prestressing cables. This was more evident on the slices of concrete cut off for expansion measurement. These cracks appeared to run parallel to the soffit, i.e., perpendicular to the direction of coring, and were seen as the delamination plane on cores. In cores from M 12 and M 26 only some of the drilled cores showed delamination at prestressing cables, whereas in Plank 67 all cores exhibited delamination.

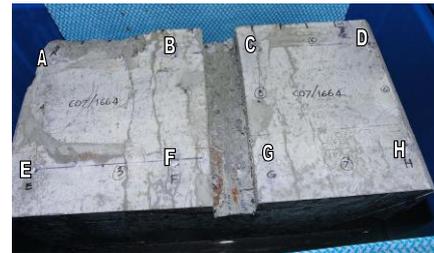
Figure 8- Expansion measured on the surface of sawn Block M26 in the transverse directions A-B, C-D, E-F and G-H, as well as longitudinally in the direction of the prestress D-H, C-G, B-F and A-E

The block cut from Plank M26 behaved quite differently, and transverse expansion was no longer larger than the longitudinal expansion. In fact, longitudinal expansion for most locations was larger than the transverse expansion. The reason for this observation is that Plank M26 was tested in flexure to failure, prior to the block being sawn off. This shows that the prestress was lost as a result of excessive flexure, and the sawn block no longer acted as a longitudinally restrained element.

Figure 8 shows that the block slightly shrank, rather than expand, in the transverse direction, and that the expansion in the longitudinal direction was rather small, with a maximum value of around 0.03%. This may have arisen because the flexure testing, and loss of prestress in the block, had generated sufficient space to accommodate the newly formed AAR gel (which would mitigate the expansion).

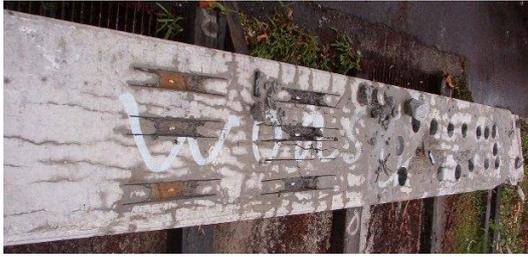
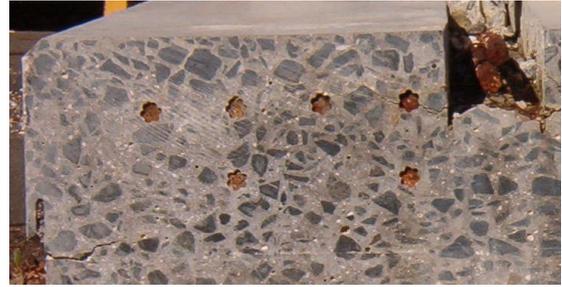
Figure 10- Left: Plank M26 after testing. The expansion measurements grid is on the far left. Right: retraction of prestressing cables (prestress loss) over the period of testing

Unlike the situation with the sawn block from Plank M26, where the prestressing had been lost, Plank M26 itself maintained its prestressing because the longitudinal expansion was far smaller than the transverse expansion. Plank M26 showed the largest transverse expansion amongst the three planks, and also exhibited up to 0.05% longitudinal expansion, whereas the other two planks recorded longitudinal shrinkage. This is believed to arise because Plank M26 was previously used for a test which involved stripping away the concrete from portions of several prestressing cables to determine their stress level, as shown in Figure 10, which also shows a portion of the plank cross section where retraction of the cables is evident. This reduced the level of prestress in the plank, and enabled larger expansion in the plank.
