ALKALI-SILICA REACTIVITY IN CONCRETE  
FROM DHEKELIA, CYPRUS

A. B. Poole

August 1975

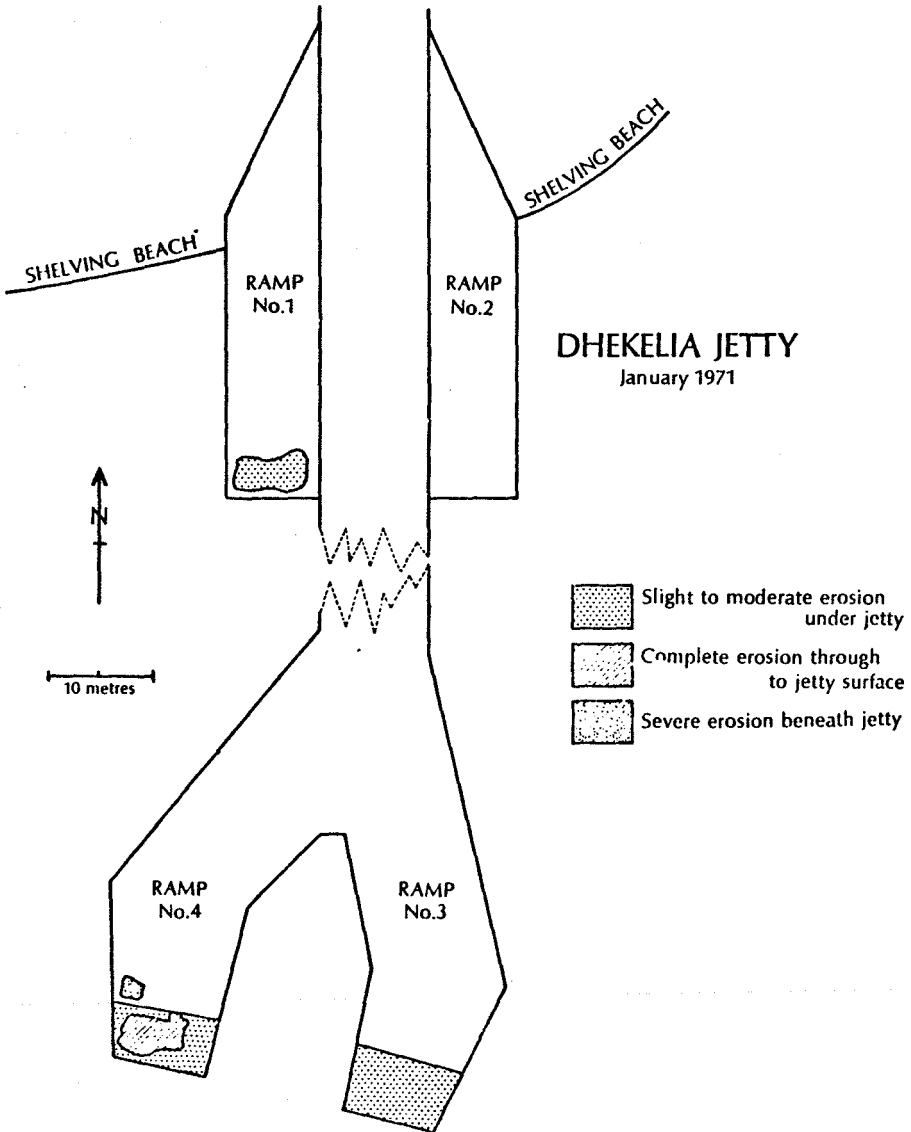
Figure 1

The structure consists of a reinforced concrete deck approximately 60 cm. thick supported on precast concrete piles about 2 metres above average high tide level. At the shore end of the jetty two ramps, one on each side of the main causeway lead down to sea level, and at the seaward end the decking divides forming a "Y" the arms of which also terminate in ramps leading down to sea level (Figure 1).

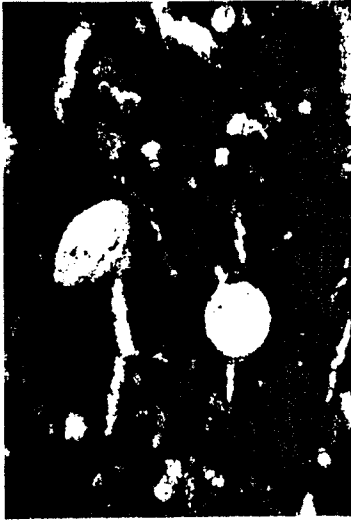
- A Development of gel filled cracks in opaline calcitic aggregate.
- B Development of a silica enriched rim and microcracks in reactive aggregate fragment.
- C Wide siliceous rim surrounding reactive aggregate (analyses 2,3 and 4).
- D Microcrack in reactive aggregate partly filled with gel. Zone surrounding the crack (L) leached free of calcium carbonate.

In broken pieces of concrete and on cut surfaces the most obvious features indicative of alkali-silica reactivity are the appearance of dehydrated silica gel, the extensive fracturing of the concrete with cracks which are filled with white dehydrated gel and the development of darker reaction rims up to 2mm. wide around the margins of the cream calcitic sandstone fragments. The dehydrated gel is readily identified by infrared spectroscopic analysis since certain absorption bands for silica gel and calcium carbonates in the 650 to 1600 wavenumber region are characteristic of these materials. The dehydrated gels examined in this work were all heavily carbonated, but in addition to calcite, aragonite is also present, presumably having formed either in a metastable state or under conditions of high pressure (5).
