Alkali-Aggregate Reaction in the Causeway Bridge, Perth, Western Australia

A. Shayan and C.J. Lancucki
*CSIRO, Division of Building Research
Melbourne, Australia*

ABSTRACT

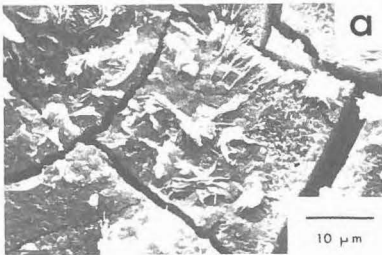
Fig. 5. Portions of gel in Fig. 3, partially (a) or fully (b) crystallized. Composition is largely Si and Ca with little K.

Microstructure: The gel shown in Fig. 3 was, in places, partially or fully crystallized (Fig. 5) into plate-like crystals which energy dispersive X-ray spectroscopy (EDS) showed to contain Ca, Si and small amounts of K, similar to the gel observed by Regourd *et al.* (1981). It is uncertain whether the crystallization occurred within the concrete *in situ* or after the reacted concrete was exposed to the atmosphere. In some portions of the gel, small islands of ettringite (identified by XRD) were observed on the surface of the gel, but they do not appear to be associated with the AAR (Pettifer and Nixon 1981).

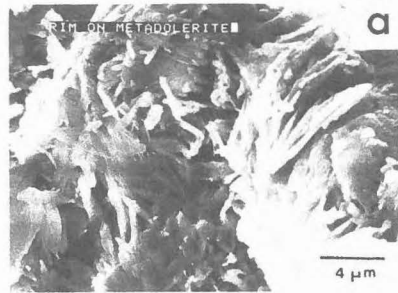
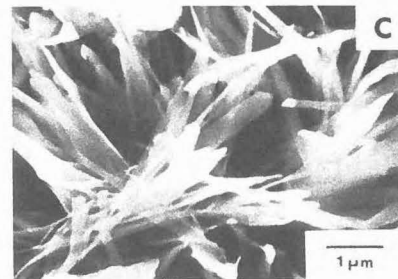
Fig.7. Various crystal habits from white reaction rim on metadolerite aggregates: (a) mixture of amorphous and crystalline material, (b) crystals not well formed, and (c) highly crystalline AAR products. All forms contain Si, Ca, Na, K.

The micromorphology of the white reaction rim on the aggregates varied considerably depending on the type of aggregate. Generally, rims on gneissic granite and quartzite aggregates were thinner and showed much less crystallization (Fig. 6) than those on metadolerite aggregates (Fig. 7). The regular rosettes of plate-like crystals (Cole *et al.* 1981, Regourd *et al.* 1981, Oberholster 1983, Fournier *et al.* 1985) were only rarely observed on the reacted metadolerite aggregates. The material that had filled some pores was massive initially, but developed poorly crystalline features after exposure to the atmosphere. Some reaction rims appeared also to be a mixture of crystalline and amorphous material. Despite morphological differences, all these materials contained qualitatively similar amounts of Si, Ca, Na, and K, except the gel in Figs 3 and 5 which did not contain Na, and its K content was small.
