Influence of the direction on alkali-aggregate reaction (ASR)-induced distress of reinforced concrete members

Robert-Bourassa/Charest (RBC) overpass (Quebec, Canada) was a concrete structure severely affected by alkali-silica reaction (ASR) due to the use of a highly reactive coarse aggregate (local siliceous limestone) in the concrete construction. Over the years, RBC overpass was monitored, and several laboratory test procedures were conducted on cores extracted from the different members of the structure. RBC was finally demolished in 2010-2011 and thus, two 3-meter sections of the reinforced columns, one coming from an exposed site and the other from a non-exposed location (i.e. under the bridge deck) were gathered and stored in the laboratory for further analyses. This paper presents the results of the multi-level assessment (i.e. microscopic and mechanical) performed on cores extracted from distinct directions (i.e. vertical, longitudinal and transverse) from the exposed and non-exposed RBC columns. Furthermore, the appraisal of the stirrups stress-state on the reinforced members was also performed. Results show that ASR-induced damage varies according to the columns exposur

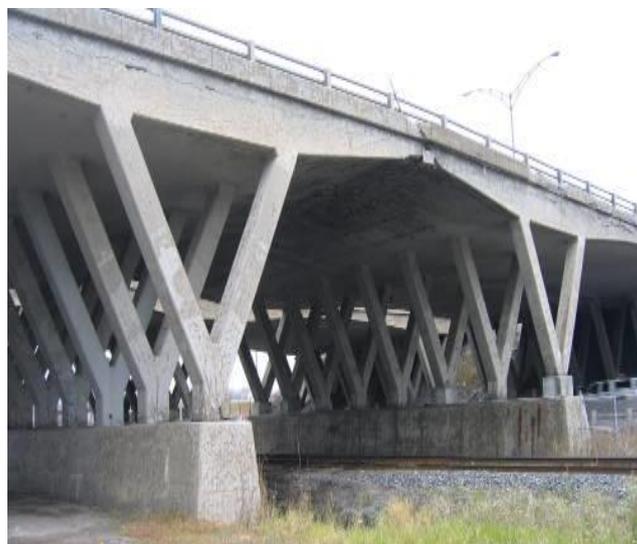
Figure 1.1: Robert Bourassa/Charest overpass

Robert-Bourassa/Charest (RBC) was a highway overpass built in 1966 using an alkali-silica reactive limestone aggregate (dark-grey, fine-grained Ordovician limestone). The structure was made of a deck resting on reinforced concrete Y-shaped columns, themselves supported by massive concrete foundations (Figure 1.1). Technical reports indicate that the 28-day concrete design strengths were 24 MPa for the foundation blocks and 28 MPa for the columns and decks; however, no specific information is available on the concrete mix-designs used for construction [1].

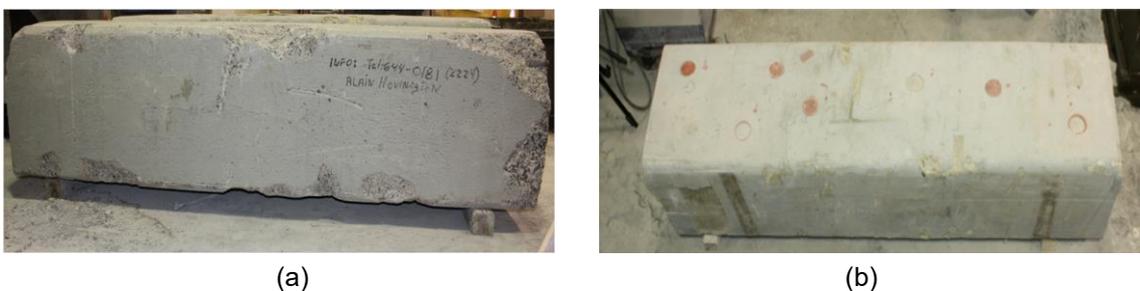
Figure 3.1: (a) Non-exposed column, (b) Exposed column

Cores were drilled along the three main directions longitudinal, vertical and transversal (identified as L, V and T in this work) from two 3-meter sections of RBC reinforced columns (one coming from an exposed site (E) and the other from a non-exposed location (NE)), both illustrated in Figure 3.1. Once extracted, all cores were saw cut to have 100 by 200 mm in size, wrapped in plastic film and stored at 12°C to stop further ASR development.

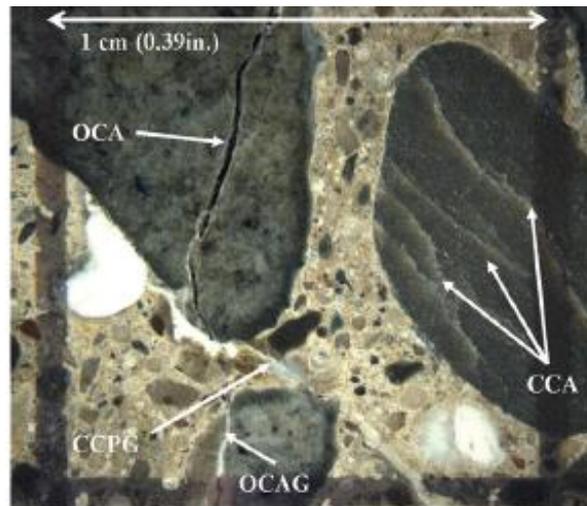
Figure 3.2: Petrographic features of different cracks [11]

Some of those features can be seen Figure 3.2, such as open cracks in the aggregate (OCA), closed cracks in the aggregate (CCA), open cracks in the aggregate with gel (OCAG), and cracks in the cement paste with gel (CCPG).

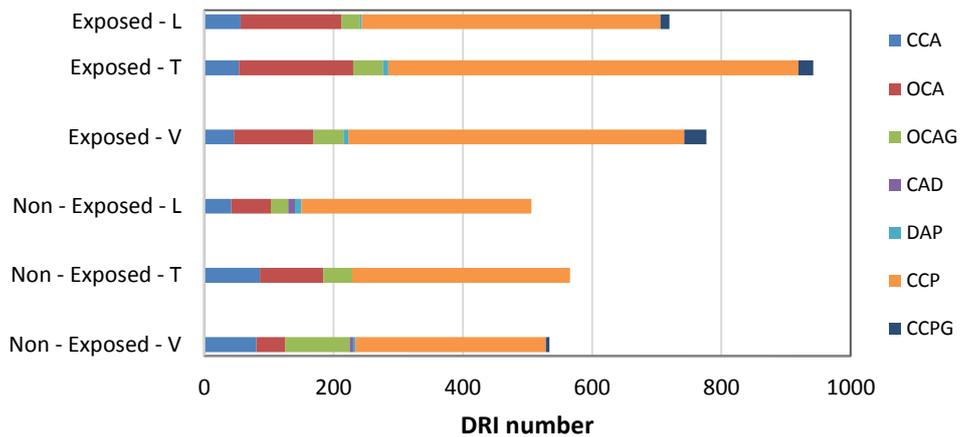
Figure 4.1: Graph illustrating the DRI values for the concrete showing two types of exposure, for three different directions

Figure 4.1 gives a plot of the DRI numbers as a function of the exposure and direction of the cores studied in this work. First of all, it is possible to observe that all samples presented some closed cracks within the aggregate particles (CCA - blue charts). This petrographic feature is not necessarily related to ASR development but rather with the aggregate’s crushing and or weathering processes. However, all the cores evaluated in this work presented important amounts of open cracks with or without gel within the aggregates (OCA and OCAG - red and green charts, respectively) along with cracks in the cement paste with and without gel (CCP and CCPG – orange and dark blue charts). All these features clearly indicate the presence of ASR deterioration.

Analyzing Figure 4.1, one verifies that the DRI numbers from the exposed columns roughly varied from 720 to 942, whereas from 506 to 566 for non-exposed columns. The latter seems to indicate that the exposure conditions indeed influence ASR-induced development, as expected. Furthermore, distinct DRI results were also found as a function of the cores direction. For both columns, the transverse cores yielded higher damaged (i.e. DRI numbers), followed the vertical and longitudinal cores. These results were more evident for the exposed columns.

In this work, the DRI and SDT tests were conducted and the DRI number, SDI and PDI parameters were determined for cores extracted from distinct directions from exposed and non-exposed columns. The DRI values obtained indicate that the amount of damage found for the exposed columns is greater than the non-exposed one. Moreover, distinct values were obtained according to the cores' direction, especially for the E column.

The DRI number of the NE column indicate that the expansion levels reached as per Sanchez et al. [16] were 0,12%, 0,12% and 0,12% for the longitudinal, vertical and transverse directions respectively. Likewise, 0,20%, 0,20% and 0,30% expansion were gathered for the E column samples in the longitudinal, vertical and transverse directions, respectively. Moreover, for both columns, an important number of cracks in the cement paste was observed (CCP) which indicates a severe ASR-induced development at both structural members. Moreover, it is not discarded that some of the measured deterioration in the cement paste might have taken place due to freeze-thaw cycles, which are very common in Canada. Finally, it is important to notice that ASR-gel could only be observed in the cement paste (CCPG) on the exposed columns samples, emphasizing once more the influence of exposure conditions on ASR development, since this feature is associated with high to very high expansion levels (>0.20%).

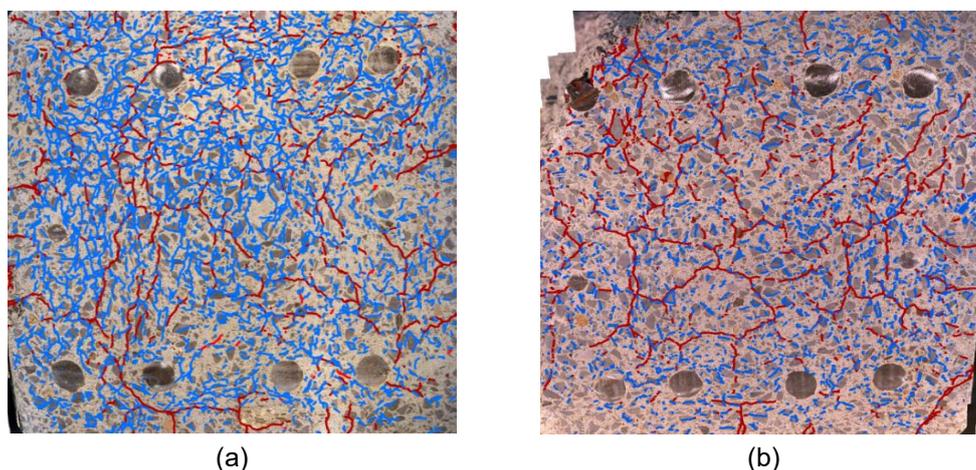
Figure 4.2: Micro/macrosopic distress features: (a) Exposed column, (b) Non-exposed column.

Figure 4.2 illustrates the image analysis conducted through the *ArcGIS* software for both E and NE columns ends.

Evaluating the images above, one verifies that both columns present an important amount of macrocracks (i.e. cracks greater than 0.3 mm - red traces). Moreover, it seems that the macrocracks number is quite comparable for non-exposed and exposed columns. Conversely, the amount of microcracks (i.e. cracks smaller than 0.3 mm – blue traces) is very different from one column to another; the exposed column presents a much higher amount of microcracks when compared to the non-exposed column. Furthermore, and interestingly, the majority of the macrocracks (although not all of them!) seem to be aligned from the top to the bottom of the cross-section of the columns. The latter is in agreement with the stress-state of the columns and DRI results, since the transverse direction presents the least

restrained direction and thus more expansion is expected; therefore a higher amount of open cracks is expected to be developed perpendicularly to this direction.

The image analysis conducted in this work was able to provide a great insight of the crack's propagation inside the column, especially within the reinforcing cage. As it could be observed, both, E and NE demonstrated to have nearly the same amount of macrocracks (i.e. > 0.3% mm). However, the number of microcracks (i.e. < 0.3 mm) are considerably higher in the exposed column. Furthermore, the image analysis highlighted (although only qualitatively for the time being), that the majority of macrocracks seem to be aligned from the top to the bottom of the cross-section of the columns. The latter is in agreement with the microscopic and mechanical results obtained in this work and indicate that further damage is obtained in the direction with the least confinement.

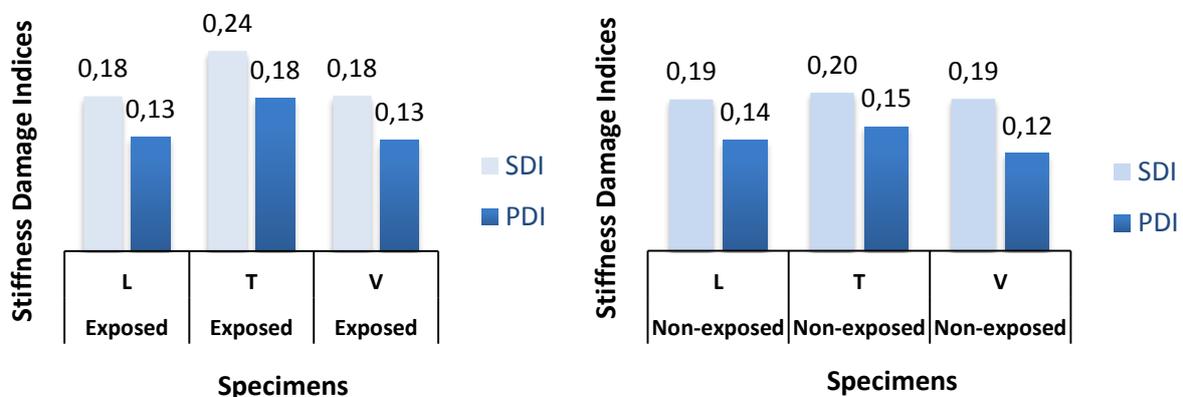
Figure 4.3: SDT indices measured in both non-exposed and exposed columns.

Figure 4.3 presents the average results of two SDT output parameters, as described by Sanchez et al. [4-8]: the *Stiffness Damage Index* (SDI), a measure of the dissipated energy caused by the closure of cracks under compression loads, and the *Plastic Deformation Index* (PDI), which quantifies the slipping across surfaces while the internal cracks close under compression loads. Both indices are a function of the extent of inner cracking present in a given material [4-8]. A full description of the SDI and PDI of the cores can be obtained in [12].

For the non-exposed column, the average SDI values ranged from 0.19 to 0.20, whereas from 0.18 to 0.24 for the exposed ones. Moreover, higher results were obtained in the transverse direction in both columns (direction of less reinforcement).

The SDI values obtained in this work were also interesting. For the NE column, very close, if not similar, SDI results were obtained as a function of the cores direction. Moreover, expansion levels of about 0.12% could be attributed to these cores as per Sanchez et al [16]. This result completely matches to the DRI number that did not yield significant differences on the distinct directions of NE samples.

Conversely, the cores extracted from E columns also presented similar average SDI values in the longitudinal and vertical directions (0.18-0.19), yet cores extracted transversely suggested a much higher degree of damage (average SDI of 0.24). The latter confirms the results obtained for the E column on the DRI. The above results are very likely linked to the confinement effects proportioned by the column asymmetric geometry and reinforcement character, which influenced the stress-state and consequently the direction of ASR-induced expansion and damage development. Such results were actually reported by [10] where heterogeneous 3D restraint in structural members were seen to enhance expansion in the direction of the least restraint.

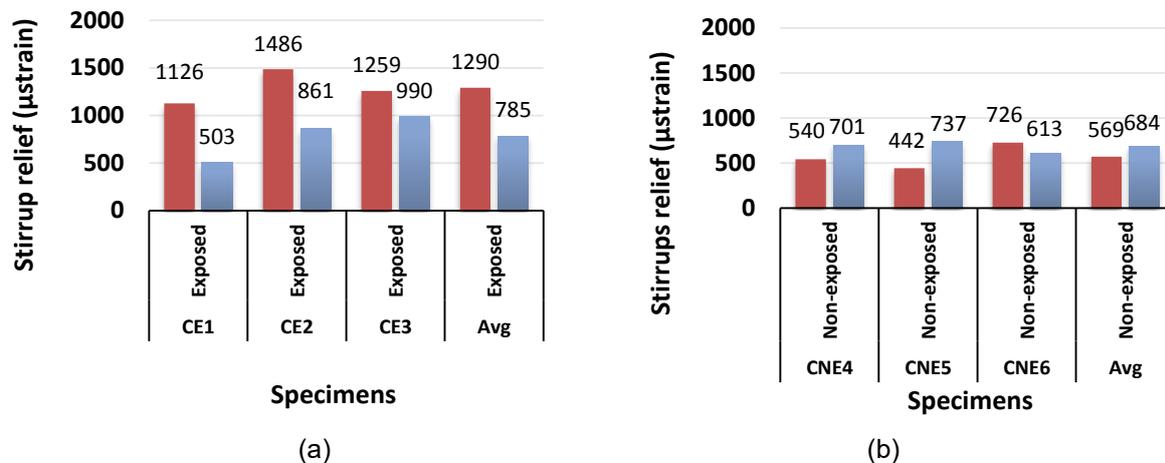
Figure 4.4: Stress-relief measured on the two columns after stirrups cutting: a) Non exposed column; b) Exposed column. Blue bars represent cuts at the stirrups' edges and red bars at the middle of the cross section.

The stress-relief (μ strains) following the cutting of instrumented stirrups from both columns is presented in Figure 4.4. It is worth mentioning that the columns were stored in the laboratory for several weeks before testing (i.e. no more live loads applied to the structural members); thus, it is fair to consider that the deformations resulting from stress-relief from the stirrups are entirely (or at least largely) related to ASR-induced expansion [12-15].

The stirrups cutting analyses were performed in two ways. First, after cover removal, stirrups were cut at their edges. However, since the stirrups are normally bent at the edges, sometimes attached and close to the columns ends, analyses were also performed in the middle of the column's cross section in order to verify whether higher, and probably more reliable, values could be obtained.

NE column stirrups presented lower deformation values compared to E column stirrups (as expected), especially when the analyses were performed at the middle of the cross section. Actually, comparing data from the edge cuttings (blue bars) and cuttings in the middle of the cross section (red bars), higher values were found in the middle for E column whereas for the edge almost similar values were found for both columns. This suggests that better and more reliable results are obtained from cuttings in the middle section of the stirrups. The average values obtained after cutting in the middle stirrup sections of the non-exposed and exposed columns were respectively 1290 and 570 μ strain.

Finally, the results obtained through the stirrups cutting showed that the E column stirrups presented a much higher stress-relief than the NE ones, as expected. Moreover, analysing the data from Figure 4.4, one verifies that the results obtained for the E column seem fairly high, especially because the columns were stored in the laboratory before testing and thus no live loads were still acting on the members when the stirrups were cut. Thus, those values might be directly linked to ASR-induced development and highlight a potential structural concern for stirrups yielding in ASR-affected structures.
