## Diagnosis and prognosis of ASR in an airfield pavement

### Abstract

**Keywords:** ASR; failure analysis; pavements; petrography; residual expansion

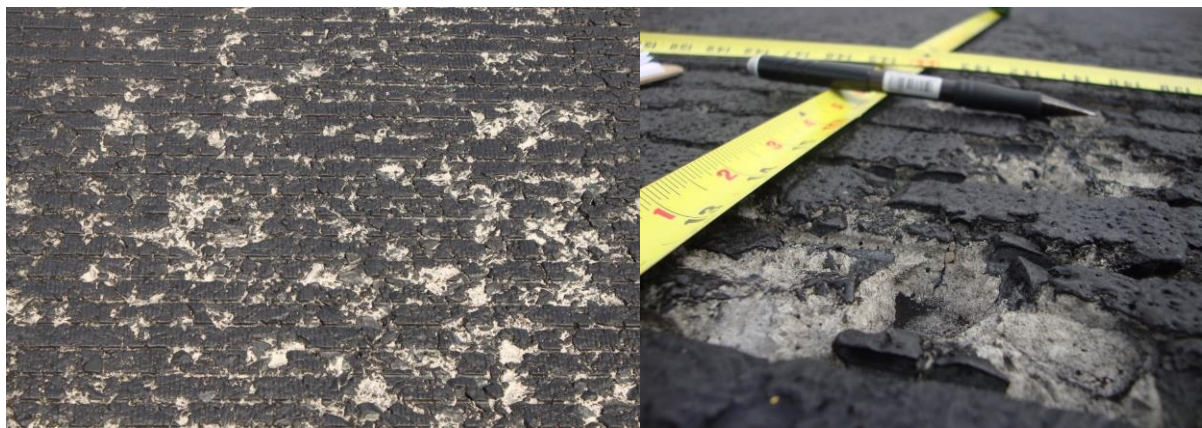
The site visits were made at night due to limited opportunities for runway closures. Figure 2.1 and Figure 2.2 show examples of the different modes surface distresses, photographed during the initial documentation of the pavement condition. Construction records were also examined to map the locations of each mixture design along the runway. Subsequent site visits were primarily conducted for sample extraction purposes.

Figure 2.1: Examples surface distress (popouts and loss of paste).

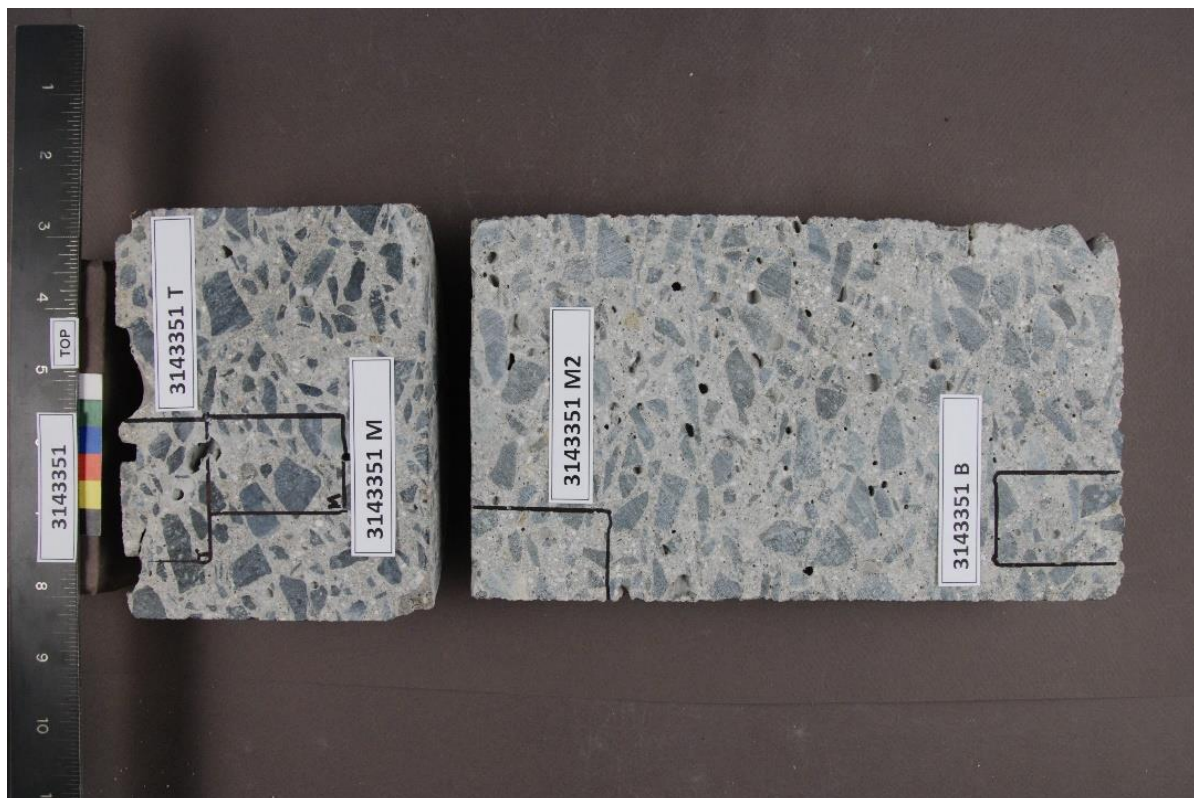
Three to four thin sections were prepared from select locations on the opposing slab to examine the concrete microstructure at various depths as indicated in the photographs in Figure 2.3. The thin sections were prepared from a 44 mm x 29 mm x 10 mm block that was vacuum-impregnated with fluorescent-dyed epoxy and mounted onto a glass slide. The thin sections were created to a thickness of 20 to 25  $\mu\text{m}$  using a Pelcon automatic thin section machine. The final polish was completed manually with a 0.25  $\mu\text{m}$  diamond oil to result in a highly polished surface for analysis. Thin sections were examined using polarized light microscopy (PLM) in plane-polarized and cross-polarized light modes at magnifications from 10x to 200x, and using reflectance fluorescent light at magnifications of 10x to 40x. The thin sections were finally examined using scanning electron microscopy with energy dispersive X-ray spectroscopy (SEM/EDS) on an ASPEX Personal SEM at magnifications of 20x to 2000x.

Figure 2.3: Photograph of cross-sectioned core showing locations of thin section preparation outlined in black.

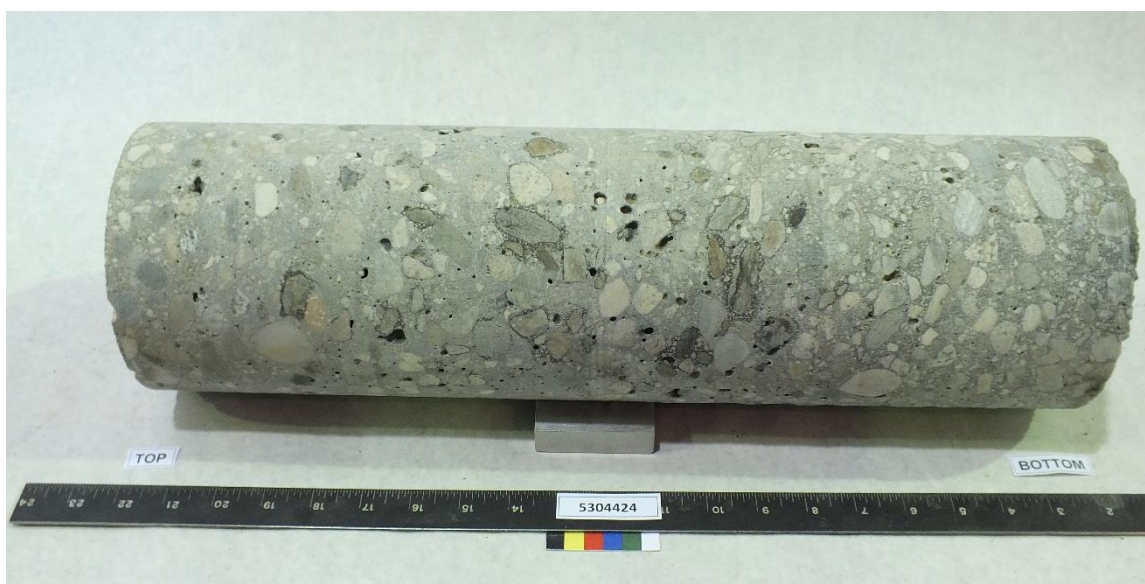
Petrographic evaluation of the cores representing the three different mixture designs verified that the concrete placed were generally consistent with the mixture designs described in project submittal documents. Visual examination of the cores received at the laboratory after air drying revealed that the cores extracted from Mix 1, which contained the natural gravel coarse aggregate (Coarse Aggregate 1 and Intermediate Aggregate 1) and no SCMs, exhibited damp patches or wet rims around coarse aggregate particles (Figure 3.1), a characteristic that is indicative of ASR [3]. Thin section evaluation using SEM/EDS confirmed the presence of slight-to-minor ASR; examples are shown in Figure 3.2. This primarily occurred within metagranite grains containing strained quartz (Figure 3.3), although a trace amount of rhyolite with amorphous or microcrystalline quartz was present in the aggregate population and also exhibited ASR.

Figure 3.1: Photograph of air dried core from Mix 1, showing wet rims around coarse aggregate indicative of ASR.

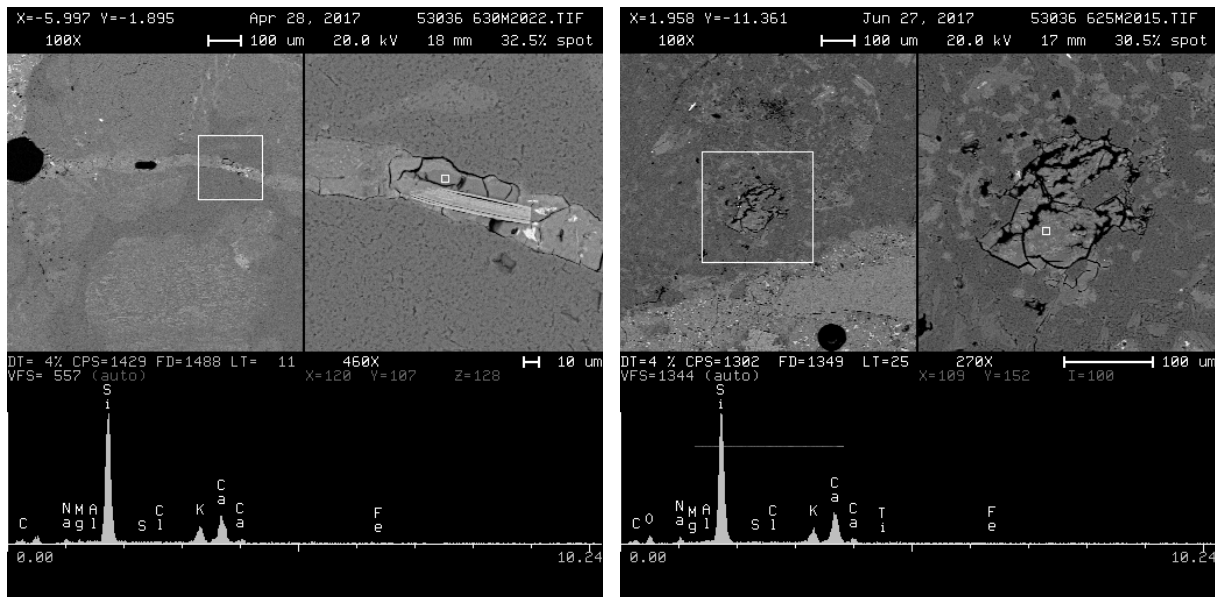
crushed natural gravel showed more significant ASR than concrete in core samples from Mix 3, which only contained the crushed volcanic rock type (Coarse/Intermediate 2). The majority of ASR in cores from Mix 2 was detected in the Intermediate Aggregate 1. Only a trace amount of ASR gel within pockets inside of aggregate particles was found in Mix 3 cores; examples are presented in Figure 3.4.

Figure 3.4: Backscattered electron (BSE) images with EDS spectra of ASR gel within pockets in Coarse Aggregate 2.
