## Concrete block sites in Brazil for assessing ASR, ISA and coupled attack over time

*This paper presents a Furnas R&D program that is being carried out in Brazil related to concrete blocks that are being monitored, and are supposed to last for a long time. They were cast with different concrete material combinations, different situations of local exposure and also microclimate in order to evaluate ASR, ISA and their coupled attack. All blocks were properly instrumented. The general purposes are to study their behaviour in respect to expansions, deformations, and changes in their characteristics over time. They are being subjected to non-destructive and also destructive tests in order to detect their changes over time due to DEF, AAR or both. Testing on their elasto-mechanical properties, as well as microstructural analyses are being performed. Similar situations were developed in the laboratory with the purpose to correlate them subsequently with real field performance of the concrete blocks. The program is at the beginning, and some results already obtained are presented in this paper.*

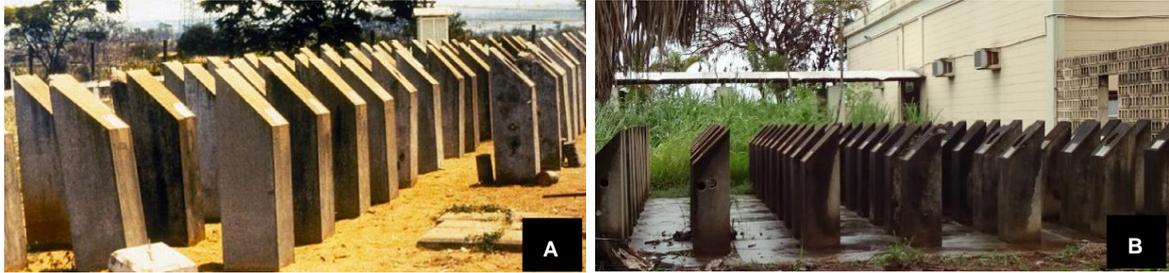
Figure 1.1: CESP's exposure blocks in Ilha Solteira laboratory: A) early 70's (Source: Flavio Salles); B) February 2019 (Source: Selmo Kuperman).

For this reason, exposure blocks are of utmost importance. In the early sixties when the construction of Jupia hydroelectric powerplant and later when Ilha Solteira hydroelectric powerplant, in Brazil, had started to use crushed basalt and also river gravel as coarse aggregates. However, the gravel contained chalcedony and agate being therefore highly reactive with the cement alkalis. A plant that produced artificial pozzolan from calcined clay was installed nearby the Jupia site and supplied material to mitigate the potential ASR. Considering that it was a new achievement, in those days, CESP the hydropower plants owner decided to build in the early seventies its first exposure site to check the performance of the new pozzolan. Several blocks were cast containing a variety of concrete mixtures, with and without pozzolan in order to compare their behavior throughout the years. Figure 1.1(a) shows the blocks and some specimens to be tested still during construction of the powerplant. Figure 1.1(b) shows the blocks at the laboratory, still being studied after almost 50 years by others. Figure 1.2(a) compares the situation of concrete block number 10, cast with the reactive aggregate and with the mentioned pozzolan in 1974 and in 1997 showing that there are no cracks. Figure 1.2(b) shows block 9 that was cast without pozzolan and presenting cracks already in 1974 and some more in 1997.

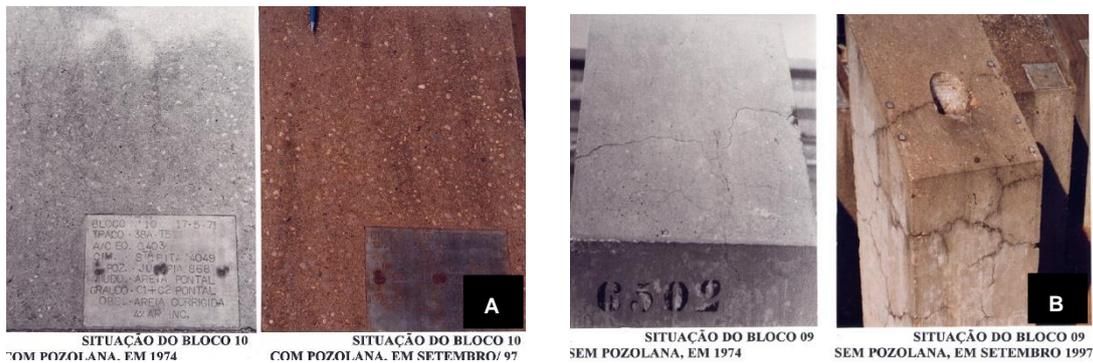
Figure 1.2: A) Block 10 - concrete containing reactive aggregates and pozzolan, in 1974; B) Block 9 – concrete with reactive aggregate and no pozzolan, in 1997 (Source: Flavio Salles).

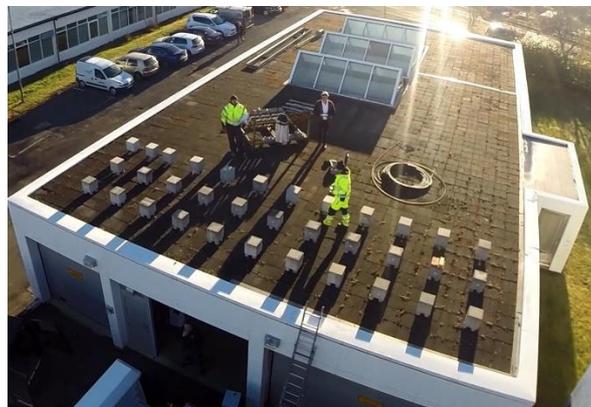
Figure 1.4: Exposure site in Reykjavik, Iceland (Source: Börge Wigum).

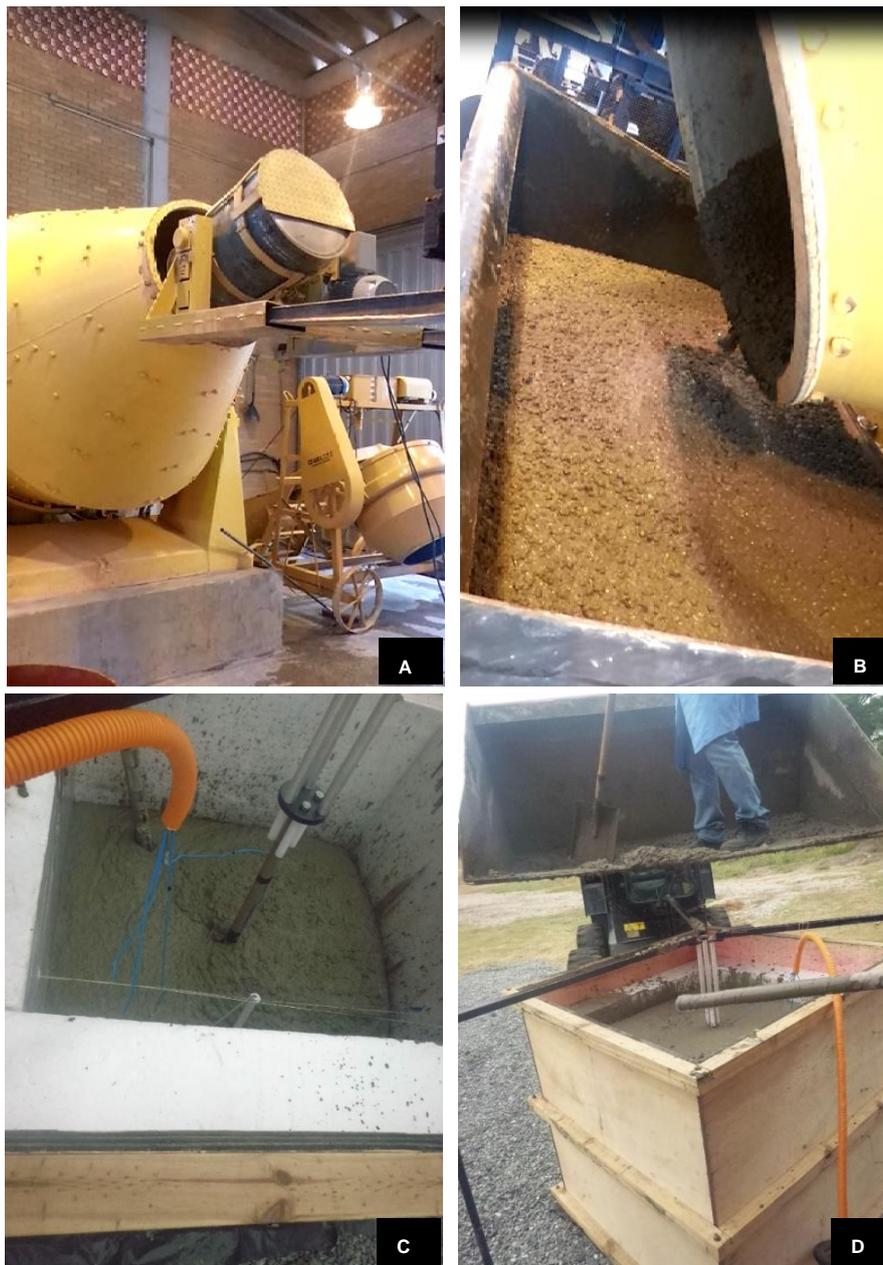
Figure 2.1: Sequence of casting and placing concrete: A) Mixer; B) Concrete aspect; C) Concrete being filled in the block, inside the polystyrene wall formwork; D) Overview of block with fresh concrete.

Brazil. It is a pumped concrete commonly used on trunnion beams of hydroelectric power plants; thus, cement content was of 471 kg/m<sup>3</sup> and a percentage of about 48% of sand was used. A 1.5 m<sup>3</sup> concrete mixer was used in order to produce the total volume of concrete for one block, each time (Figure 2.1). Two Portland cements were used in the experimental program, as follows: a high early strength Portland cement – HSPC (Brazilian standard CPV ARI - similar to type III of ASTM) and a Portland Pozzolanic cement with fly-ash (Brazilian standard CPIV ARI - similar to type IP of ASTM). Nanosilica was also used as mineral admixture besides fly-ash in order to evaluate the mitigation process. Concrete slump was 200 mm, and air content equal to 1.3%. A water-reducing admixture was also used in order to set the consistency of concrete mixtures (Figure 2.1; 2.2). Supposedly the admixture that was used will not affect neither DEF nor ASR reactions that will occur.

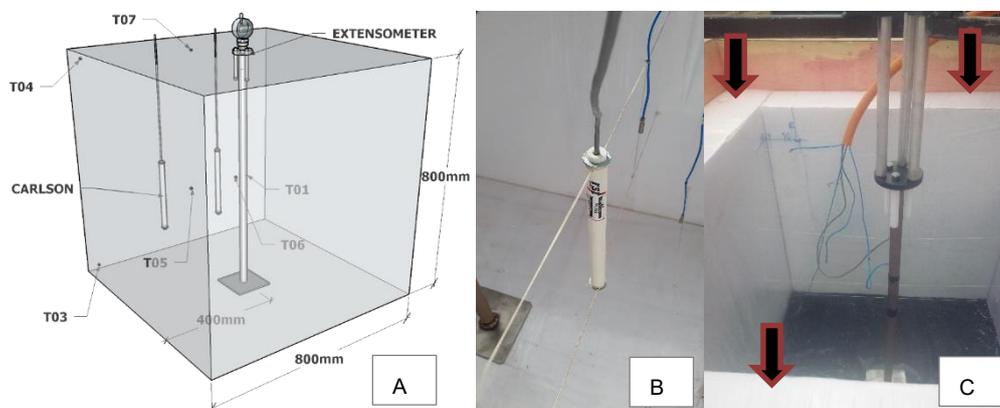
Figure 2.3: Schematic location of each instrument: A) Schematic figure of measuring instruments; B) Carlson type strain meter; C) Rod extensometer with a view of the white polystyrene plate (see arrows).

All blocks are cubes with dimensions 0.80 m x 0.80 m x 0,80 m. Wooden formwork was used and in order to retain heat and simulate mass concrete polystyrene plates were placed inside the formwork, in the sides and also at the bottom and top. A proper plate thickness of 0,15 m was required, according to a previous thermal modelling study involving concrete characteristics and heat dissipation. Instruments were meticulously installed, such as Carlson type strain meter and also a rod extensometer, according to Figure 2.3. For the first blocks, four thermometers (thermocouple type) were also inserted at fixed points to measure the blocks internal temperatures (Figures 2.3 and 2.4). Carlson instrument measures deformation and temperature and rod extensometer allows monitoring vertical displacements in the center of blocks. Those instruments are currently used in the hydroelectric power plants during the auscultation campaigns of the concrete structures, according to the requirements fixed on the national standard for dam safety. For the reference blocks and also ASR evaluations, temperatures were not allowed to rise above 60°C. To achieve this a pre-cooling system with ice replaced water in the mix and a post-cooling system was used by embedding pipes inside the block and circulating water cooled with ice to prevent high temperatures (see Figure 2.4). Also, for those situations, the polystyrene plates were not used inside the formwork. After the temperatures reached their maximum, the formworks were removed and pre-defined areas for NDT were marked in the surface of all concrete blocks. The rod extensometer is adjusted and positioned at the top of blocks in order to register the first measurements. Data of temperatures from the thermocouples and deformations measured by Carlson type strain meters are continuously read through dataloggers.

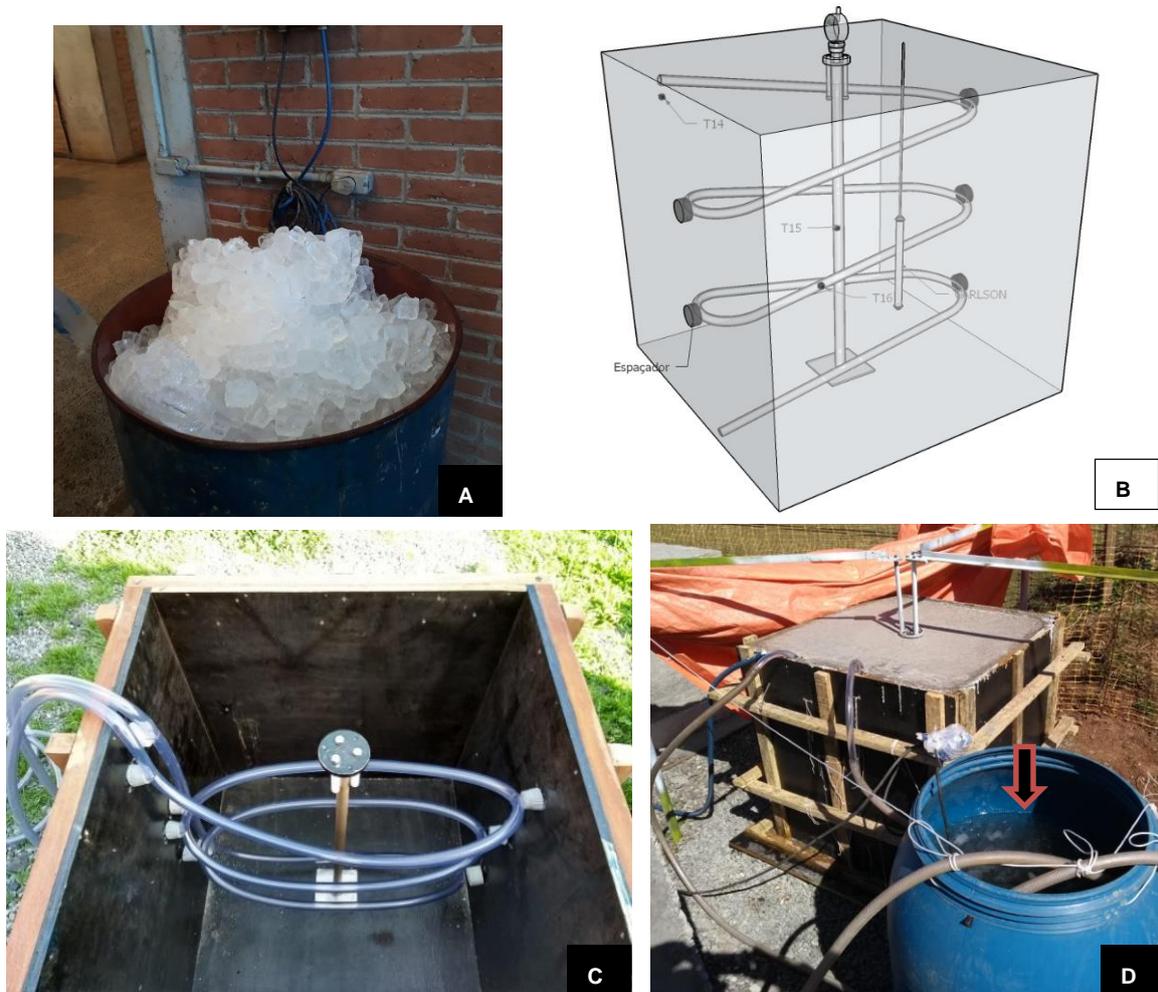
Figure 2.4: Details of pre-cooling with ice (A) and pos-cooling system (B;C) with ice water (D), see arrow (block without polystyrene plates).

Reference blocks were cast with cooled concrete through the use of ice instead of water in the mix and were subjected to post cooling through embedded pipes of flexible PVC. Tests are being conducted on extracted samples from the blocks, compared with laboratory cylinders and prisms casted with the same concrete mix design and also with pastes and mortars produced with the same materials.

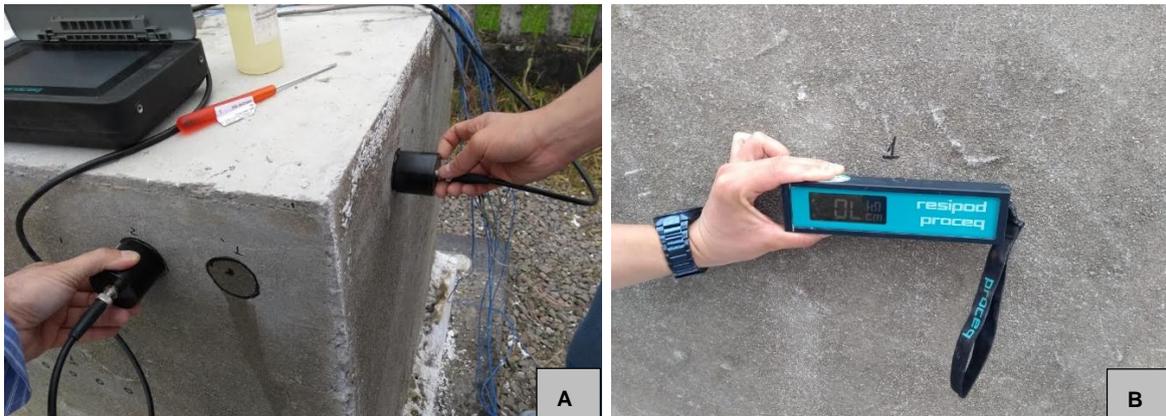
Figure 3.2: NDT ongoing measurements: A) Ultrasound; B) Electrical Resistivity.

There is a periodicity of above investigations: for the mechanical and microstructural analyses of concrete cores, it will depend on the symptoms observed along time with, at least, one drilling per year. Each age of drilling considers 1 sample able to be divided into 2 specimens for mechanical properties; after tests, the material will be analysed by SEM/EDS and other techniques, if possible. A reference sample is always taken from each block at about 4-6 months, before considering damages from the expansive reactions (Figure 3.3 and 3.4). NDT tests involve Ultra Sound tests and Electrical Resistivity

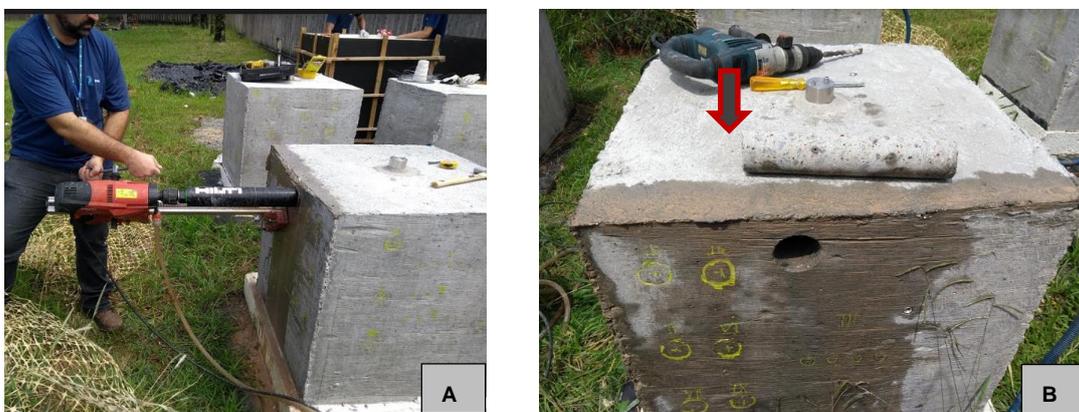
Figure 3.3: Core drill in operation & concrete core drilled.

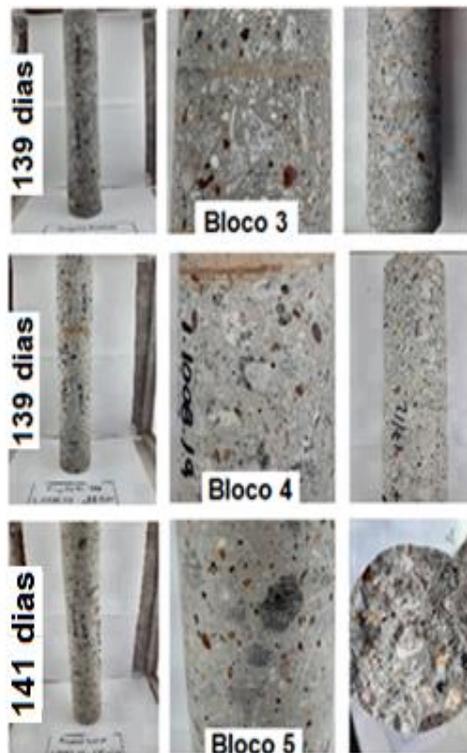
Figure 3.4: Some concrete cores drilled from blocks.

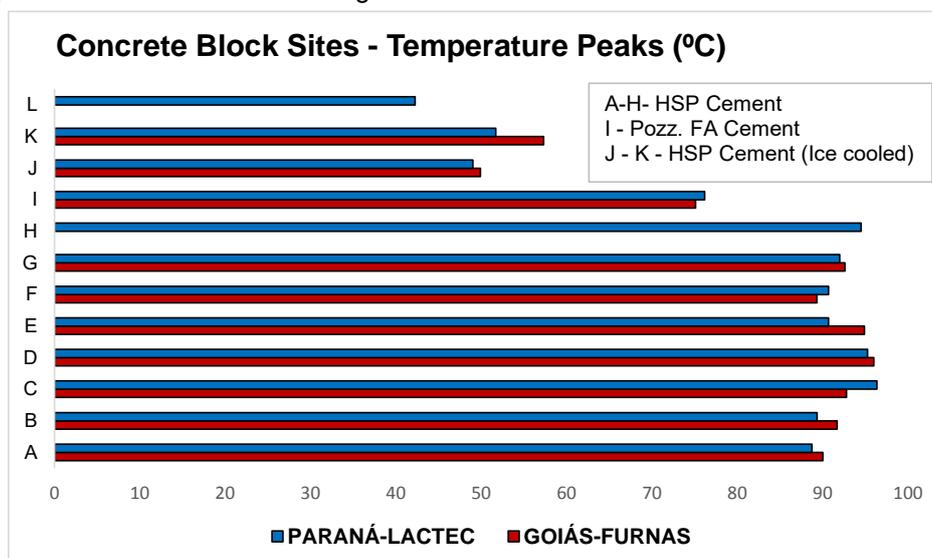
Figure 3.5 presents temperature peaks (maximum values) achieved for each concrete block. It is important to highlight that the blocks with peak temperatures below 60°C were those submitted to pre-cooling and post-cooling. Some were destined to be reference concrete for DEF tests (with non-reactive aggregates). Others were reference concrete for ASR (with reactive coarse aggregate). Concrete cast with Portland pozzolanic cement with about 26% of fly-ash reached temperatures about 75°C. Concrete produced with high early strength cement reached an average temperature of 92°C, being therefore able to trigger DEF and also DEF&ASR. Thus, the initial simulation of temperatures provided by the finite element method modelling proved to be adequate, since the objective of obtaining a high temperature was attained favouring the DEF attack.

Figure 3.5: Maximum temperatures achieved in the centre of block.

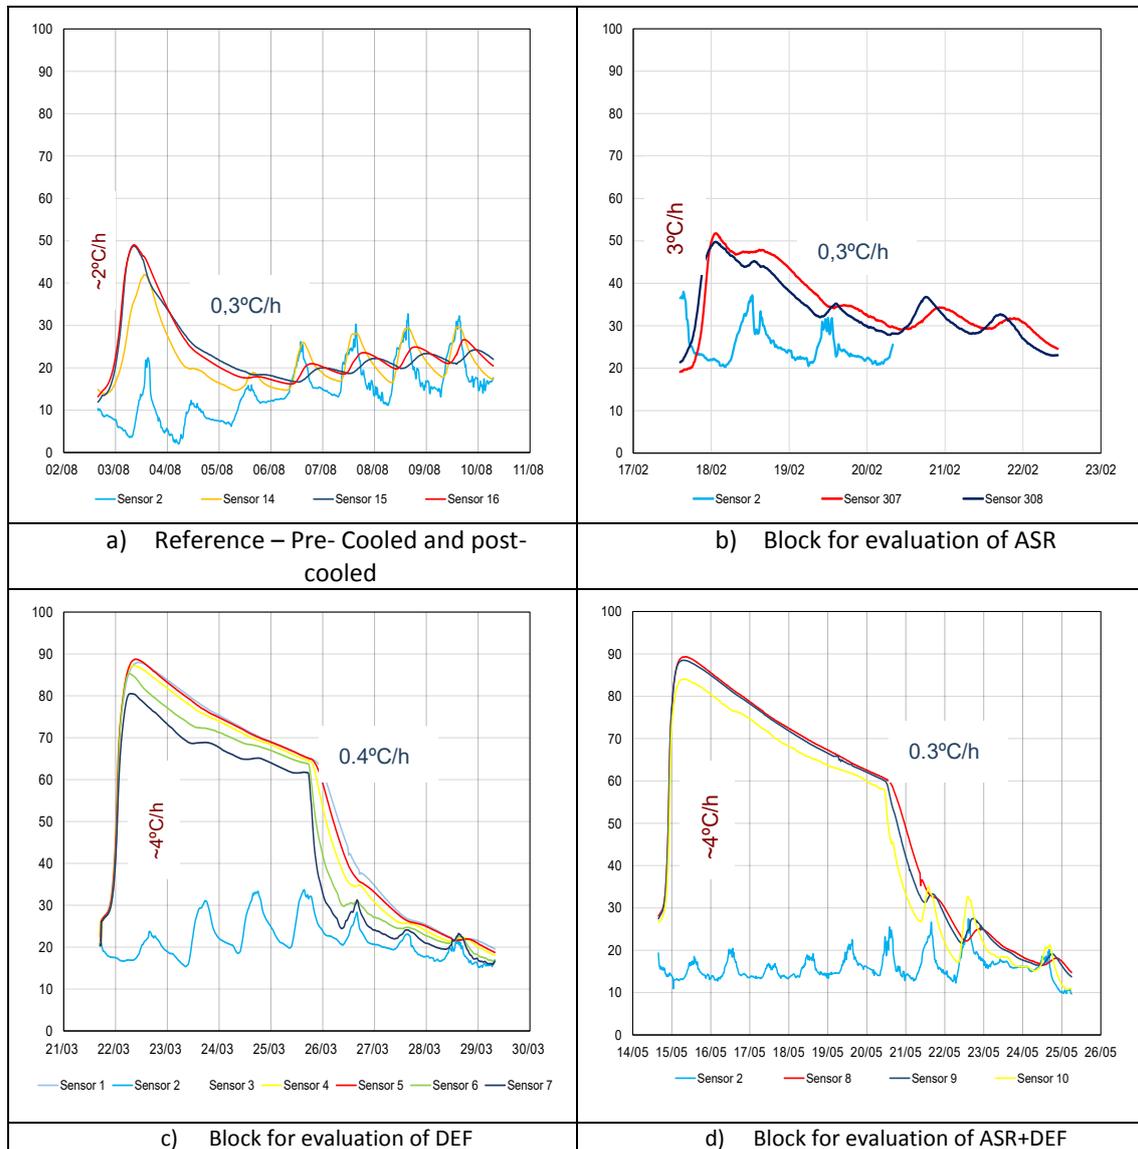
In the Figure 3.6 the temperatures that were collected from the datalogger, after casting concrete blocks, and also the behaviour of thermocouples installed in different points are presented. The ambient temperature was also registered (in blue). It is interesting to observe in the figures the heating and cooling rates. The pre-cooled and post-cooled concrete mixtures (a;b) show that both rates are smaller when compared to the others (concrete casted in the presence of the polystyrene plates) (c;d), that achieved temperatures next to 90°C.

Figure 3.6: Temperatures collected after casting concrete and their behavior between the four thermocouples installed inside some blocks.

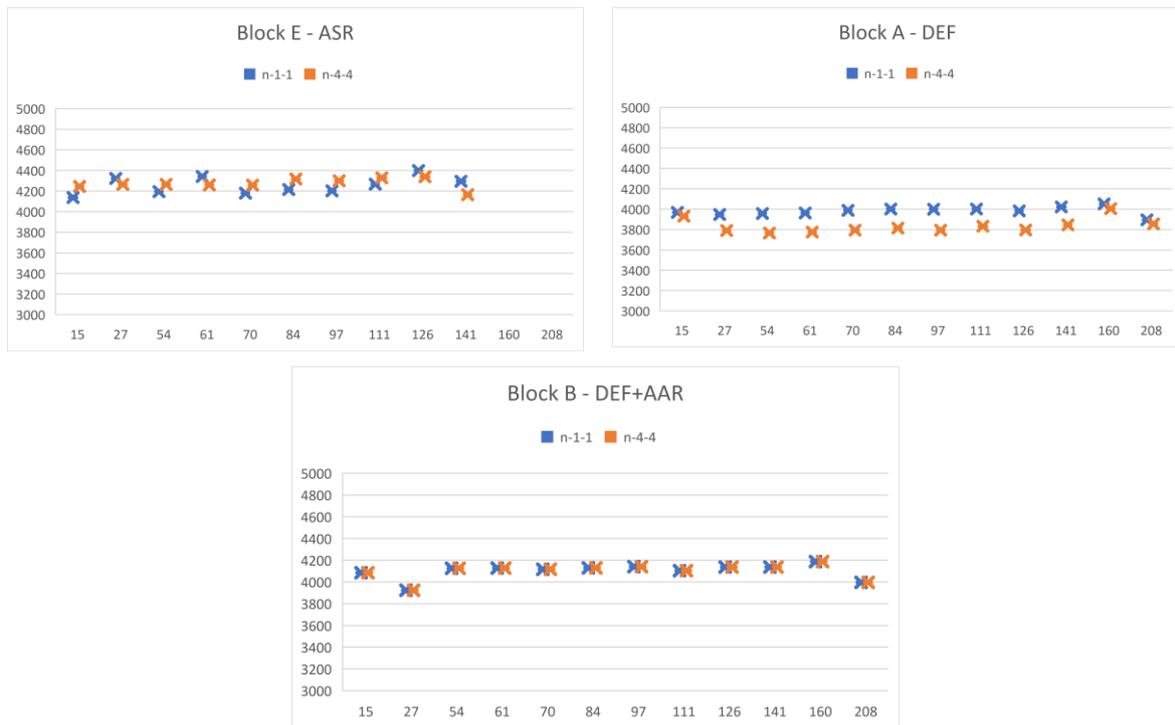
As for NDT, some results from US velocity are presented (Figure 3.7). The direct method and two locations at each block were used (n.1-1 and n.4-4). The lowest values of ultrasound velocity were achieved for DEF situation. By comparing the average between all blocks, once more, no important variation was perceived until the last age of evaluation (Figure 3.8) neither for both tested points. The main purpose of using US is to follow the occurrence of cracks in the blocks that will be subjected to DEF. It is important to notice that no cracks are visible in the blocks yet.

Figure 3.7: US data over time for ASR, DEF and ASR&DEF situations of blocks. (Site: FURNAS-Goiás)

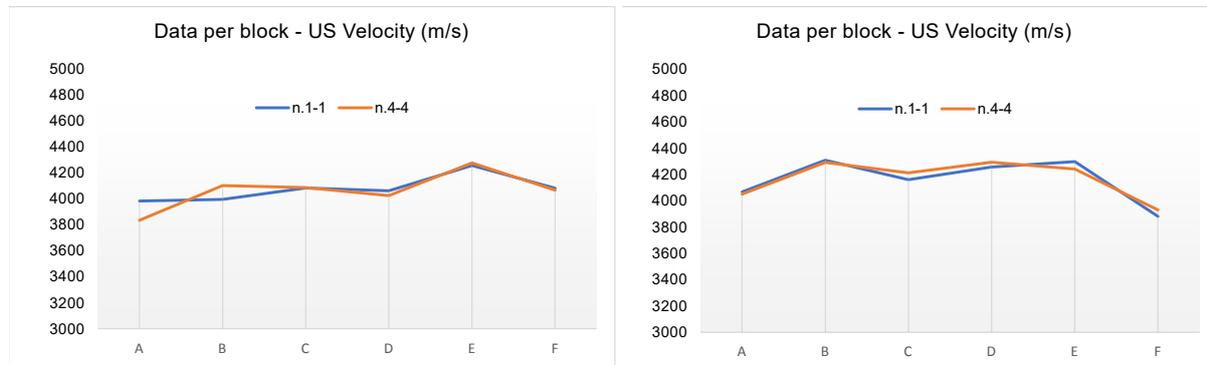
Data from Furnas concrete blocks.

Data from Lactec concrete blocks.

Figure 3.8: US average data per block

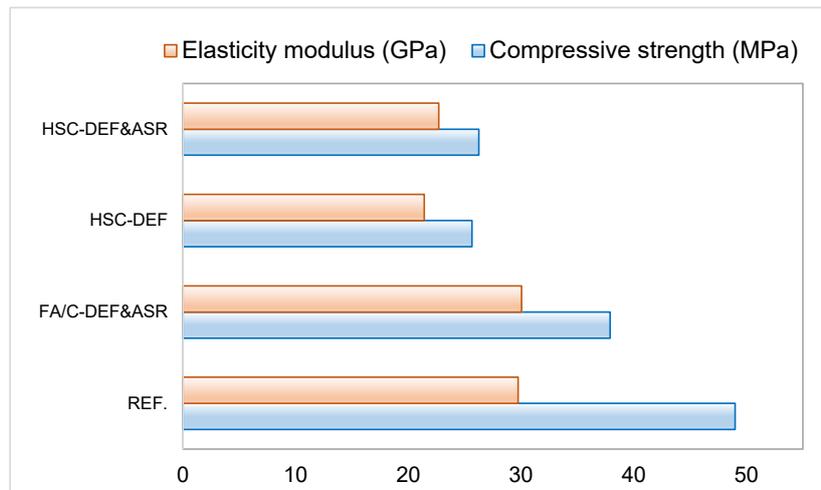
Concrete cores were drilled from the blocks at about 4-6 months as reference samples for comparisons at further ages of monitoring. Results of elasticity modulus and compressive strength are presented hereinafter (Figure 3.9). It is important to inform that REF (Reference concrete) was not subjected to high temperatures. Compressive strength and also elasticity modulus are higher for REF., followed by the block made with Portland pozzolanic cement, as expected. For both studied conditions (DEF and DEF&ASR) involving HSC (high early strength Portland cement), results are almost the same and lower than the formers mentioned.

Figure 3.9: Mechanical properties of some concrete cores drilled from blocks.

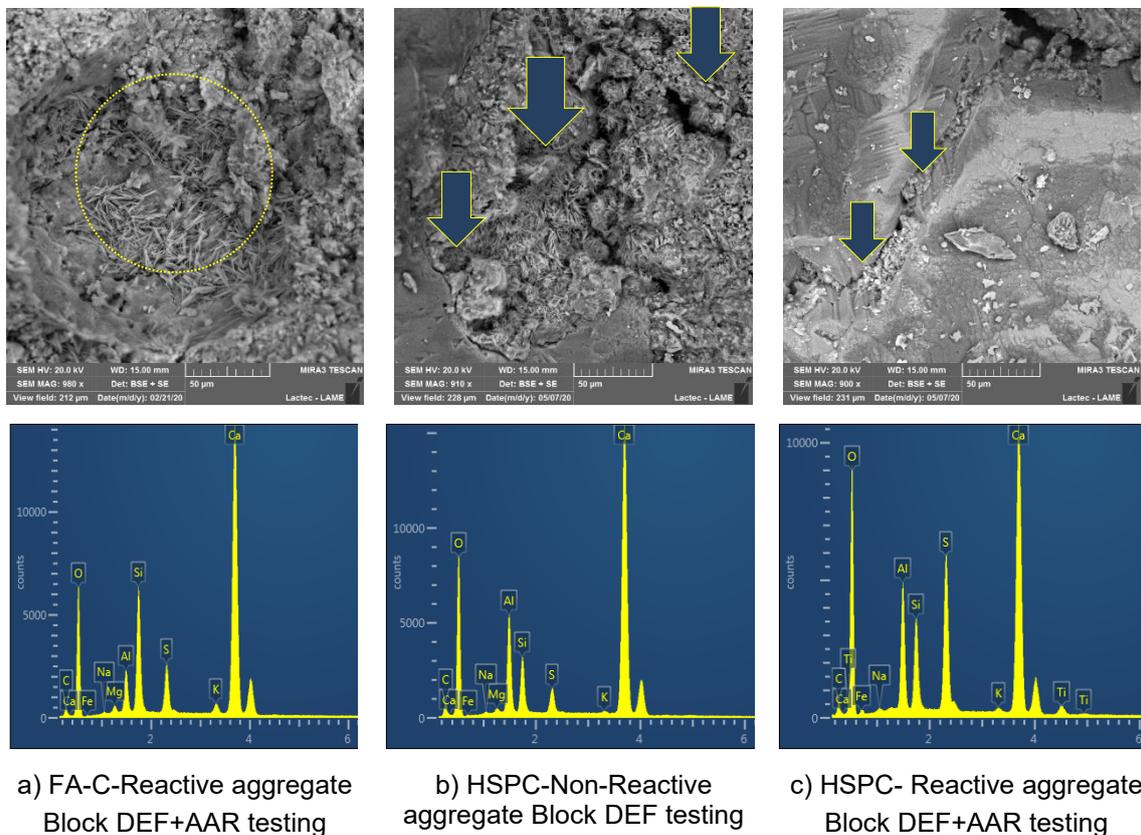
A few microstructural analyses of concrete cores were performed due to the early age of concrete blocks. Figure 3.10 (a-c) presents initial images and EDS spectra for three situations analyzed by MEV/EDS in fracture samples (i.e.: DEF and ASR+DEF). In the concrete mixtures with reactive aggregate no ASR gel was detected yet, probably due the recent age of concrete; besides some ettringite crystals were seen (a;c). For concrete with fly-ash, the incidence was minimal, and solely in the void bottom. In the presence of high strength cement, some ettringite was detected inside an aggregate cleavage, filling it (see arrow). Considering the analyses in the concrete condition for DEF, individually, several crystals appeared concentrated inside voids and next to the ITZ (b).

Figure 3.10: SEM/EDS analyses.
