Assessment of ASR damage to a heavily trafficked dual carriage concrete roadway in South Africa

This paper reports on the diagnosis and rehabilitation strategy used to repair 11.2 kilometres of a dual carriageway concrete pavement forming part of a South African National Road (N2), near Somerset West in the Western Cape Province. Construction of the section of interest in this study took place between 1971 and 1972. The original design comprised of a 25 km span jointed unreinforced concrete pavement on a stabilised base. The pavement exhibited signs of serious ASR deterioration in 1986. Subsequently, the entire dual carriageway surface was sealed with a 14 mm stress-absorbing membrane interlayer (SAMI) in a bid to preserve the integrity of the pavement. A 40 mm Bitumen Rubber Asphalt Semi Open Graded (BRASO) mix was also overlaid on the concrete surface. However, by 2017, the road section exhibited transverse cracks through the asphalt overlay across all lanes, mimicking the underlying jointed concrete slabs. Cores were extracted from the dual carriageway trial section to evaluate the performance of the existing BRASO overlay and to assess the degree of ASR degradation. The initia

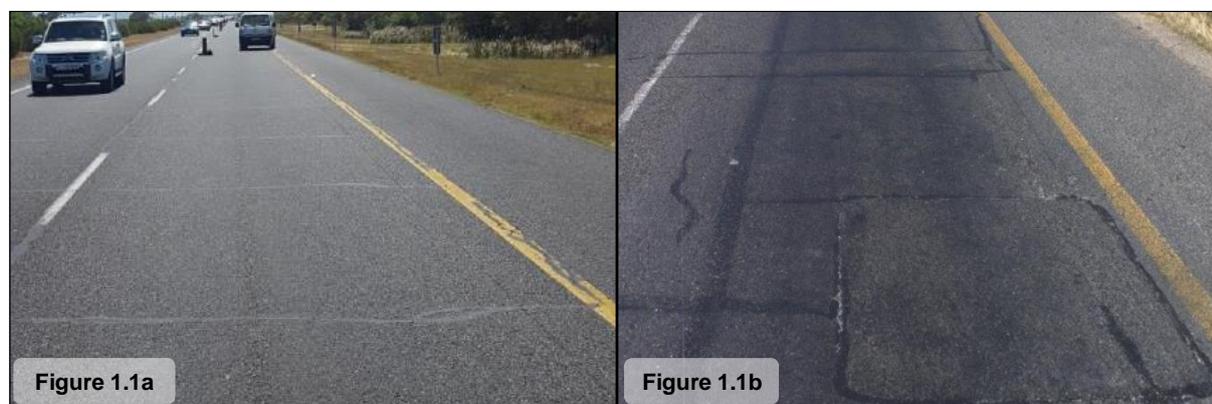
However, in 2017, transverse reflective cracks propagated through the aged BRASO overlay at regular 4-meter intervals, across all the four lanes of the dual carriageway (as seen in Figure 1.1a and 1.1b). Additional cracking was seen to branch off the original reflective cracks and at numerous transverse joints (Figure 1.1a). Subsequently this resulted in asphalt being shoved in the wheel track. Reflective cracking was also noted around previously patched areas and at old joints (Figure 1.1b). Secondary effects of the cracking included a reduction in riding quality of the composite pavement structure [14].

Figure 1.1: a - Transverse reflective cracks propagated through the aged BRASO overlay at regular 4-meter intervals. b - Reflective cracking around previously patched areas and at old joints

A consulting engineering firm (Royal Haskoning DHV) was appointed in 2017 to advise on the repair of a section of the pavement (11.2 km span), and recommended a rehabilitation approach which involved:

- (i) milling and removing the 40 mm existing BRASO overlay and 14 mm Stress Absorbing Membrane Interlayer (SAMI);
- (ii) thoroughly cleaning the exposed plain-jointed concrete surface to remove all loose material. Approximately 5-8 mm of the exposed JCP surface was finely milled and removed, and thoroughly cleaned again to remove all loose material before it was inspected to ascertain its integrity. In the instance where its integrity was compromised, the defective joints were repaired by partial depth repairs (concrete patching).
- (iii) application of a bituminous tack coat on the concrete surface to promote bonding between the existing concrete and the overlay;

construction of a 50 mm Bitumen Rubber overlay proceeded by a 20 mm Ultra-Thin Friction Course (UTFC).

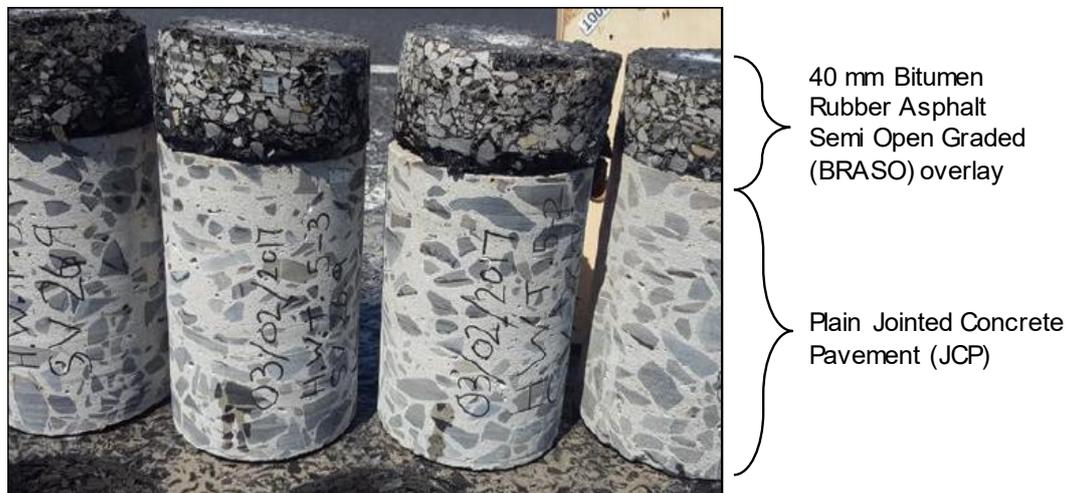
The existing BRASO overlays on top of the concrete pavement (see Figure 2.2) were sawn off and tested. The scope of testing of the BRASO overlays and the results thereof are not within the scope of this paper.

Figure 2.2: Image of cores extracted from N2 Pavement comprising of 40mm Bitumen Rubber Asphalt Semi Open Graded (mix) overlay constructed on original the plain jointed concrete pavement

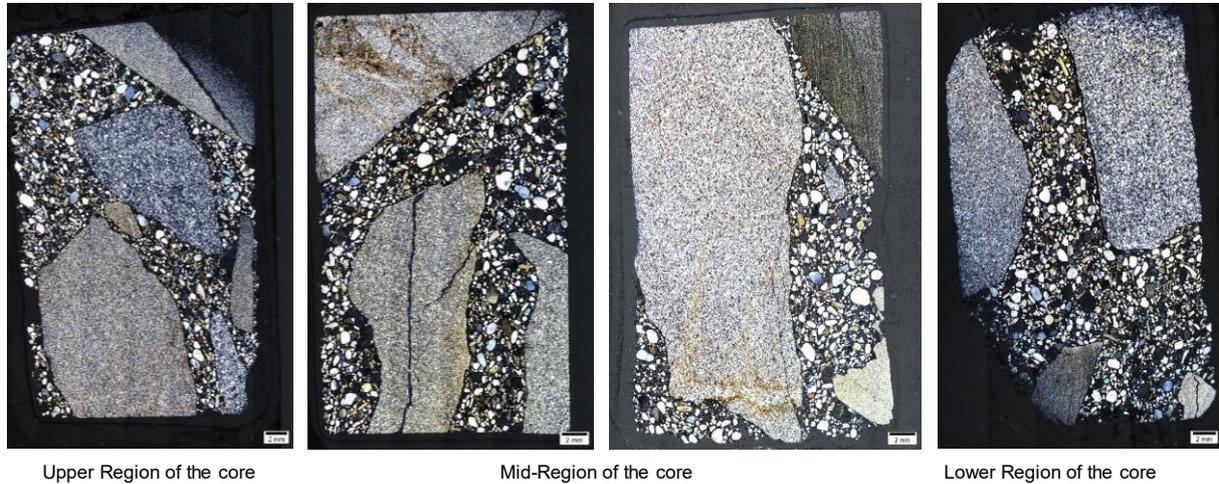
Thin sections were produced from the upper, mid and lower region of the concrete cores. Figure 3.2 confirms the presence of cracking primarily present in the coarse aggregates which was more pronounced in the mid-region as noted in the initial visual assessment of the cores.

Figure 3.2: Images of thin section taken from the upper, mid and lower region of the concrete core, under crossed polarised light (scale bar = 2 mm (as shown at the bottom right of each image))
