Evaluation of the presence of ettringite in concrete structures affected by alkali-silica reaction

Víctor Lanza ⁽¹⁾, Pilar Alaejos ⁽²⁾

(1) CEDEX (Ministry of Public works), Madrid, Spain, vlanza@cedex.es

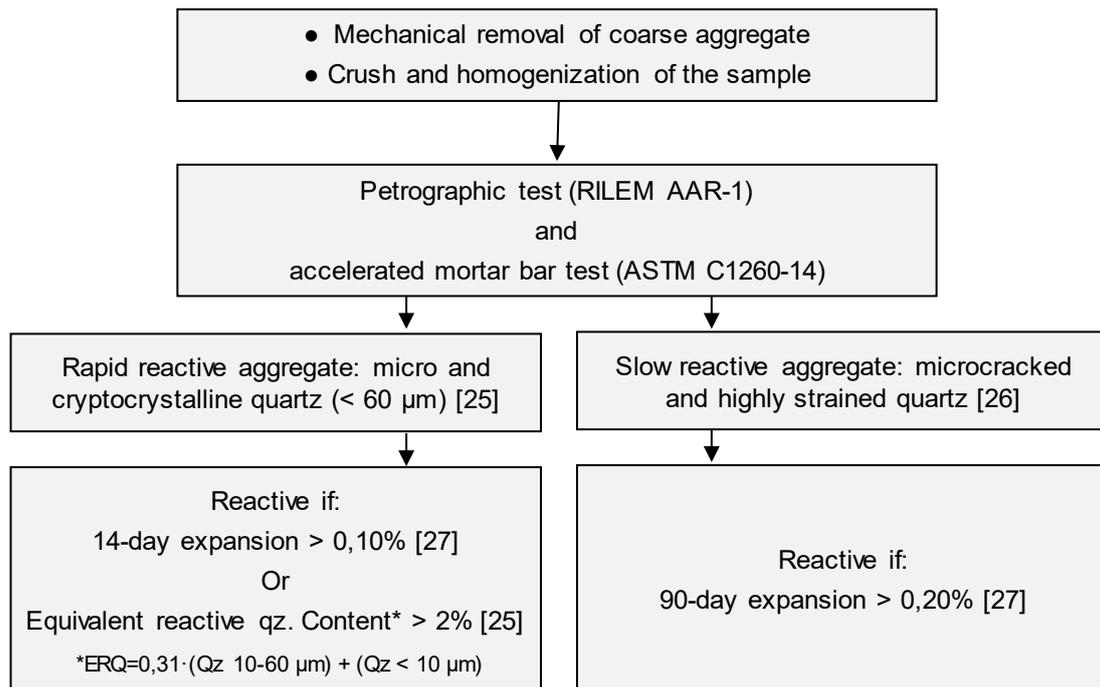
Figure 3.1: Methodology for Alkali silica reaction diagnosis in field concrete based on the study of the aggregates [25–27].

Finally, in aggregates with some evidences of ASR (from A to E), the evaluation of aggregate reactivity has also been carried out. Figure 3.1 shows the methodology followed in CEDEX to evaluate it.

Figure 3.1 shows the methodology followed to evaluate the reactivity of aggregates with alkalis of concrete.

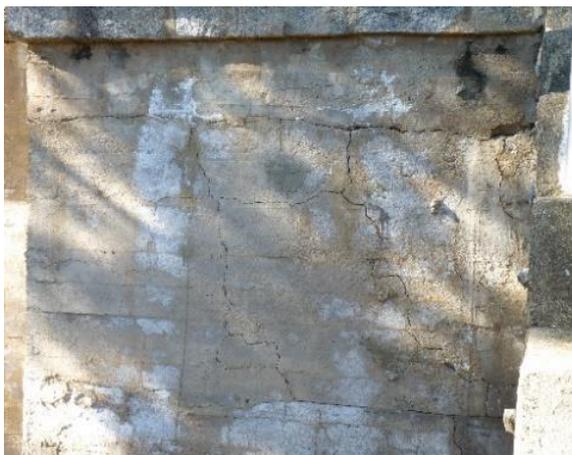
Figure 4.1: Cracking in DAM C

The inspection of structures has distinguished two groups: structures A, B, C, D and E have shown apparent signs of pathology: expansion, movement and cracking of concrete (Figures 4.1 and 4.2 are shown as examples of the visual damage). However, dams X, Y and Z have not shown any prove of expansion, movement or cracking.

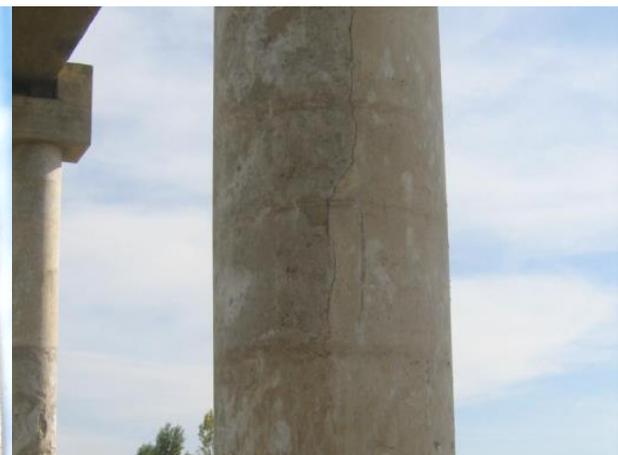
Figure 4.2: Cracking in pillar of Channel E

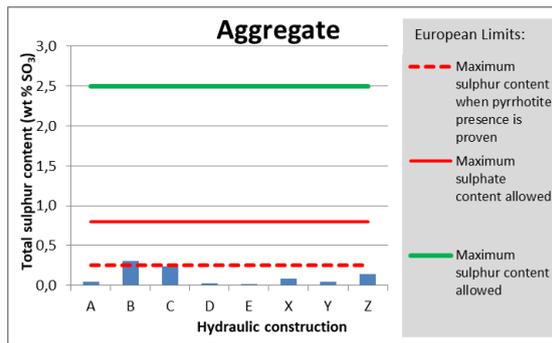
Thereby, the presence of ettringite in concrete and opaques in petrography could be indications of possible internal sulfate attack due to the presence of oxidizable sulfides. Even so, it is necessary to identify and quantify sulfides to prove it. For that purpose, Figure 5.1 shows the total sulfur content of aggregates and the threshold content for sulfur and sulfate in the European Standard UNE-EN 12620:2003.

Figure 5.1: Total sulfur content and limits.

Results of quartzites, quartzarenites and carbonated aggregates (belonging to structures A, D, E, S, Y Z) have been far from any limit (Figures 5.1 and 5.2). Therefore, an internal attack coming from the presence of sulfur in these aggregates can be discarded.

Only igneous aggregates B and C have total sulfur content close to the sulfur limit when pyrrhotite presence is proved (0,1% S). Specifically, total sulfur content of aggregate B exceeds this limit, so a deep study is necessary in this case. To do this, Spanish Standard [29] and Rodrigues et al [24] recommend that the sulfate content should be subtracted from the total sulfur content to apply the 0,1% S limit.

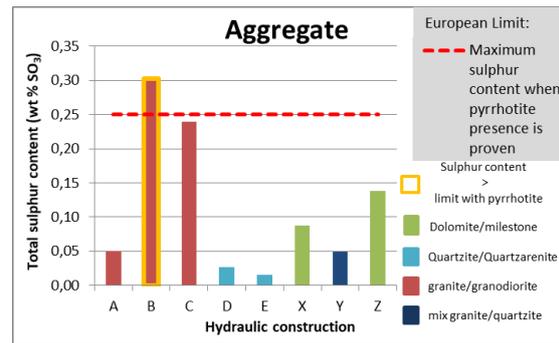
Figure 5.2: Enlargement of the Figure 2, focus in sulfide contents and its maximum content allowed.

The measure of the sulfate content in aggregate B is carried out (0,119% SO₃ [UNE-EN 1744-1:2010]) and the difference between sulfur and sulfate content has provided its sulfide content. The sulfide content of aggregate B is 0,074% S. This value is lower than the maximum allowed (0,1% S), discarding the presence of an internal attack coming from the aggregate also in this case.

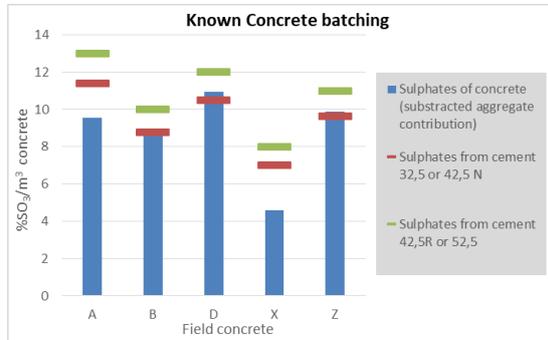
Figure 5.3 shows the results obtained when sulfate content of concrete is compared with the cement contribution, when the cement content is known.

Red and green lines are the maximum sulfate contribution of each kind of Portland cement to concrete. Blue bars are the sulfate content of field concrete, after subtracting aggregate contribution. The sulfate content of concretes A, B, D, X and Z are in accordance with the cement content used. Thus, in these hydraulic structures there has not been an internal sulfate attack because of an excess of sulfates in concrete.

Figure 5.3: Evaluation of sulfate content of concrete when cement content is known.

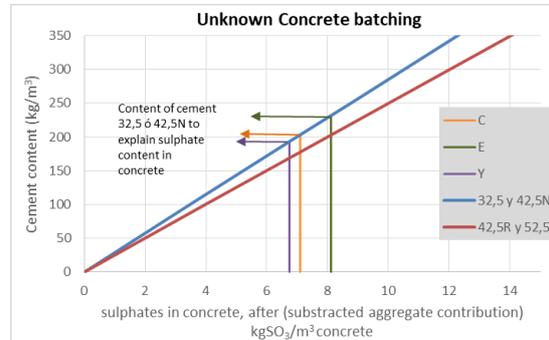
When cement content is unknown (field concrete C, E, Y), it is calculated the amount of cement that fits the sulfate content measured in each concrete. Although the analysis of results is more accurate when cement content is known, this estimation will allow to evaluate if concrete has an excess of sulfates.

Figure 5.4: Evaluation of sulfate content of concrete when cement content is unknown.

The cement contents obtained in field concrete C, E and Y are between 193 and 232 kg cement 32,5 or 42,5N by m³ of concrete (Figure 5.4). These cement contents are consistent with the other concretes from the dams studied, always with cement content lower than 350 kg/m³. Thus, field concretes C, E and Y have a normal amount of internal sulfates according to the usual cement content in concrete for dams, so an internal sulfate attack due to an excess of sulfates in these structures is discarded.

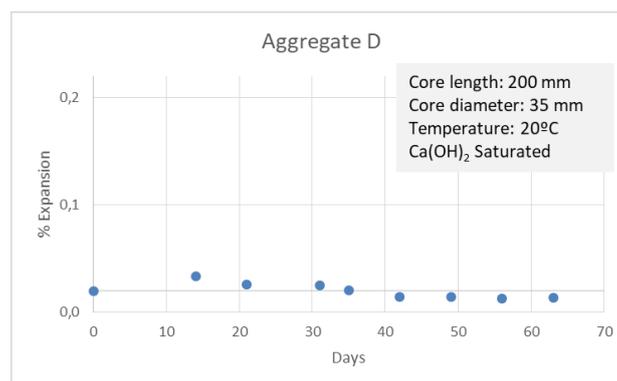
Figure 5.5 shows the expansion results obtained.

Figure 5.5: Aggregate D. DEF Residual expansion

Although the test is still going on, Concrete from dam D has not expanded during the first 63 days of test. These results indicate that delayed ettringite formation is not expanding concrete nowadays.
