Monitoring the structural effects of internal swelling reactions in Aguieira bridges

Extended Abstract

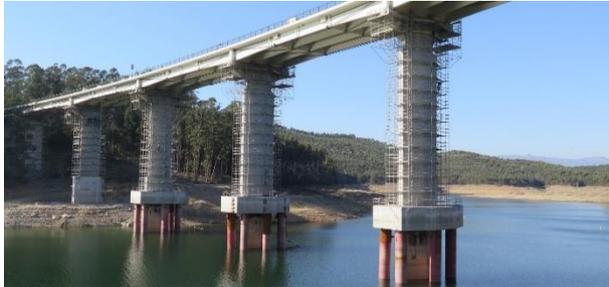
Figure 1: Criz II Bridge at the end of the rehabilitation works

The Second Bridge over the river Criz, usually called Criz II Bridge, has a total length of 300 m with six intermediate spans of 40,0 m and two extreme spans of 30,0 m. The height of the piers varies between 27 m and 70 m. The piers P2 to P6 are founded inside the reservoir, with a maximum foundation depth of about 35 m.

The rehabilitation works of the piers and foundations of these bridges took place in 2016 and 2017. As mentioned, it consisted in the execution of six piles around each pier, headed by a pre-stressed reinforced concrete pile cap, to ensure the load transfer to the new foundations when the stiffness of the immersed part of the pier decreases due to the swelling reactions. The piles built have 1,50 m diameter in Criz II Bridge (Figure 1) and 1,20 m diameter in São João da Madeira Bridge (Figure 2).

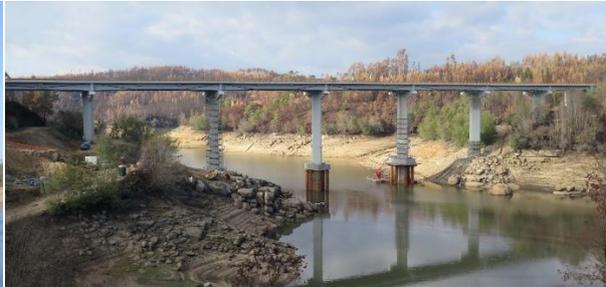
Figure 2: São João das Areias Bridge at the end of the rehabilitation works

The São João das Areias Bridge over the Mondego River has a total length of 260 m, with five intermediate spans of 40,0 m and two extreme spans of 30,0 m. The height of the bridge piers varies between 17,2 m and 50,6 m.
